City of Oxnard

Public Works Integrated Master Plan

**PROJECT MEMORANDUM 5.3
CONDITION ASSESSMENT**

CITY OF OXNARD STORM DRAINAGE CONDITION ASSESSMENT

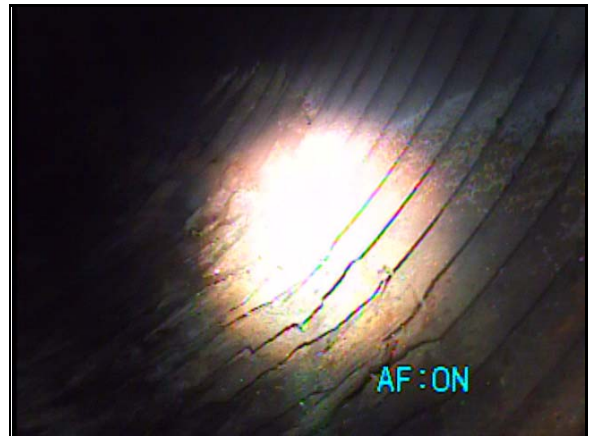
Surface corrosion

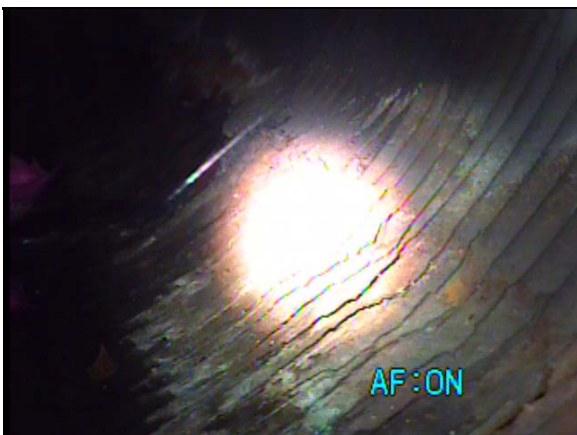
Surface corrosion

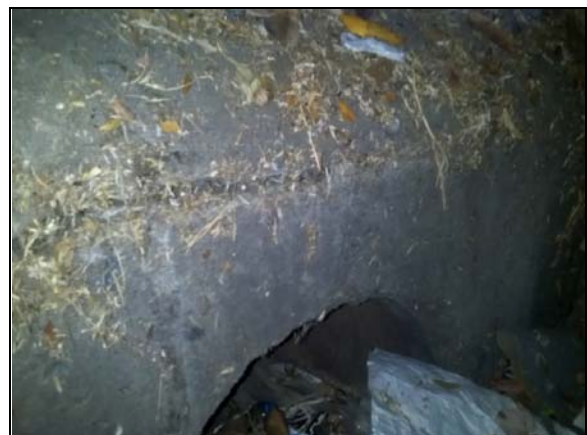
Cracking in wall

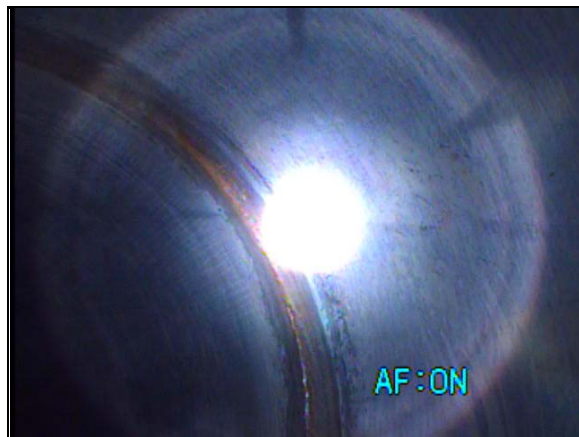
Infiltration stain
