This is a Maintenance Report generated by Cappsure for the property below.

Property Name : **58 - Westwind**

Date : **01/14/2019**

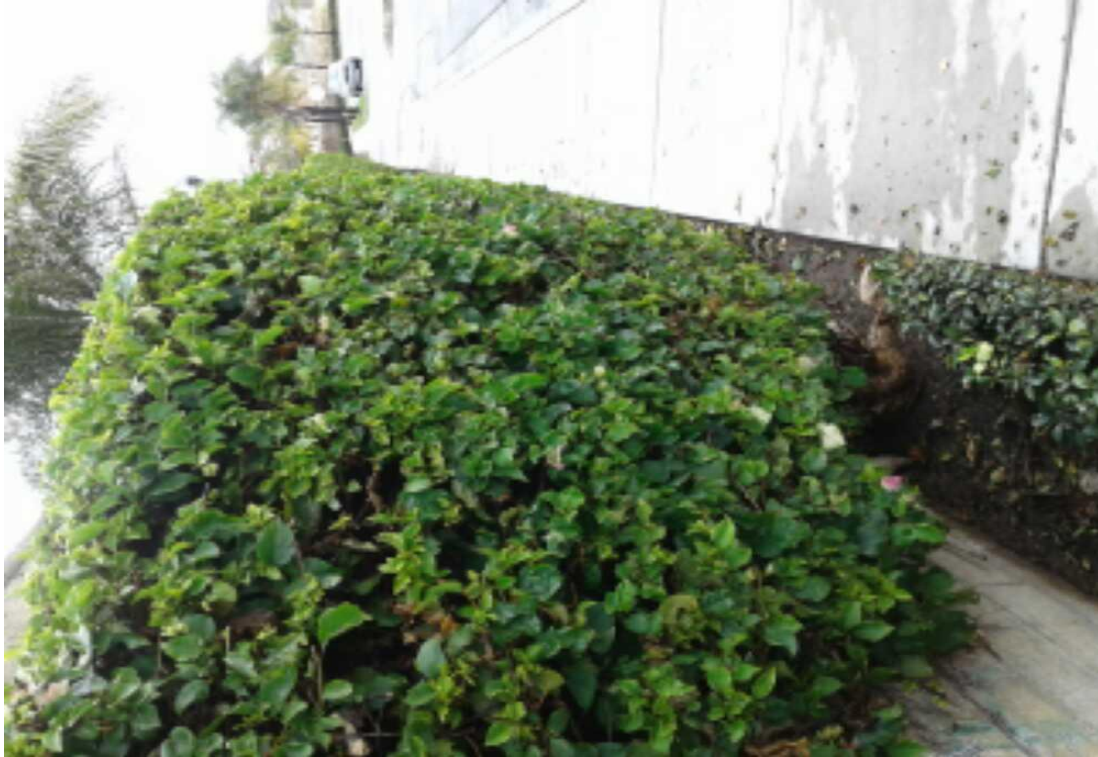
**Picture: 1**

S.NO	Item Name	Notes
1	CHECK IN-CHECK IN	
2	UNSATIS. VINE NEEDS TRIMMING- UNSATIS. VINE NEEDS TRIMMING	Vines have been well maintained, however need to start trimming them back closer to the wall to avoid some of the detaching issues that are occurring in other areas.

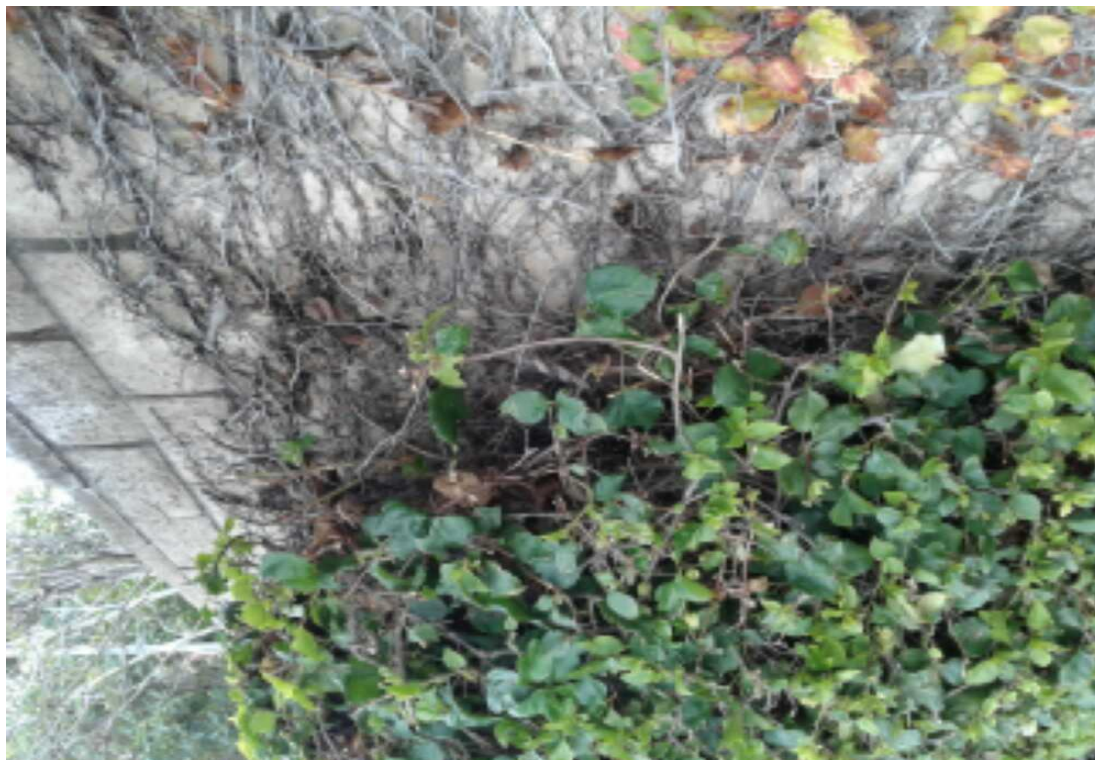
**Picture: 2**

S.NO	Item Name	Notes
2	UNSATIS. VINE NEEDS TRIMMING- UNSATIS. VINE NEEDS TRIMMING	Vines have been well maintained, however need to start trimming them back closer to the wall to avoid some of the detaching issues that are occuring in other areas.
