# Mandalay Bay Seawall Repair Conceptual Study and Feasibility Analysis - FINAL

TC39527  
March 6, 2020

**City of Oxnard**  
305 West Third Street  
Oxnard, CA 93030

**Tetra Tech, Inc.** P +1-(562) 257-2589  
249 E. Ocean Blvd., Ste. 325 F +1-(562) 495-5029  
Long Beach, CA 90802 tetratech.com

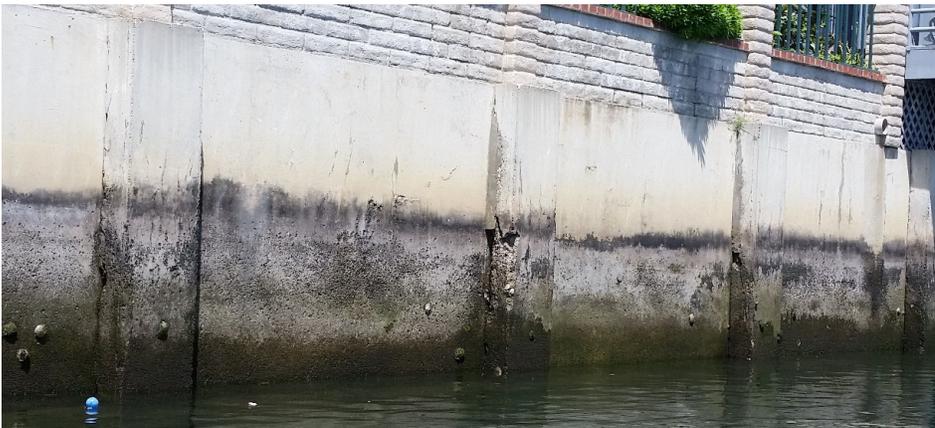
The walls are approximately 50 years old and are showing their age. The concrete face of the wall exhibits significant erosion in numerous areas, with the erosion being more significant in the cast-in-place Zurn walls. The erosion typically appears to be most significant between 2-3 feet and 5-6 feet above mean lower low water (MLLW). The

Figure 4 - Surface erosion/marine attack on Boise wall panels with cracking and spalling at pilasters

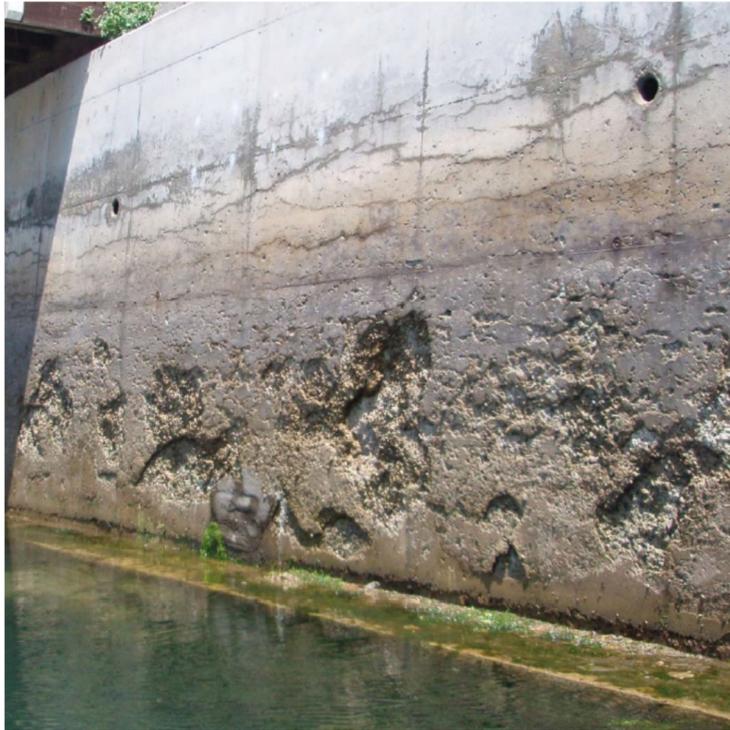
*Figure 5 - Spalling and surface erosion on Zurn wall [from TranSystems (2017)]*

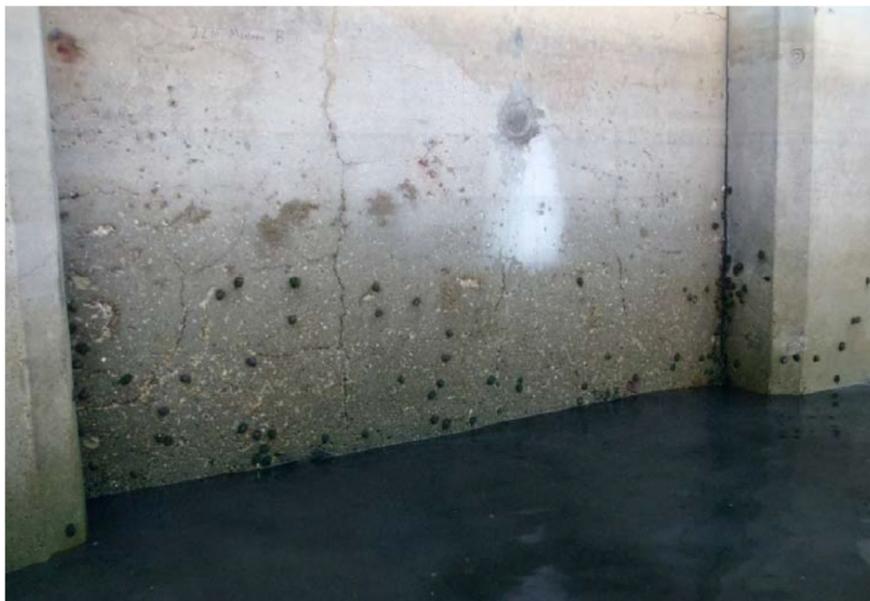
Horizontal and vertical cracking is common on the Boise wall panels, as is vertical cracking on the pilasters. In some cases, the cracks on the pilasters are several millimeters across. Surface cracking is less prevalent on the Zurn walls and appears to be most common near corners and joints where thermal movement may be contributing.

*Figure 6 - Surface erosion and vertical cracking on a Boise wall panel [from TranSystems (2011)]*

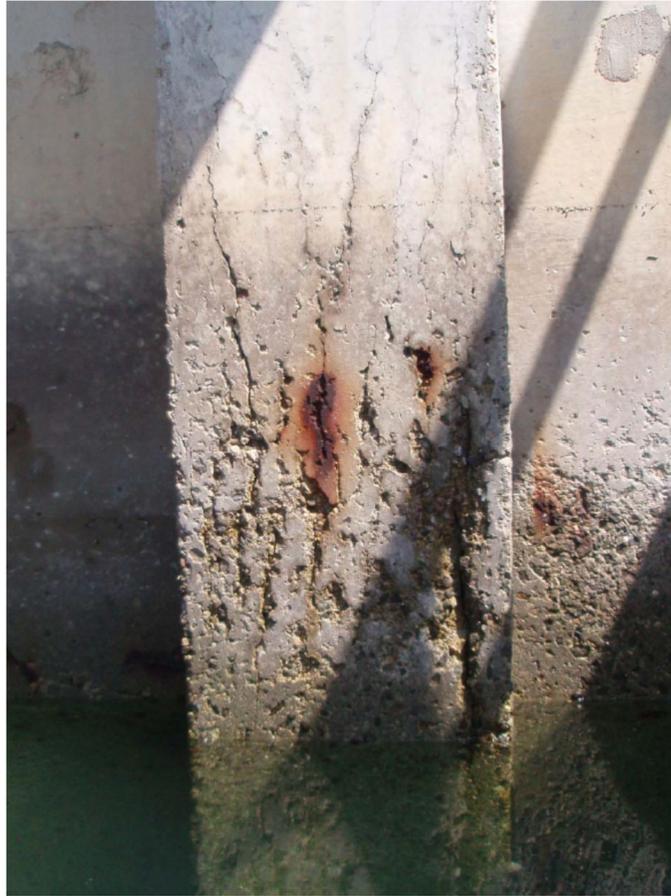
*Figure 7 - Vertical cracking and spalling on Boise wall pilaster [from TranSystems (2017)]*

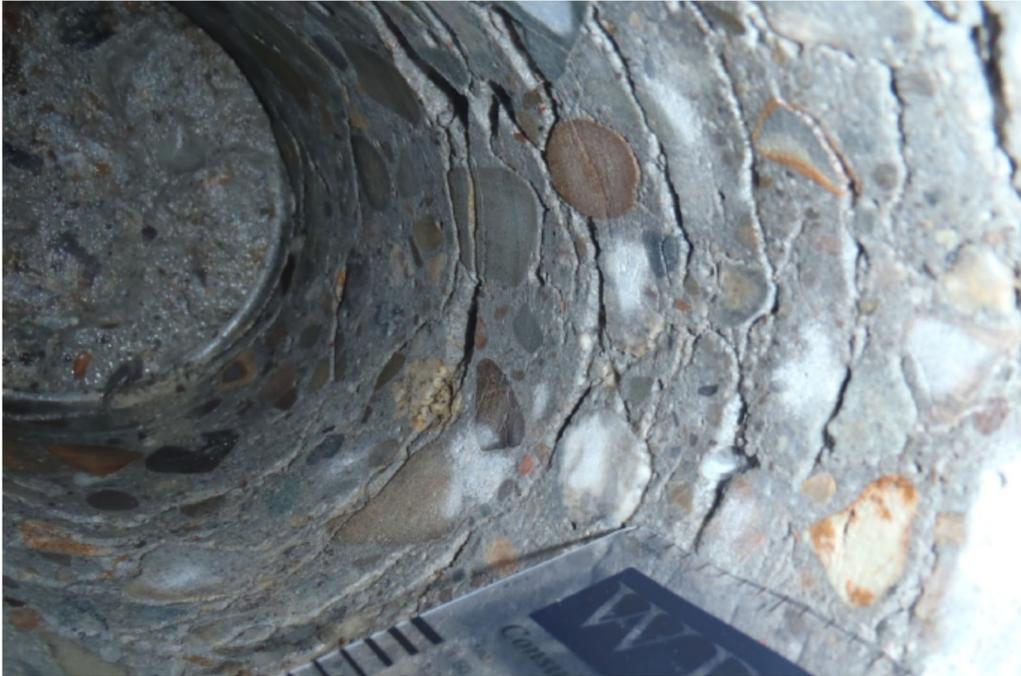
- Petrographic examination of cores taken from various locations showed that the concrete is undergoing alkali-silica reaction (ASR) and this is the likely cause of much of the cracking and erosion in the walls. The severity of the reaction varied between the cores from very severe to minor.

Figure 8 - Inside of core showing expansive cracking [from TranSystems (2011)]

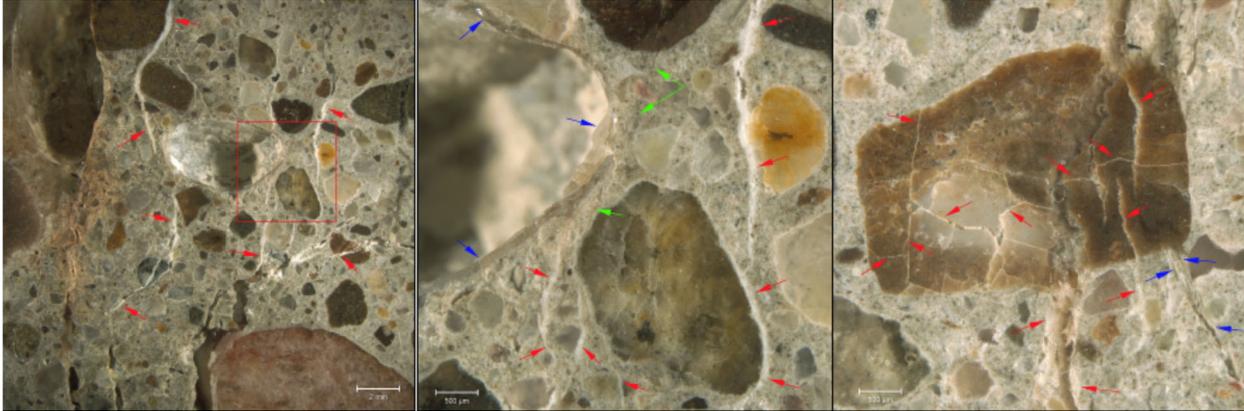
The previous evaluation reports identified alkali-silica reaction (ASR) as one of the major sources of degradation in the existing concrete. ASR is a chemical reaction between alkali in the cement paste and silica in the aggregate that creates an expansive gel, which swells in contact water. The swelling of the gel creates an expansive force that causes cracking of the concrete. The concrete cracking then creates a path for further water ingress leading to progression of the reaction and the cracking as well as corrosion of the reinforcing. Petrographic analyses of core samples taken from the sea wall during the evaluation studies confirmed ASR through the presence of silica gel as well as fracturing of aggregates and cement paste. In general, it has been found that in reinforced concrete, the cracking does not extend past the reinforcing layer, but that depth of cracking is sufficient to allow accelerated corrosion of the rebar.

Figure 9 - Photomicrographs of polished core samples showing deposits of ASR gel (indicated by arrows) [from TranSystems (2011)]
