City of Oxnard  
Wastewater Division  
**Wastewater Collection System**  
Capital Improvement Projects

# Central Trunk Sewer Manhole Replacement

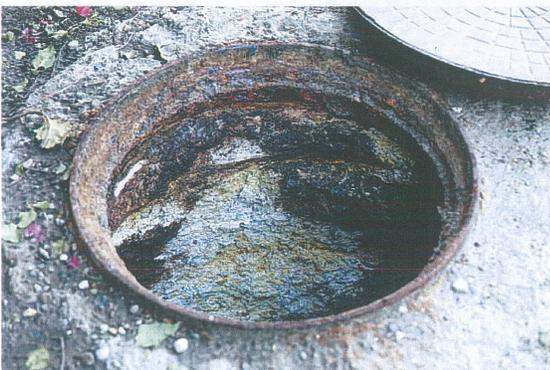
- Extensive concrete corrosion of interior of the sewer manhole structure
- Manhole access covers are severely corroded in certain locations and pose a direct safety hazard to maintenance staff
- Concrete structures are degraded to the point where both rebar and aggregate are exposed

- Extensive corrosion of interior concrete structure, which could lead to structural failure and collapse of the manhole.
- Extensive corrosion of access covers and supporting rings could result in severe fall injuries to City staff and unauthorized persons walking on top of the manholes.
- Failure could result in a large Sanitary Sewer Overflow (SSO) spill that would discharge directly into the Ormond Lagoon Waterway as well as Cal-Gisler, Blackstock North, Blackstock South and the College Estates neighborhoods. This would pose both a significant impact to public health as well as regulatory violations and financial penalties.

Phase 1	Improvements	Estimated Cost
Emergency (Yrs 1-2)	Replacement of 47 manholes	\$1,410,000
CIP (Yrs 3-5)	Replacement of 27 manholes	\$810,000
CIP (Yrs 6-10)*	None Identified	---

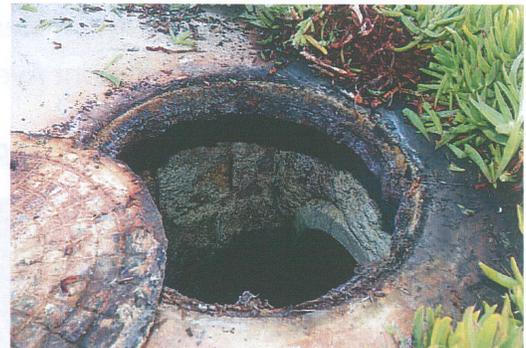
- Extensive concrete corrosion of interior of the sewer manhole structure
- Manhole structures have severe groundwater infiltration causing flow restrictions at the manholes
- Groundwater infiltration results in costly and unnecessary treatment costs as it is combined with the raw wastewater in the collection system and passes through the treatment process at the Wastewater Treatment Plant

- Extensive corrosion of interior concrete structure
- Corrosion, if not addressed, will eventually cause structural failure of the manholes
- Failure could result in a Sanitary Sewer Overflow (SSO) that would discharge directly into the Ormond Lagoon Waterway, Tsumas Creek (formerly J Street Canal), Channel Islands Harbor, as well as the neighborhoods of Redwood, Bryce Canyon North, Bryce Canyon South, Pleasant Valley Village, Southwinds, Terrace Estates, Tierra Vista, and Channel Islands.

Phase 1	Improvements	Estimated Cost
Emergency (Yrs 1-2)	None Identified	---
CIP (Yrs 3-5)	Rehabilitate 64 manholes	\$600,000
CIP (Yrs 6-10)*	Annual manhole Rehabilitation	\$200,000/yr

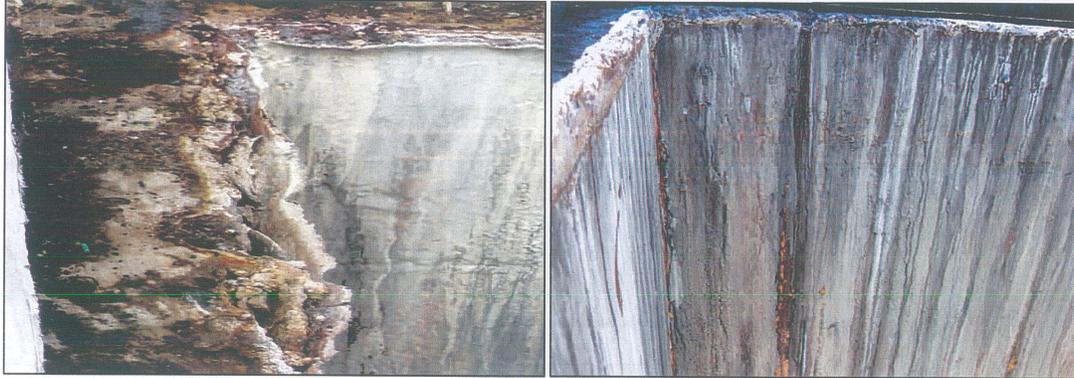
- Concrete coating in the Meter Vault/Vortex Structure has failed.

- Corrosion of the vault is accelerating due to failure of coating.

- Concrete coating in the Meter Vault/Vortex Structure has failed and corrosion is accelerating creating conditions for potential structural failure.
- Structural failure of the Meter Vault/Vortex Structure would likely lead to raw wastewater spills, implementation of temporary pumping measures and costly emergency repairs.

Phase	Improvements	Estimated Cost
Emergency (Yrs 1-2)	Concrete coating repair	\$280,000
CIP (Yrs 3-5)	None Identified	---
CIP (Yrs 6-10)*	None Identified	---

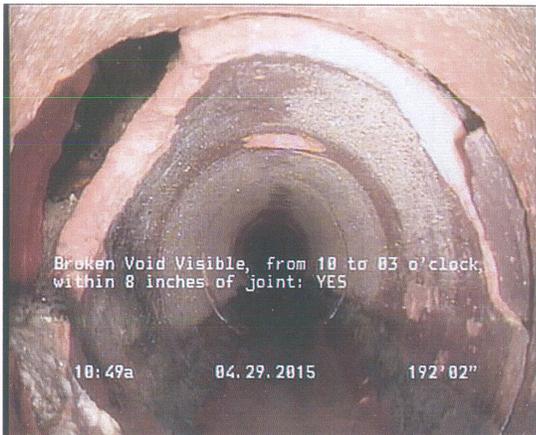
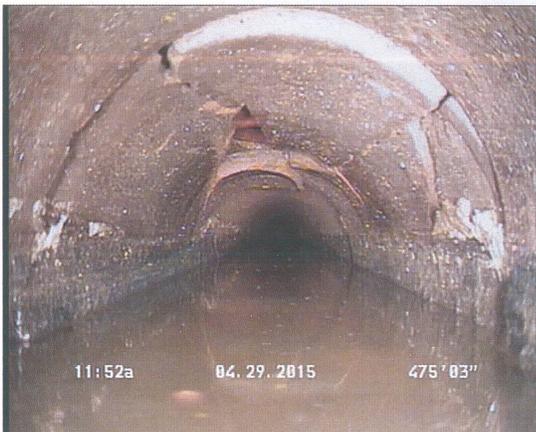
- Existing sewer mains that have a poor rating (Grade 4) condition or in need of immediate attention (Grade 5) have been identified for repair or replacement under these projects.

- Based on the “critical” grade of these facilities, it is projected that Sanitary Sewer Overflow (SSO) may likely occur if these pipes are not repaired

- There are 244 pipe repairs identified in the collection system that are assigned a Poor Condition Grade (4) and contain severe defects that will probably cause failures within 5-10 years based on NASSCO PACP rating standards. These are industry wide rating standards used to assess and quantify the condition of publicly owned wastewater collection system assets.
- There are 63 pipes repairs identified in the collection system that are rated a Grade (5) condition, which contain severe defects and are projected to likely fail within the next 5 years or sooner.
- Failure may likely result in a SSO that would discharge directly into the storm drain system
- Failure may result in the creation of a sinkhole causing an immediate hazard to the residents within the community

Phase 1	Improvements	Estimated Cost
Emergency (Yrs 1-2)	Annual Pipe Repairs – None Identified	---
	Concrete Sewer Replacement – None Identified	---
CIP (Yrs 3-5)	Annual Pipe Repairs	\$200,000/yr
	Concrete Sewer Replacement	\$500,000/yr
CIP (Yrs 6-10)*	Annual Pipe Repairs	\$200,000/yr
	Concrete Sewer Replacement	\$500,000/yr

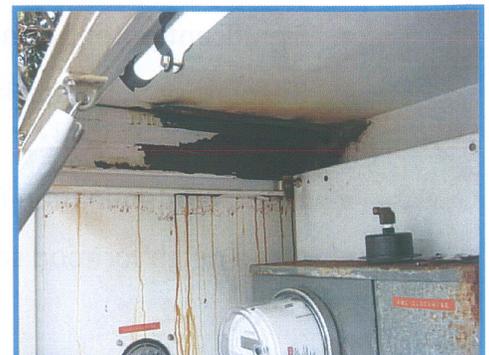
- Existing SCADA and MCC panels have significant corrosion. The SCADA communications panel and MCC electrical panel are necessary for lift station operation. Failure of either panel will cause lift station failure. Lift station failure will cause Sanitary Sewer Overflow (SSO) spills into adjacent neighborhoods, storm drains and waterways.
- Existing valve vault is not functional. Access to valve vault is required for proper lift station operation and maintenance.
- Deteriorated concrete in wet well. Continued deterioration could lead to structural failure at lift station.

- Existing SCADA and MCC panels have significant corrosion, which failure of either panel would render lift station non-operational.

- Existing valve vault is not functional. Assess to and proper functionality of valving is required for lift station operation and maintenance.
- Deteriorated concrete in wet well. Continued deterioration of concrete could lead to overall lift station failure.

Phase	Improvements	Estimated Cost
Emergency (Yrs 1-2)	None Identified	---
CIP (Yrs 3-5)	Replace SCADA (communication) panel Replace motor control center (MCC) Replace valve vault door Repair and coat deteriorated concrete in wet well	\$500,000
CIP (Yrs 6-10)*	None Identified	---

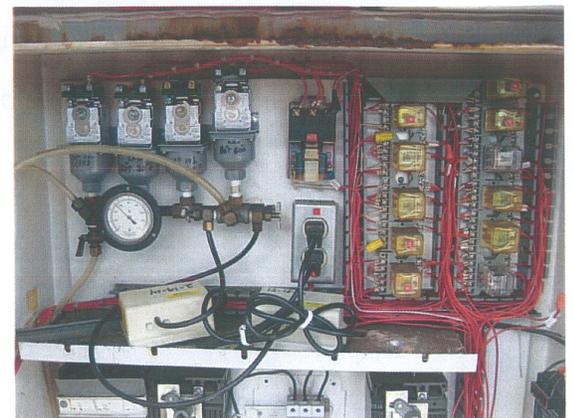
- Existing submersible pumps are beyond their useful life.
- Existing MCC panel has significant corrosion. The MCC electrical panel is necessary for lift station operation. The lift station will fail should the panel become non-functional. Lift station failure will cause Sanitary Sewer Overflows (SSO) spills into adjacent neighborhoods, storm drains and waterways. There is no emergency backup power in the event of utility failure. Risk of lift station overflows are significant if not addressed quickly with potable pumping equipment.

- Existing submersible pumps are not considered reliable due to their age, which is beyond the projected useful life of the equipment.
- Existing MCC panel has significant corrosion, which

reduce reliability due to increased incidents of failure.

Phase	Improvements	Estimated Cost
Emergency (Yrs 1-2)	None Identified	---
CIP (Yrs 3-5)	Replace existing submersible pumps Replace motor control center (MCC) Install new emergency standby generator	\$500,000
CIP (Yrs 6-10)*	None Identified	---

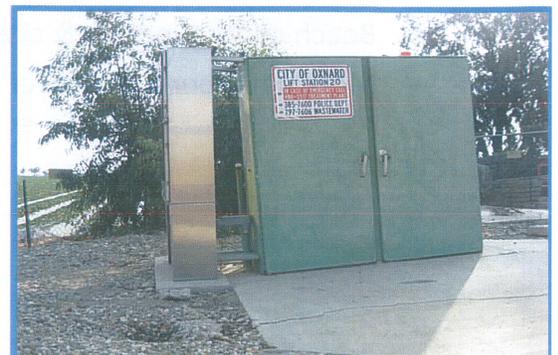
- The original MCC panel failed in 2016 due to issues associated with the presence of significant corrosion. City staff has installed a temporary panel to maintain the station in operation before permanent improvements can be made.
- The MCC panel concrete pad is severely sloped due to settlement issues. A new pad will be required to properly support the new MCC.

- The station is not considered reliable following the MCC panel failure in 2016. The temporary panel installed is not considered a reliable long term solution. The lift station will fail should the panel become non-functional. Lift station failure will cause Sanitary Sewer Overflows (SSO) spills into adjacent neighborhoods, storm drains and waterways. There is no emergency backup power in the event of utility failure. Upon a failure event, risk of SSO is significant if not addressed quickly with potable

Phase	Improvements	Estimated Cost
Emergency (Yrs 1-2)	None Identified	---
CIP (Yrs 3-5)	Replace motor control center (MCC) panel which has shown significant corrosion. Replace MCC panel concrete pad which is severely tilted.	\$300,000
CIP (Yrs 6-10)*	None Identified	---
