PRIMARY RECORD

Resource Name or #: (Assigned by recorder) 102 E FIFTH ST

San Buenaventura Research Associates. Downtown Oxnard Historic Resources Survey. City of Oxnard, CA., 2005.

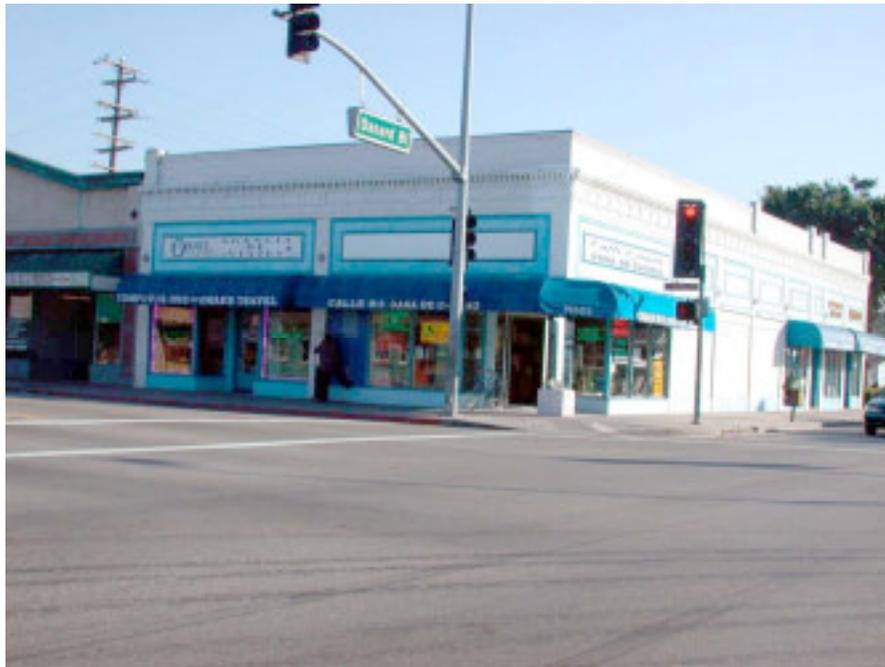
This commercial storefront building is vernacular in design. The building has a rectangular plan, is one story tall, and is topped by a flat roof. Located on a corner parcel, the building is two bays wide on its primary street-facing elevation and seven bays deep on its secondary street-facing elevation. The main façade is divided into two equal-sized storefronts. The left bay has a recessed central entrance with flanking storefront windows. The right bay has a storefront that wraps the corner of the building and extends one bay deep on the secondary façade. The entrance is placed on the diagonal and is recessed behind the wall. A structural pier atop a brick base supports the corner of the building. Vertical storefront windows are divided by wood mullions. A brick bulkhead is located below each storefront. A slightly recessed, framed horizontal band extends the width of each bay, providing space for signage. Above these horizontal bands, a beltcourse of decorative brick fretwork and corbels wraps around the building at the cornice line. A plain brick parapet rises above the cornice line. On the secondary façade, three narrow bays are enclosed and two storefront bays are located at the end of the wall. The condition of the building is good.

P5b. Description of Photo: (View, date, accession #)
100-02 E. Fifth St. (View toward southwest). Photo No: 113-31, 1/20/2005

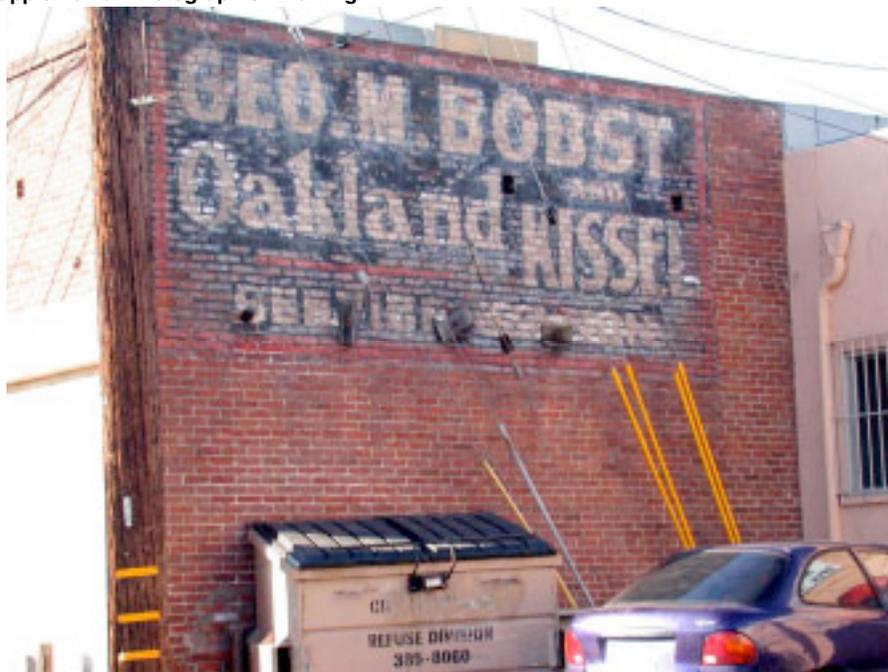
Rear of 102 E Fifth Street

100 E. Fifth St. (rear) (View toward northwest). Photo No: 113-46, 1/20/2005

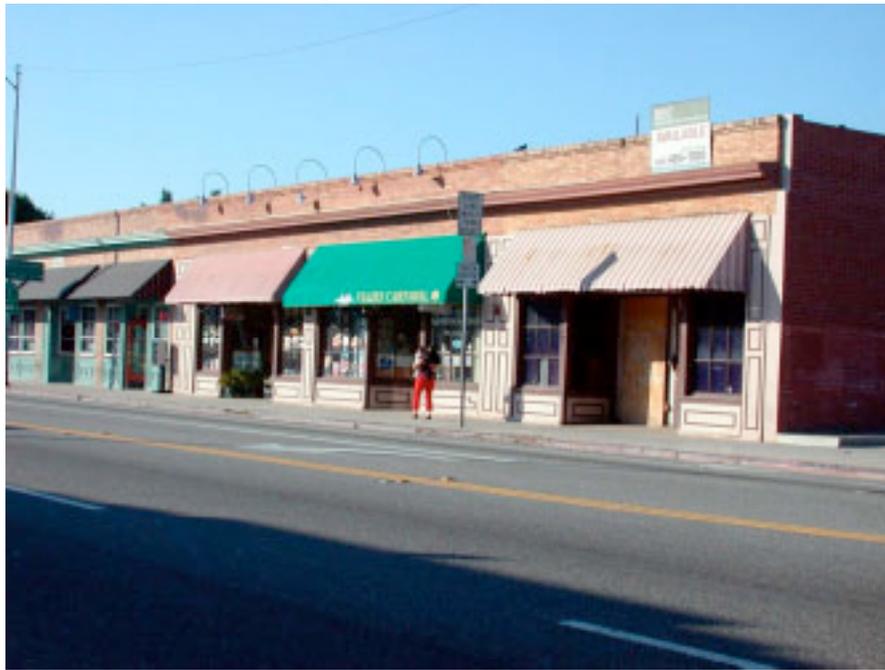
This commercial storefront building is vernacular in design. The building has a rectangular plan and is one story in height. A parapet wall conceals a flat roof. A series of storefronts fills the wall's pedestrian level. Each storefront has a recessed central entrance with angled flanking storefront windows. The windows are woodframe, divided-light fixed sash. Horizontal panels decorate the bulkhead. Pilasters with vertical panels frame and separate each storefront. Canvas awnings shade each storefront. A molded cornice runs the length of the wall below the parapet. A brick stringcourse creates coping at the top of the parapet. The condition of the building is good.

P5b. Description of Photo: (View, date, accession #)
111-27 E. Fifth St. (View toward northwest). Photo No: 113-29, 1/20/2005

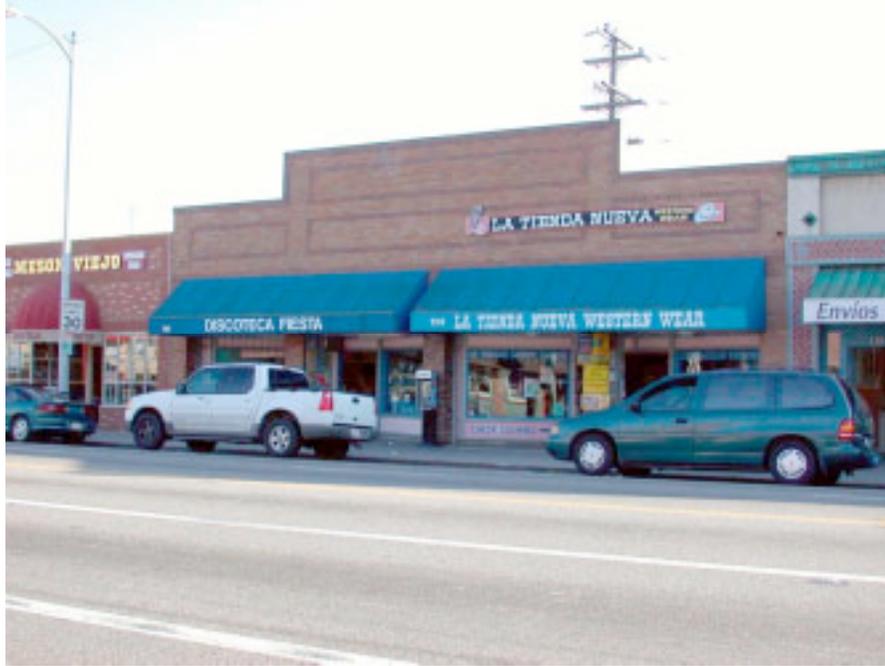
This commercial storefront is vernacular in design. The building has a rectangular plan and is one story in height. The exterior walls are clad with brick. The flat roof is concealed by a tall, stepped parapet. The pedestrian-level is a two-part storefront. Storefronts are composed of two woodframe plate glass windows above a simple wooden bulkhead and a single wooden entrance door. The half-width storefronts are divided and framed by simple brick piers. A canvas awning is installed on the wall above the storefronts. The brick wall above the awnings is decorated with four decorative, brick-framed blank friezes. A single sign has been installed on the upper portion of the wall. The stepped parapet is lined with brick or tile coping. The condition of the building is good.

P5b. Description of Photo: (View, date, accession #)
114-16 E. Fifth St. (View toward southwest). Photo No: 113-32, 1/20/2005

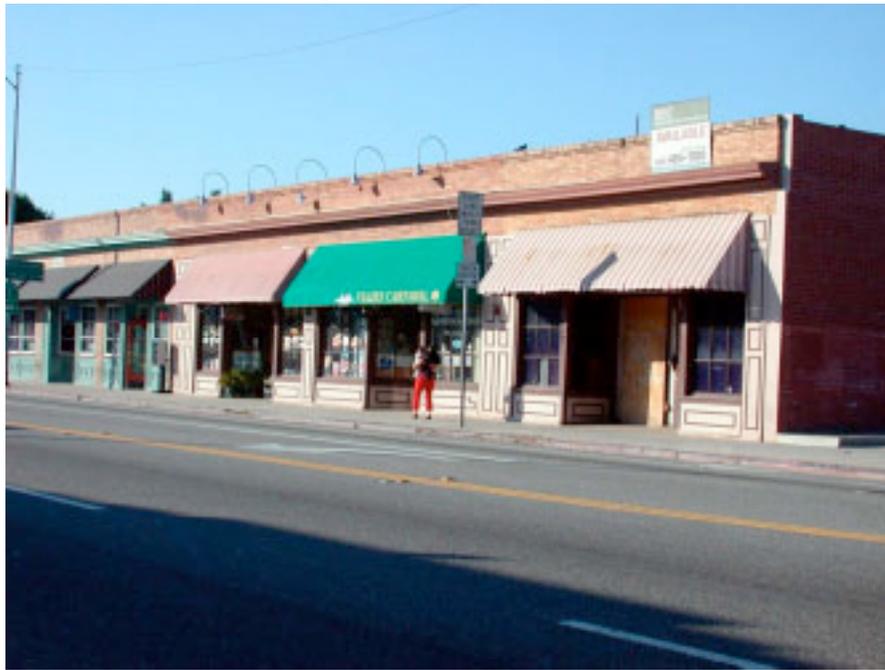
This commercial storefront building is vernacular in design. The building has a rectangular plan and is one story in height. A parapet wall conceals a flat roof. A series of storefronts fills the wall's pedestrian level. Each storefront has a recessed central entrance with angled flanking storefront windows. The windows are woodframe, divided-light fixed sash. Horizontal panels decorate the bulkhead. Pilasters with vertical panels frame and separate each storefront. Canvas awnings shade each storefront. A molded cornice runs the length of the wall below the parapet. A brick stringcourse creates coping at the top of the parapet. The condition of the building is good.

P5b. Description of Photo: (View, date, accession #)
111-27 E. Fifth St. (View toward northwest). Photo No: 113-29, 1/20/2005

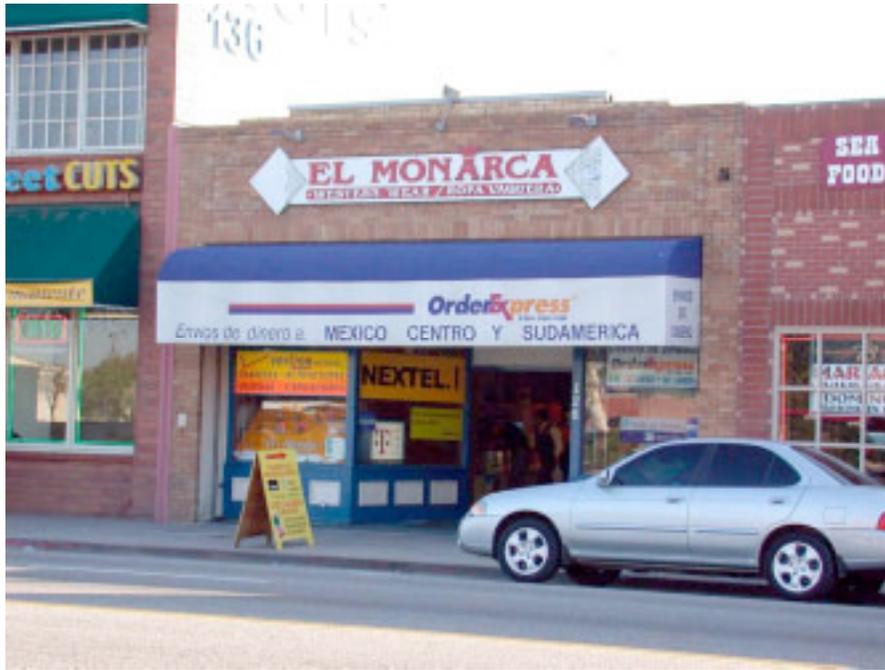
P5b. Description of Photo: (View, date, accession #)
128 E. Fifth St. (View toward south). Photo No: 113-33, 1/20/2005

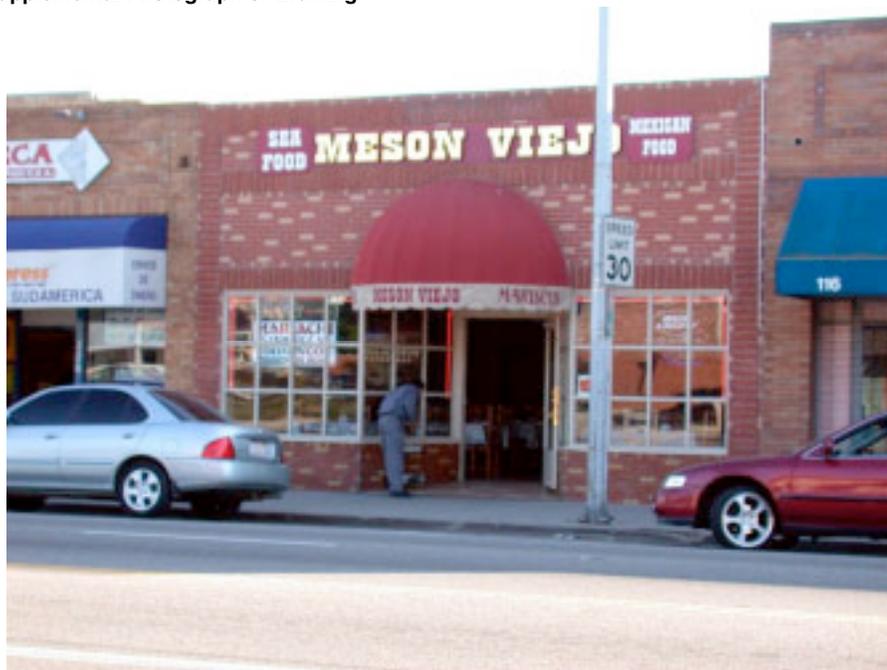
The building at 124 E. Fifth Street was built in 1952 for James J. Krouser by Edwin D. Marsh architect and E.A. Kaiser, builder. In 1988 the storefront was apparently extensively altered. This building is considered a non-contributor to the small district of pre-war buildings located on East Fifth Street.

124 E. Fifth St. (View toward south). Photo No: 113-35, 1/20/2005

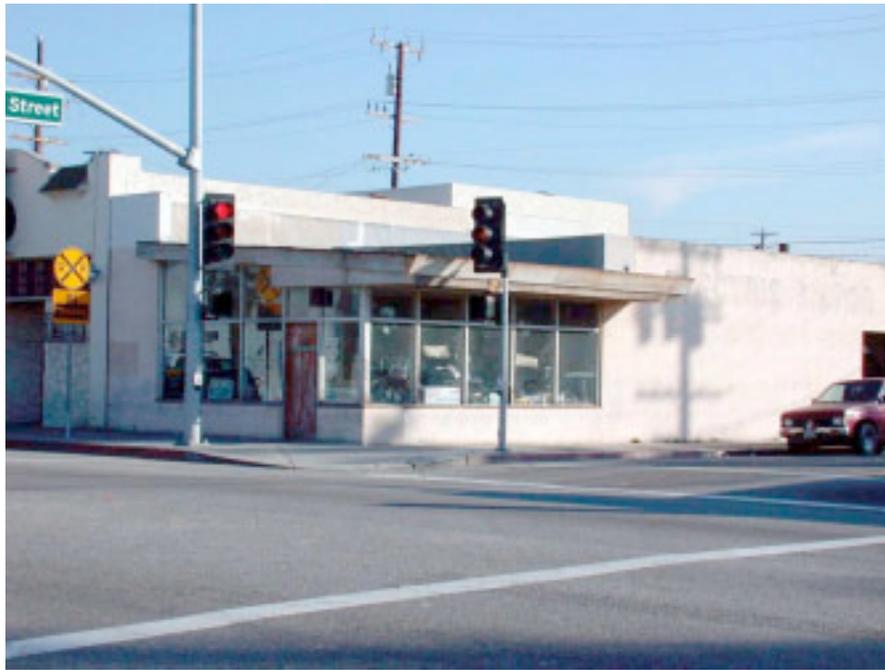
P5b. Description of Photo: (View, date, accession #)
200 E. Fifth St. (View toward). Photo No: 113-39, 1/20/2005

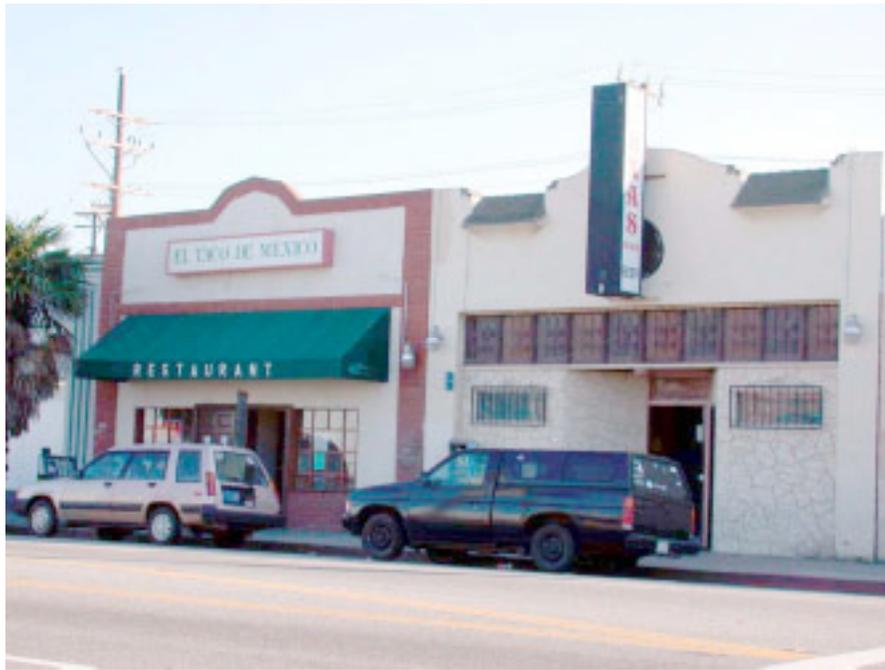
This commercial storefront exhibits elements of the Mission Revival style. The building has a rectangular plan, is one story in height, and has a flat roof. The exterior walls are primarily clad with stucco. The main façade is a two-part storefront. The storefront has been enclosed with faux-stone veneer. It has a central entrance. A full-width multi-light transom appears to be original. The wall rises to a shaped parapet with pent roves at the eaveline. A blade sign has been installed along the center of the upper wall. The condition of the building is fair.

P5b. Description of Photo: (View, date, accession #)
204-10 E. Fifth St. (View toward southeast). Photo No: 113-40, 1/20/2005

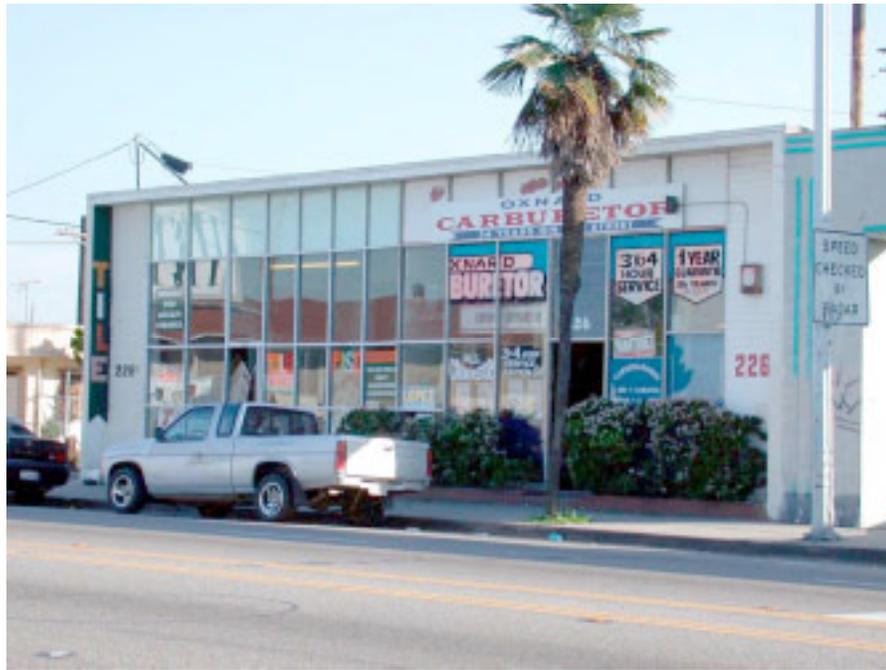
The building at 226 E. Fifth Street, constructed in 1965, is one story tall and constructed of brick or concrete block. The main façade is filled with four continuous rows and columns of single pane glass divided with metal mullions and muntins. The window wall is flanked by brick piers at the wall's edges. The condition of the building is fair.

P5b. Description of Photo: (View, date, accession #)
226-28 E. Fifth St. (View toward southeast). Photo No: 113-42, 1/20/2005

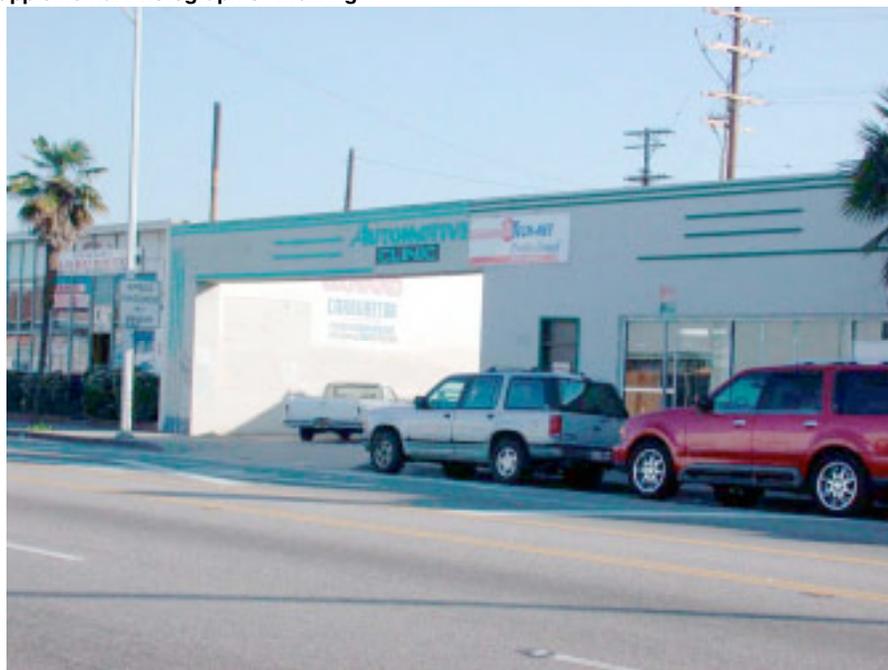
This commercial property is Modern in design. It is composed of two building, linked only by a small portion of common wall. The building located at 214 E. Fifth, constructed circa 1948, is a one story building with a flat roof. The building is two bays wide. The right bay is filled with a large metal-frame storefront window with multiple plate glass panes. A single entrance door is located to the left of the storefront window. A large, double-wide opening is located in the left bay, provided access to the rear of an auto body shop. The edges of the walls, the parapet wall, and the top of the parapet are decorated by raised stringcourses, arranged in pairs or groups of three. Along the upper wall, the stringcourses are broken for decorative effect. The condition of the building is fair.

214 E. Fifth St. (View toward southeast).

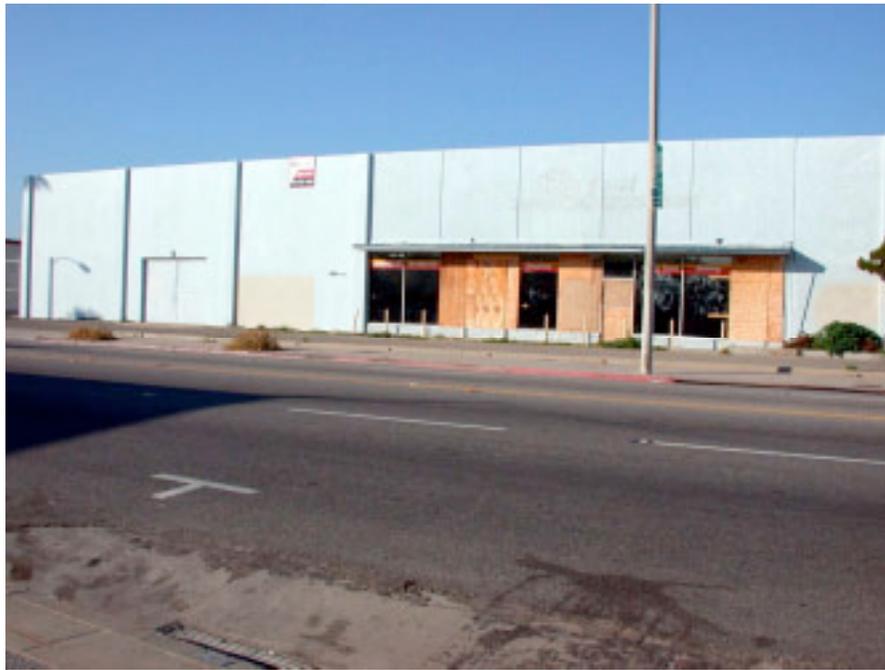
This commercial building is rectangular in plan, one-and-a half stories in height, and has a flat roof. The exterior walls are stucco with vertical scoring and pilasters. The entrance and storefront window, with a shallow cantilevered canopy, are located at the center of the main façade. The storefront windows have been partially enclosed. There is no other visible fenestration on the building. The condition of the building is poor.

P5b. Description of Photo: (View, date, accession #)
235 E. Fifth St. (View toward north). Photo No: 113-44, 1/20/2005
