PRIMARY RECORD

Resource Name or #: (Assigned by recorder) 143 W FIFTH ST

San Buenaventura Research Associates. Downtown Oxnard Historic Resources Survey. City of Oxnard, CA., 2005.

Resource Name or #: (Assigned by recorder) 318 W FIFTH ST

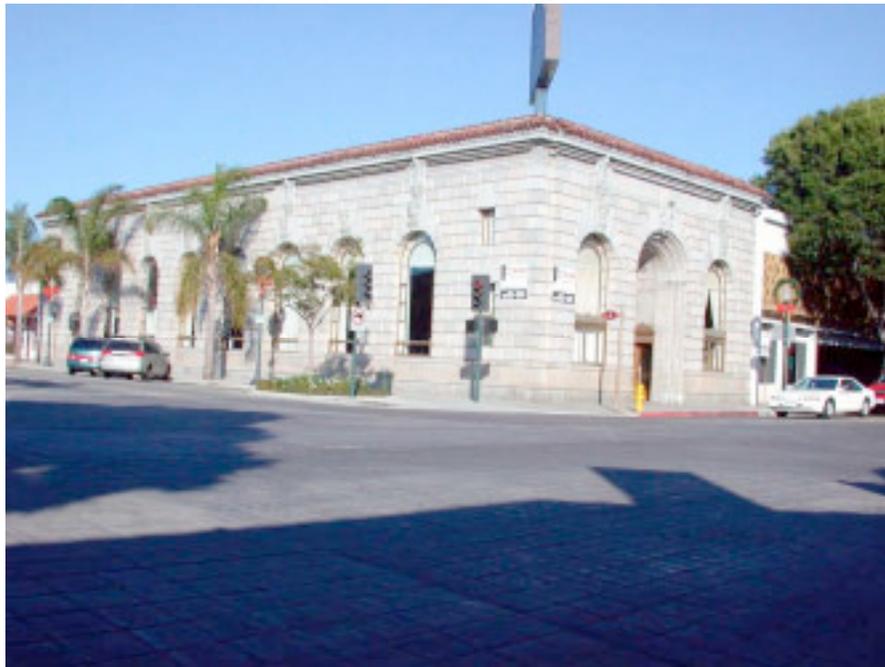
P5b. Description of Photo: (View, date, accession #)
143 W. Fifth St. (View toward northeast). Photo No:
109-7, 11/12/2004

This commercial building is designed in the Beaux Arts style. The building has a simple rectangular plan and rises one-and-one-half stories tall. The building is composed in a classical three-tiered pattern. Two wide smooth stone courses define the building's foundation. The body of the walls are clad with square-cut dressed stone. Curved stone beltcourses ring the cornice line. The low-pitch hipped roof is covered with red clay tile. Located on a corner parcel, the building has two street-facing elevations. The entrance façade is three bays wide; the secondary street elevation is nine bays deep. The entrance is recessed behind a nearly full-height archway with carved stone pilasters and a cartouche keystone. The flanking bays on the short façade and all but the two outermost bays on the long facade are filled with a single tall arched window. The stonework flares around the top of the arch; a keystone with a carved face tops each arch. Each window consists of a large single-pane archtop window with smaller horizontal panes that trace the outside line of the arch. The two outer bays on the long façade have two small rectangular windows arranged vertically within each bay. The condition of the building is excellent.

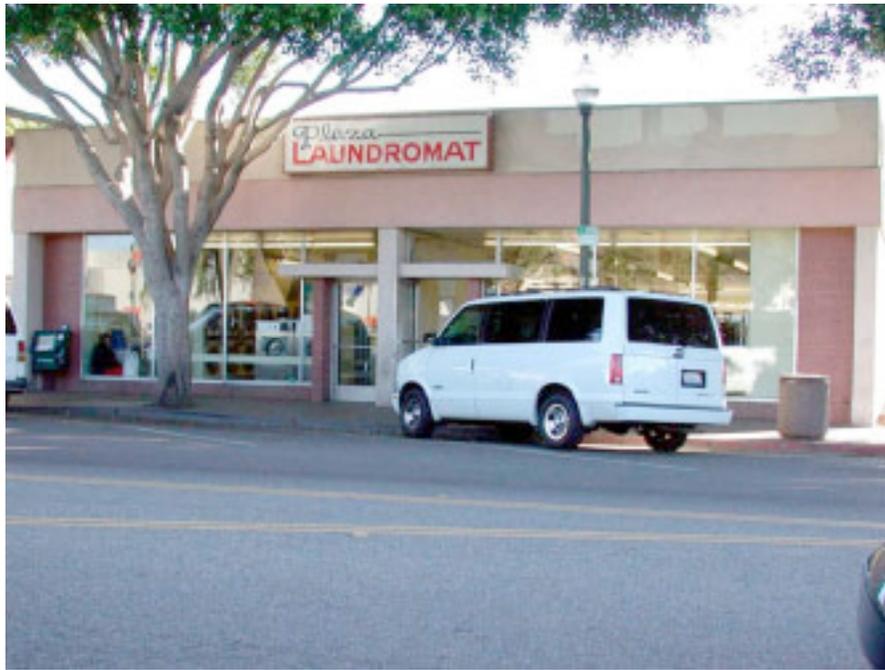
P5b. Description of Photo: (View, date, accession #)
318 W. Fifth St. (View toward south). Photo No: 109-5, 11/12/2004

Modern in design, this one-story commercial building houses a laundromat. The building has a rectangular plan, is two bays wide and is topped by a flat roof with a short parapet. Exterior walls are primarily stucco but the current finish does not appear to be original. The main façade is divided into two symmetrical bays. Two storefronts and a center entrance are framed by a brick bulkhead and piers. The storefront windows are three large vertical plate glass panes divided by metal mullions. Two metal glazed entrance doors are located at the center of the façade and are divided by intersecting metal pier and canopy. A simple stucco frieze extends the full width of the façade, just below the simple parapet. A business sign has been applied at the center of the parapet. The condition of the building is fair.

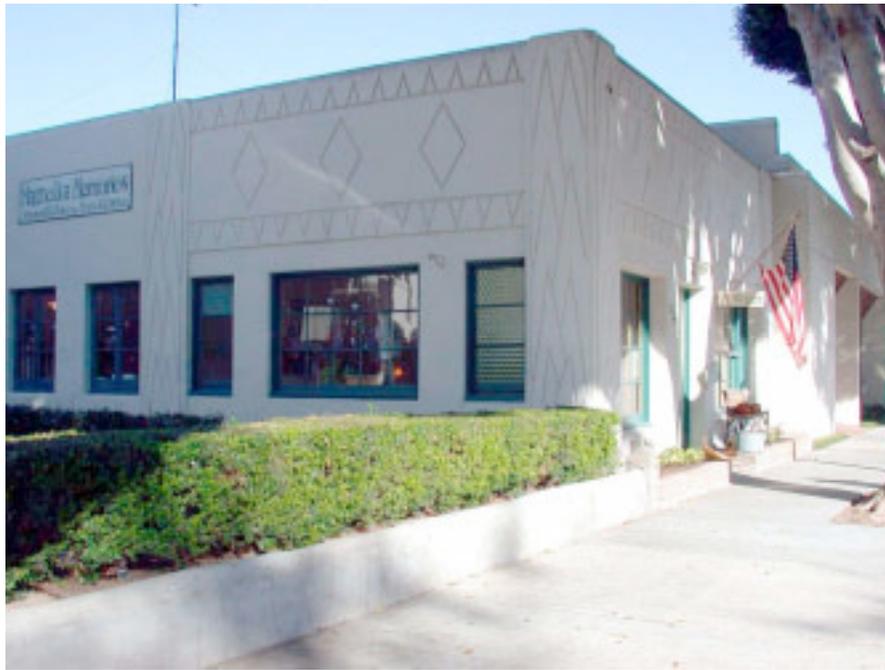
P5b. Description of Photo: (View, date, accession #)
329 W. Fifth St. (View toward northeast). Photo No:
109-4, 11/12/2004

This commercial building is a modest example of the Zig-Zag Moderne style. The building is rectangular in plan, is one story tall, and topped by a flat roof. The exterior walls are clad with stucco. The main (street-facing) elevation is divided into three bays. The center bay houses the entrance. Each of the outer bays is filled with a single woodframe divided-light window. A flagstone planter projects from the base of the main façade. The upper level of the wall, including the parapet, is scored with a pattern of slanted lines at its base and at the cornice level. A similar pattern of scoring, with diamonds and triangles, fills the upper wall of the first bay on the secondary façade. At the lower level, the secondary façade is filled with a large center divided-light window and two narrow flanking windows. A ziggurat pattern is scored in the stout pilasters at the corner of these bays. The remainder of the building's depth is unadorned. Windows are primarily woodframe multi-light casements set in recessed openings. The condition of the building is good.
