Resource Name or #: (Assigned by recorder) 160 W FOURTH ST

San Buenaventura Research Associates. Downtown Oxnard Historic Resources Survey. City of Oxnard, CA., 2005.

Resource Name or #: (Assigned by recorder) 314 W FOURTH ST

Resource Name or #: (Assigned by recorder) 403 W FOURTH ST

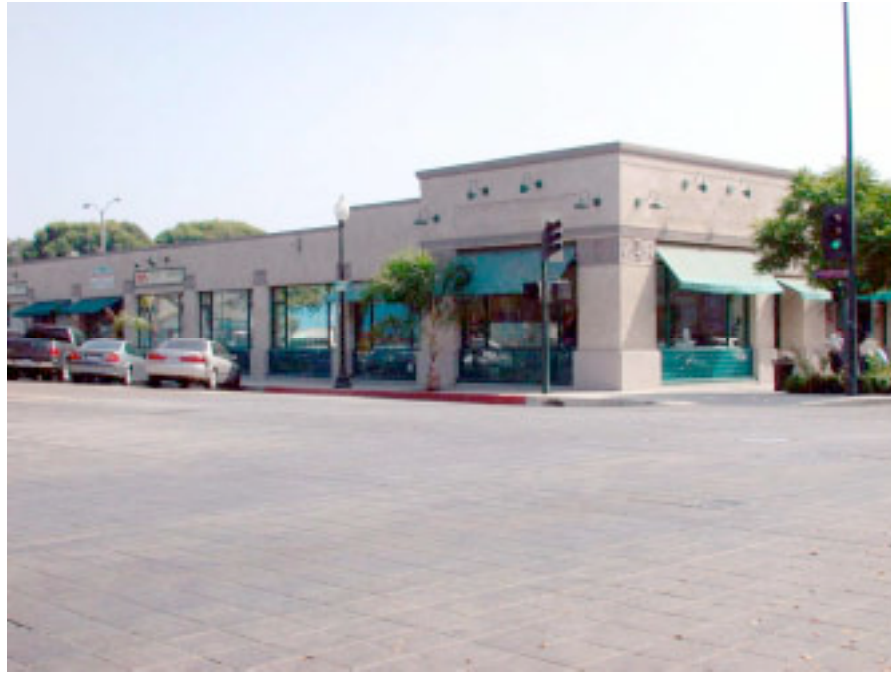
P5b. Description of Photo: (View, date, accession #)
400 S. A St. (View toward southeast). Photo No: 102-9, 10/6/2004

This commercial property is vernacular in design but exhibits elements of classical detail. With a rectilinear plan, the building is one story in height with a short, stepped parapet wall. The exterior walls are clad with stucco. The building occupies a corner parcel, creating two streetfront elevations. These facades are dominated by the boxy massing of the corner bays which rises slightly taller than the rest of the building. Storefronts are located in nearly every bay of the building on both elevations, each divided by a pilaster. The structural corner column and the pilasters on each side of the storefront windows have a flat square base and shaft. A flat, stylized tile has been applied to the top of each pilaster and column to create the appearance of a classical capital. A simple molding runs above the storefronts of the corner section; molded coping runs the entire length of the parapet wall. Each storefront window is divided into three parts: a large center pane with mullions separating it from the more narrow flanking elements. Green glass tile covers the bulkhead below the windows. Canvas awnings shade the corner windows. The condition of the building is good.

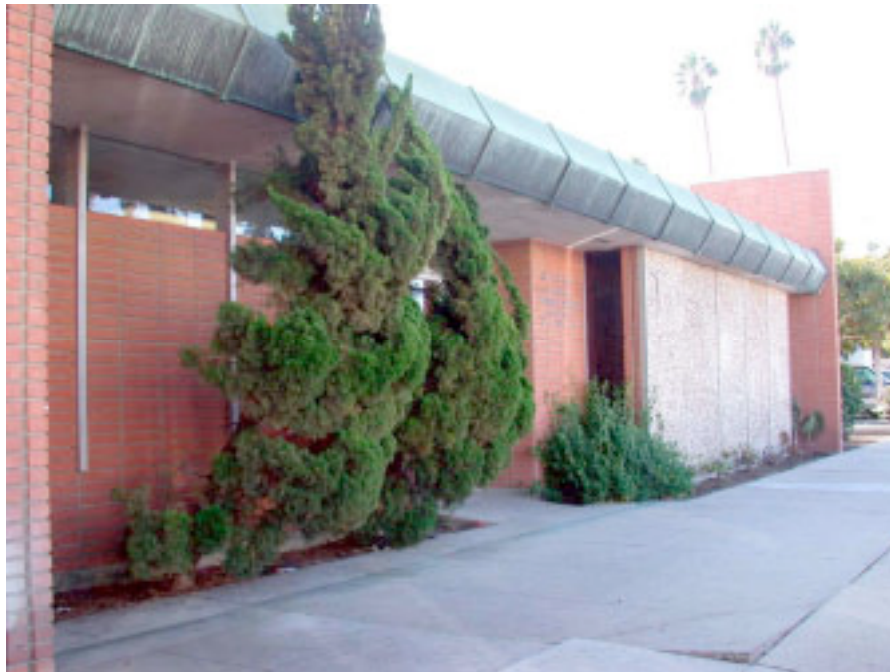
P5b. Description of Photo: (View, date, accession #)
314 W Fourth St. (View toward southwest). Photo No: 109-2, 11/12/2004

This one-story commercial building is Modern in design. The building has a rectilinear plan and a flat roof. Exterior walls are primarily brick. The main façade exhibits a rich combination of textures and lines. The entrance is located at the center of the main façade, slightly recessed behind the eaveline. The left bay is enclosed with brick. Metal mullions rise from mid-height on the wall past the top of the wall, separating a band of horizontal single pane transom-type windows above the wall. The right bay has a decorative panel of plaster or stucco with a large stone aggregate. A folded plate of standing seam coppery decorates the face of the flat roof. A single plan of brick rises perpendicular to the main façade at the right end of the building. The condition of the building is excellent.

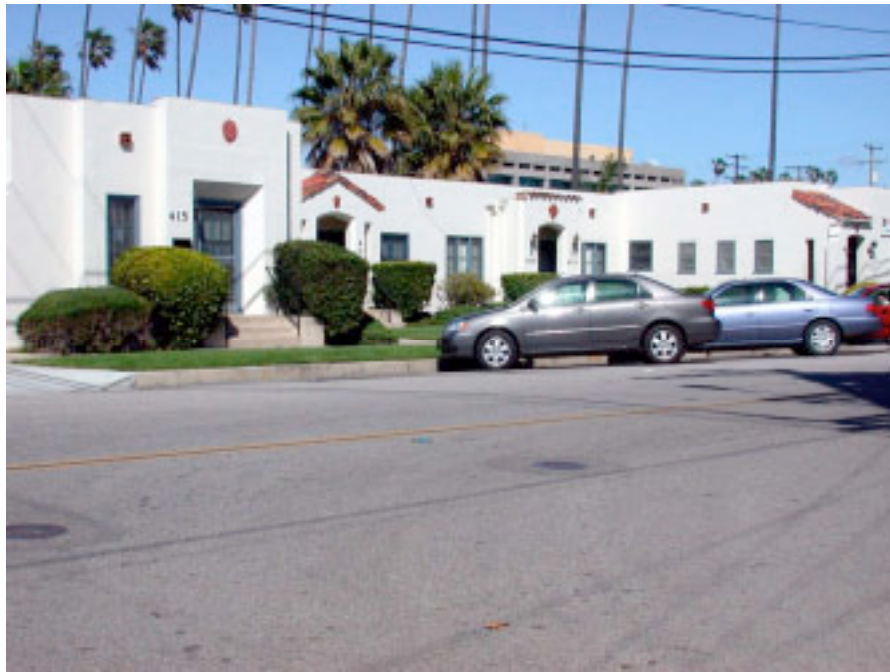
P5b. Description of Photo: (View, date, accession #)
403 W. Fourth St. (View toward northeast). Photo No: 120-6, 3/23/2005

This building is Spanish Colonial Revival in style. Located on a corner parcel, the building has a U-shaped plan and is one story in height. A flat roof is concealed by a low parapet wall. Projecting shed-roof and gabled porticos mark the various entries throughout the building. Portico roofs are covered with red clay tile. Ceramic tile vents, located at the top of the wall plane below the start of the parapet, are located throughout the building and characteristic of the style. One wing, that fronts the sidewalk of a commercial street, has been dedicated for commercial use. Original windows along this wing have been replaced with projecting window bays. Fenestration on the rest of the building consists of wood frame windows set in recessed openings. The condition of the building is good.
