PRIMARY RECORD

Resource Name or #: (Assigned by recorder) 131 E SIXTH ST

San Buenaventura Research Associates. Downtown Oxnard Historic Resources Survey. City of Oxnard, CA., 2005.

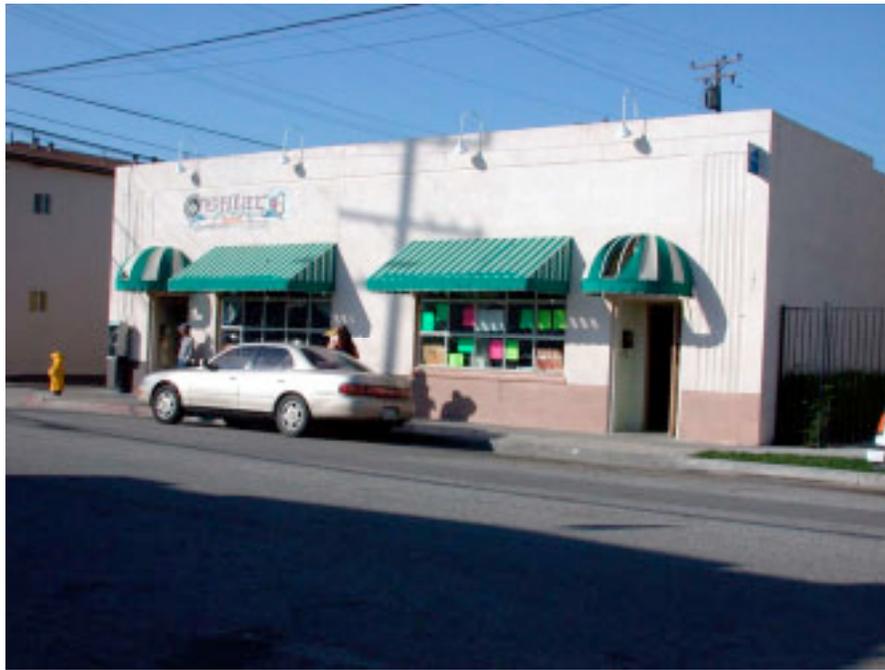
This commercial building is vernacular in design. It has a rectangular plan, is one story tall, and has a flat roof with a short parapet. Exterior walls are stucco. The main façade has two mirror-image storefronts. Each consists of a single door and a fifteen-pane fixed wood sash window. Both the windows and doors are shaded by canvas awnings. Ornamentation on the façade is limited to fluting at each end. The condition of the building appears good.

P5b. Description of Photo: (View, date, accession #)
125-31 E. Sixth St. (View toward northwest). Photo No: 113-20, 1/20/2005

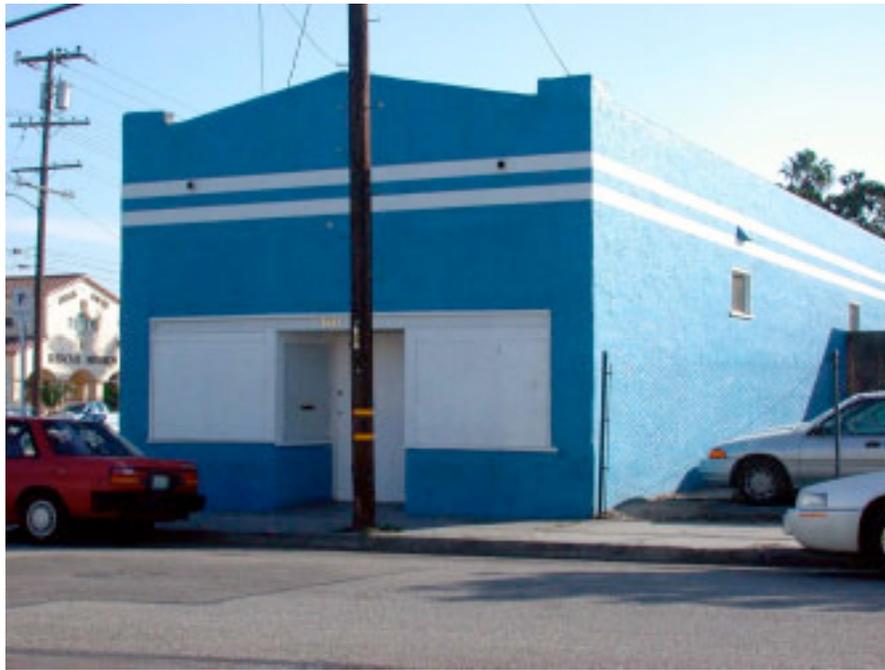
This commercial building is vernacular in design. The building has a rectangular plan and is one story tall. The flat roof is concealed by a short parapet wall that rises to a gable peak with crenellated corners. Exterior walls are clad with stucco but the current coat does not appear original. The main façade is one bay wide. A storefront with a central entrance door fills the base of the wall. Woodframe storefront windows have been enclosed. Small square woodframe windows light the interior from the secondary facades. The condition of the building is fair.

P5b. Description of Photo: (View, date, accession #)
140 E. Sixth St. (View toward southeast). Photo No: 113-22, 1/20/2005

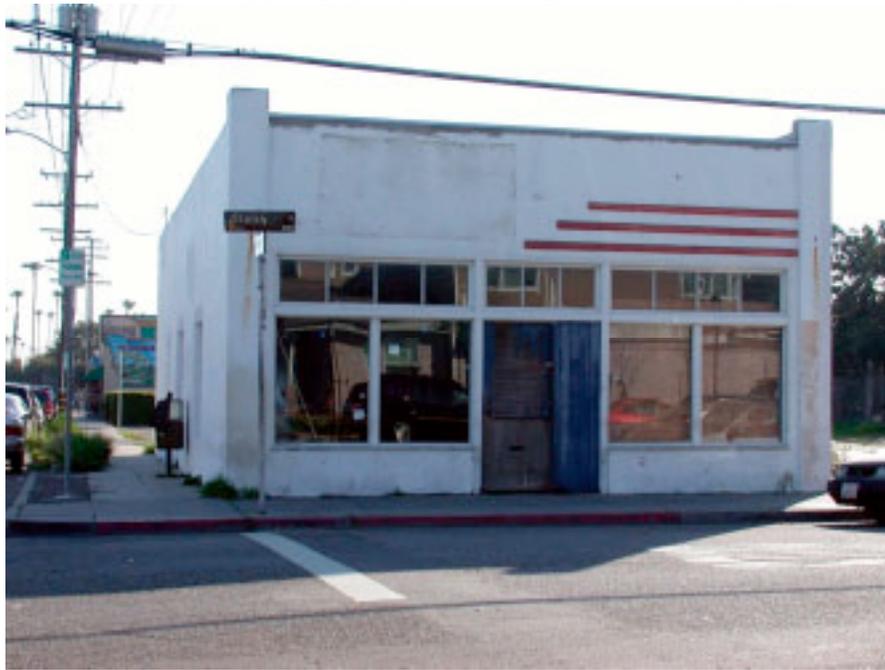
This commercial building is vernacular in design. The building plan is rectangular; it is one story tall. The roof is flat with a short parapet. Exterior walls are stucco. Two-part storefront windows, with plate glass and wide wood mullions, flank a central entrance. Three transoms, with vertically divided panes, are located above the windows and doors. Unadorned pilasters frame the storefront at each end of the façade and break the parapet line. The wall space above the storefronts is unbroken by fenestration. Secondary facades have a regular pattern of single windows, recessed in the wall. The condition of the building is fair.

P5b. Description of Photo: (View, date, accession #)
150-54 E. Sixth St. (View toward southwest). Photo No: 113-23, 1/20/2005

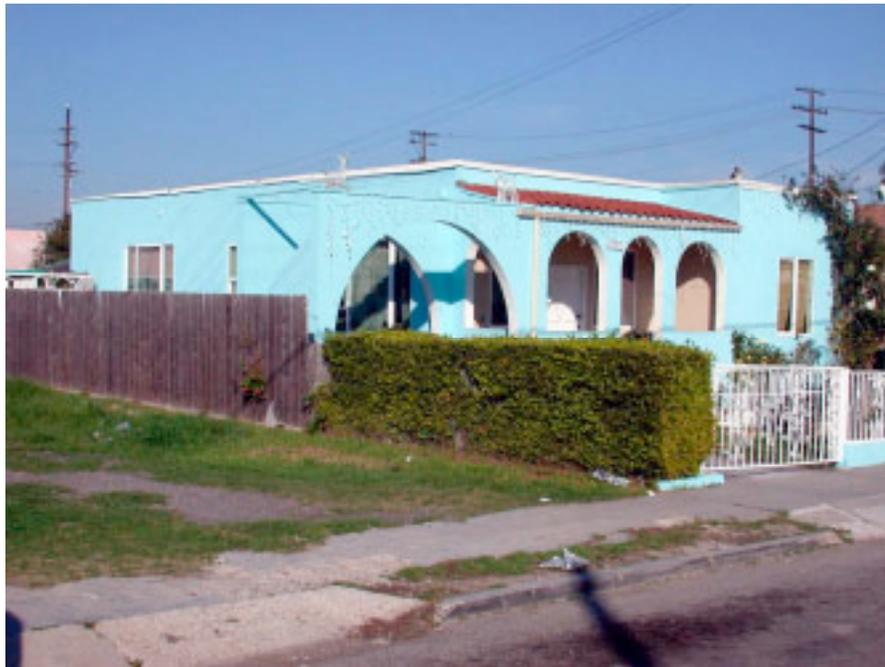
This single family residence has a rectilinear plan, is one story tall, and topped by a flat roof with a short parapet wall. The exterior walls are clad with stucco. A projecting wing extends from the right side of the main façade. A single vinyl sliding window is located in the wall of the projecting wing; this window is not original. An arcaded porch, with a red clay tile shed roof, extends across the remainder of the primary façade. A non-original door and two vinyl sliding windows are located on the main wall behind the porch. Two arcaded side walls extend from the porch's edge and span the driveway. These walls do not appear to be original. Fenestration on the secondary facades consists of a combination of vinyl sliding and wooden double-hung windows. Many of the original windows on this building have been replaced. The condition of this building is fair.

P5b. Description of Photo: (View, date, accession #)
209 E. Sixth St. (View toward northeast). Photo No: 113-24, 1/20/2005

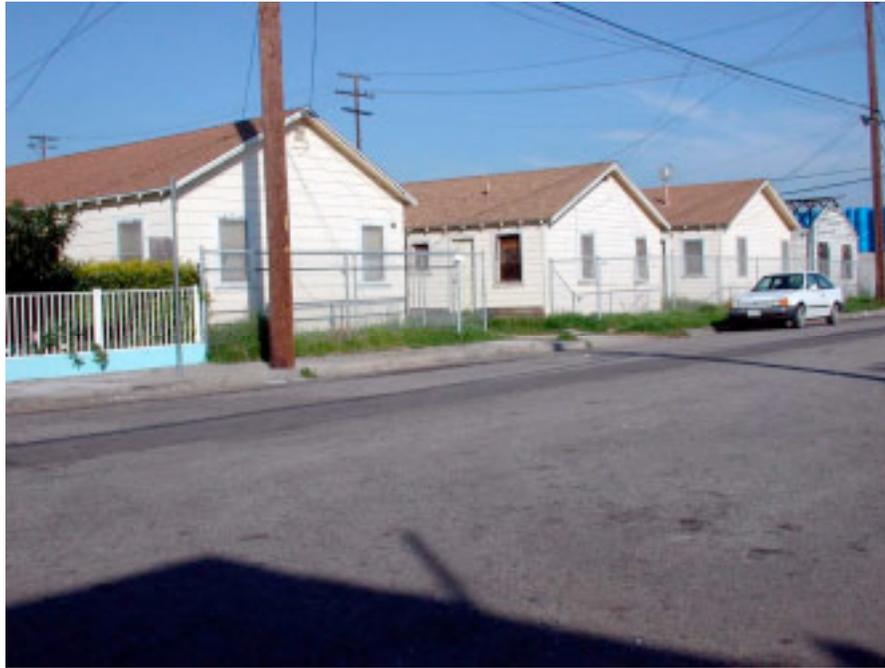
This property consists of four identical residential buildings. These buildings exhibit elements of the California Bungalow style. Each building has a rectangular plan, is one story tall, and has a side gable roof. The gable end is oriented to the street; the primary façade is oriented to the interior of the parcel. Exterior walls are clad with shiplap siding and corner boards. The roof has open eaves and exposed rafter tails and is covered with composition shingles. Windows consist primarily of one-over-one double-hung wood sash. Two doors are located on the secondary (off-street) façade. Windows and doors have simple flat wood surrounds. The condition of three buildings is fair; the fourth building is missing its roof and is in poor condition.

P5b. Description of Photo: (View, date, accession #)
219 E. Sixth St. (View toward northeast). Photo No: 113-25, 1/20/2005

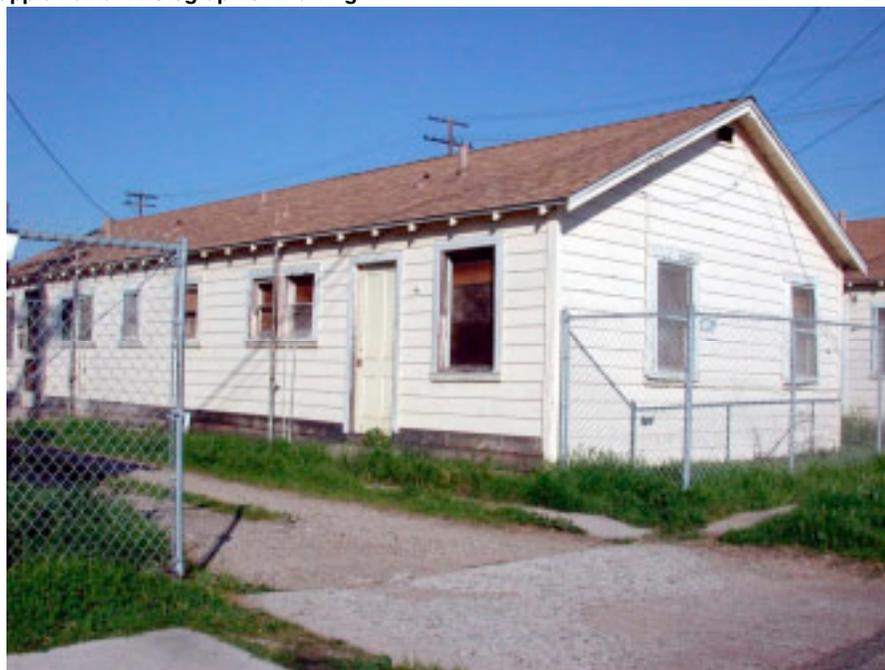
Description of Photo: (View, date, accession #)
*225-31 E. Sixth St. (View toward
northeast). Photo No: 113-26, 1/20/2005*

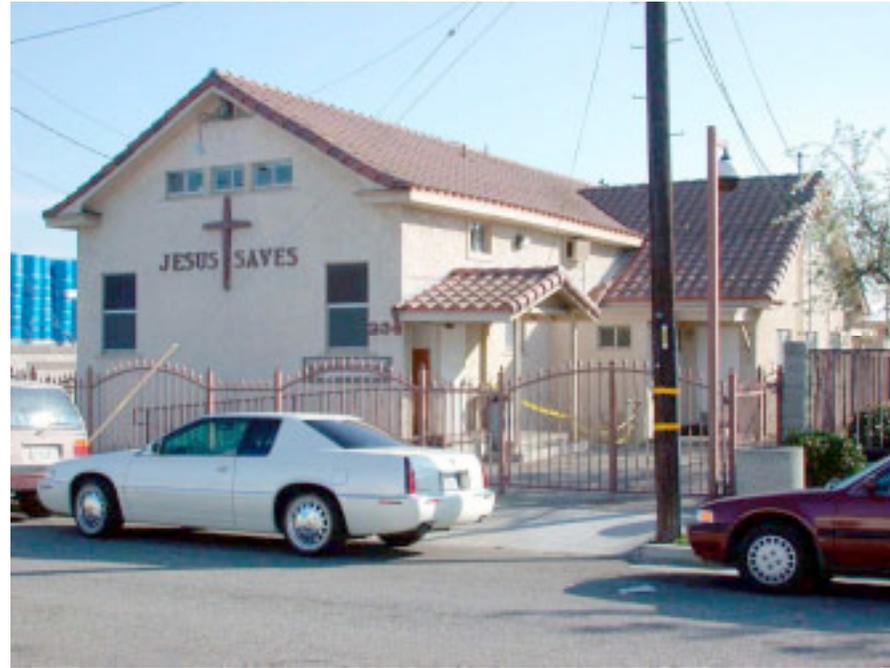
P5b. Description of Photo: (View, date, accession #)
234 E. Sixth St. (View toward southeast). Photo No: 113-27, 1/20/2005

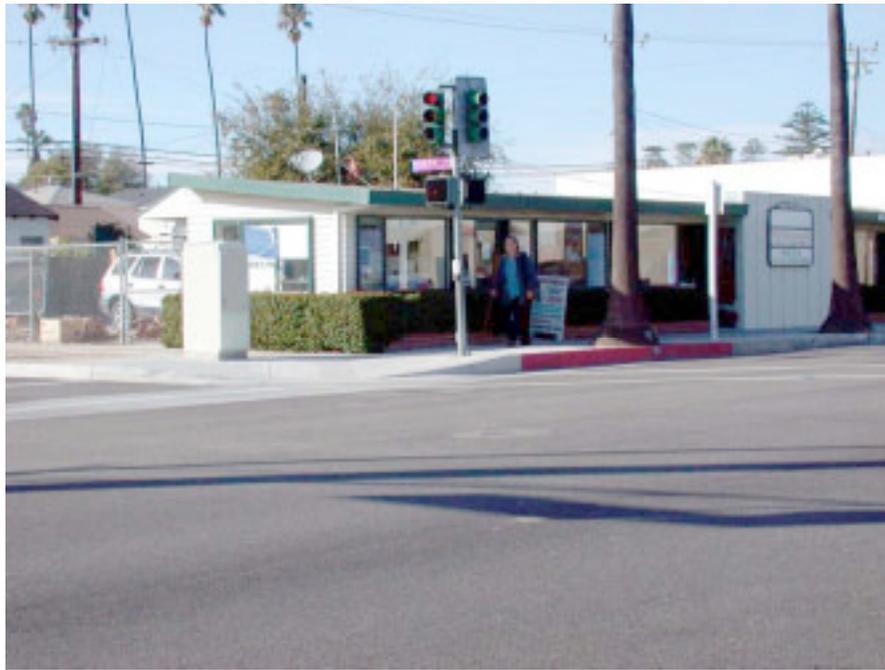
This commercial building is vernacular in design. It has a rectangular plan, is one story in height, and is topped by a sloping flat roof. Exterior walls are clad primarily with wood clapboard or vinyl siding. Fenestration on the two streetfront elevations consists of a large fixed single pane window with adjacent narrower single pane windows. One window is located on the short elevation; a band of these windows fills the longer elevation. The entrance is located along the long elevation. The condition of the building is good.

P5b. Description of Photo: (View, date, accession #)
555-63 S. C St. (413 W. Sixth St.) (View toward northwest). Photo No: 106-16, 11/4/2004
