PRIMARY RECORD

Resource Name or #: (Assigned by recorder) 220 W THIRD ST

San Buenaventura Research Associates. Downtown Oxnard Historic Resources Survey. City of Oxnard, CA., 2005.

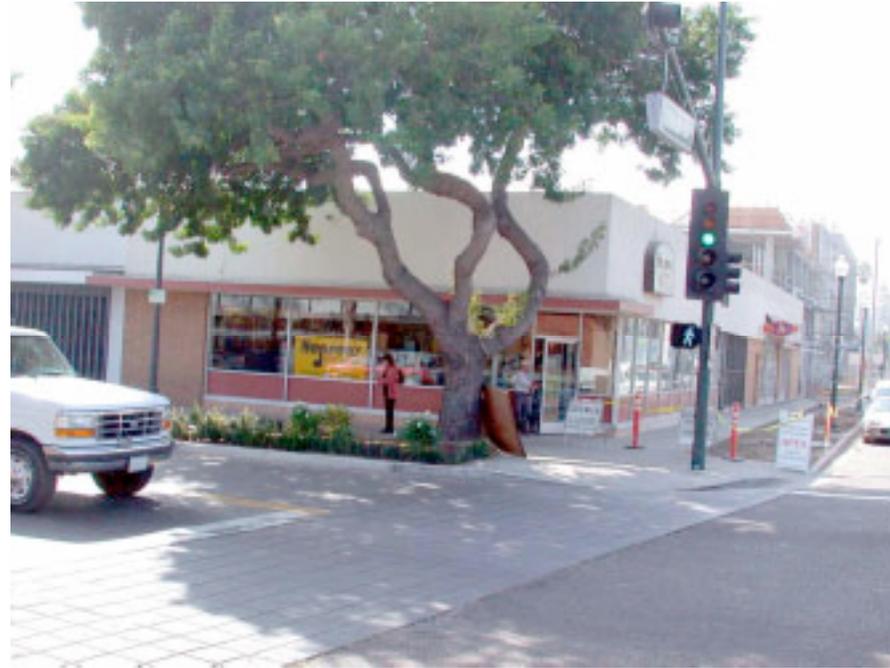
This commercial building is vernacular in design. Located on a corner parcel, the building is one story tall and has a flat roof with a short parapet. Exterior walls are clad with a combination of stucco and roman brick. A continuous row of large plate glass windows wraps the corner of the building, above a short roman brick bulkhead. Each bay of the metal-frame window consists of a large square plate glass window above a small narrow window opening. The lower window is enclosed with an opaque material. A glazed metal entrance door is located in the corner bay. A flat cantilevered canopy extends along one wall of the building above the windows. The upper wall of the building is stucco and has no fenestration. The condition of the building is good.

P5b. Description of Photo: (View, date, accession #)
301 S. A St. (View toward southwest). Photo No: 102-31, 10/6/2004

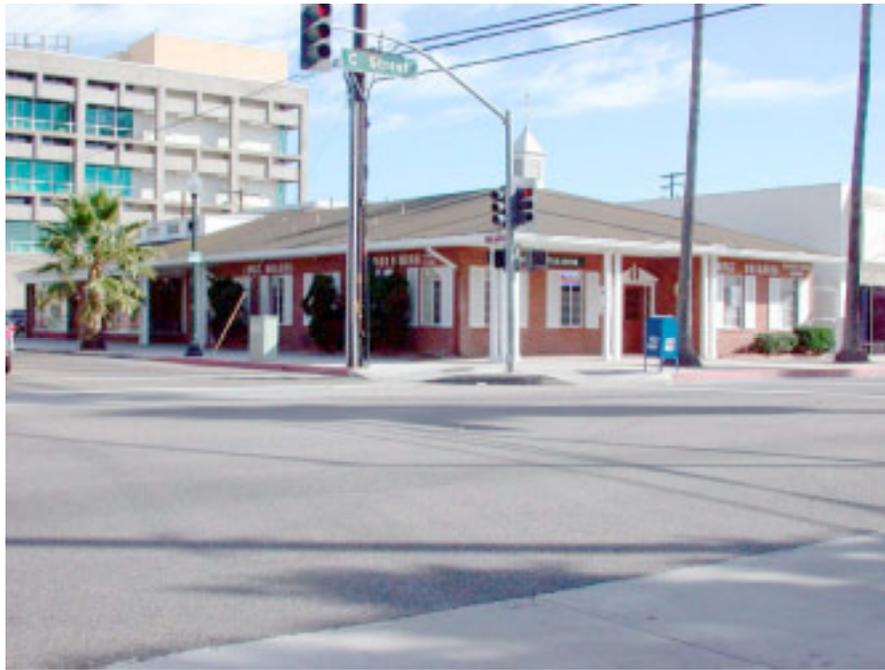
This commercial building exhibits elements of the Colonial Revival style. The building has a rectangular plan, is one story tall, and is topped by a low-pitch hipped roof. Exterior walls are clad with brick; the roof is sheathed with composition shingles. A portion of the walls, as it wraps around the corner of the building, is recessed deeply behind the eaves, creating a canopy. Simple paired columns support the canopy. Windows consist primarily of paired, multi-pane casements. Windows are flanked by decorative louvered shutters. Two floor-to-ceiling plate glass storefront windows are located at the far end of the building's long elevation. A broken pediment ornaments the entrance doors. A cupola and weathervane rise above the roof. The condition of the building is good.

P5b. Description of Photo: (View, date, accession #)
300 S. C. St. (View toward southeast). Photo No: 106-1, 11/4/2004
