Final Report Technical Review of FEMA CCAMP for Ventura County

August 2017

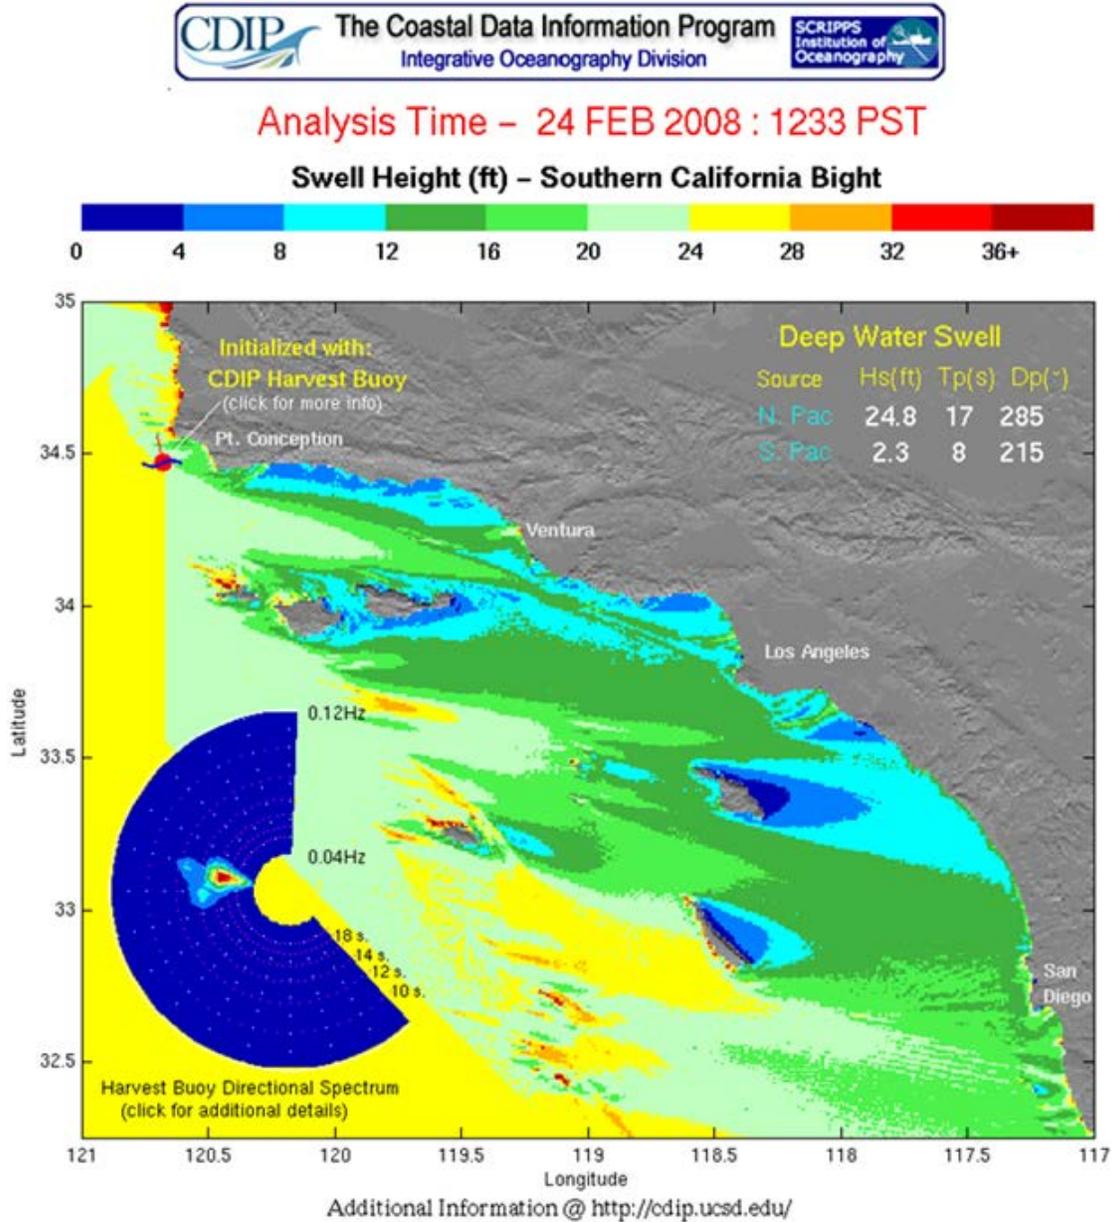
Figure 4-1: Wave Event from 2/24/08 Illustrating a Typical Wave Refraction Pattern (CDIP 2008)

- 3. The pattern of BFE shall be close to the typical pattern of refracted waves inside the Santa Barbara channel.*

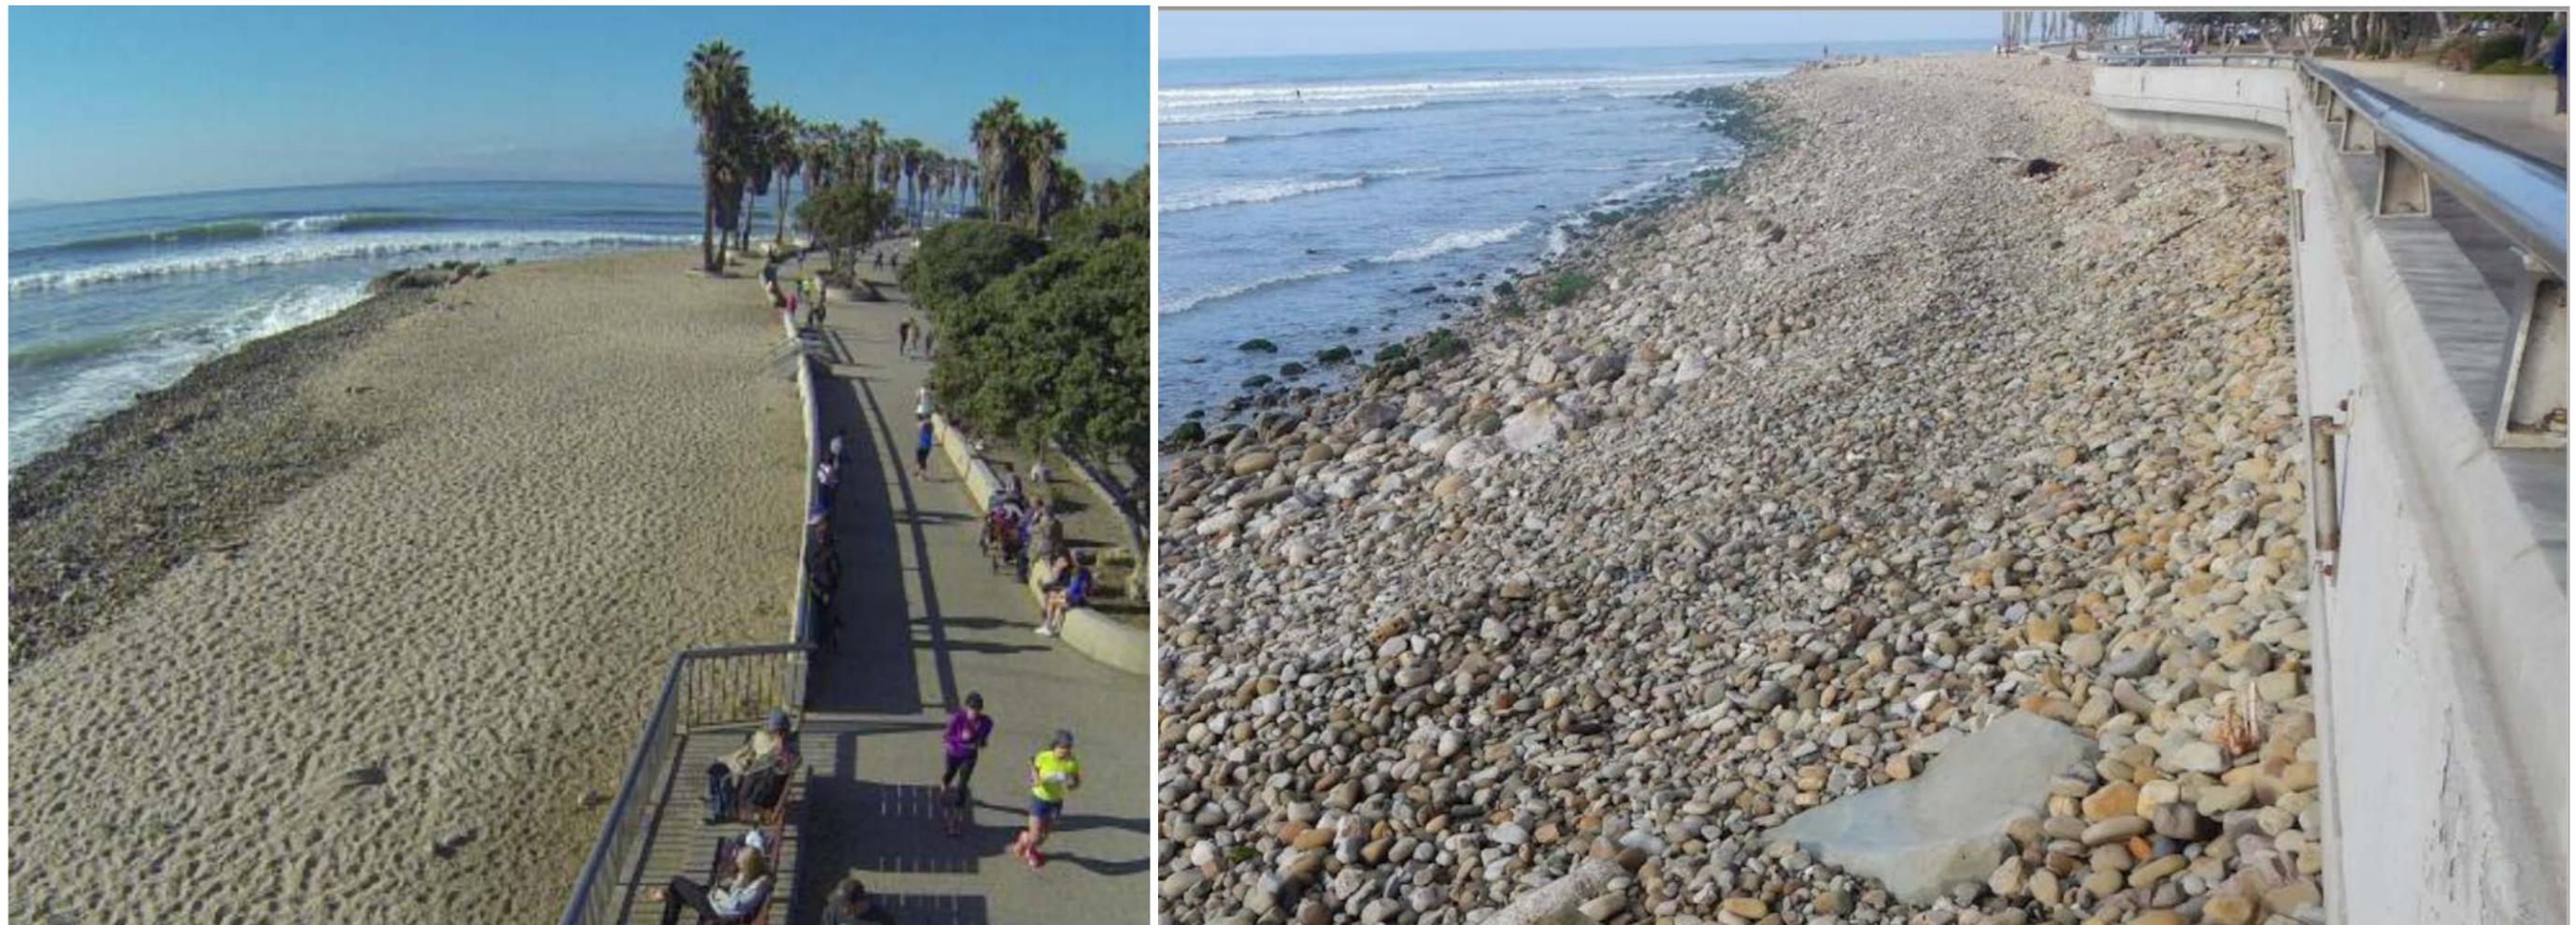
Figure 4-3: Seasonal Changes in Beach Composition along the Ventura Promenade: Sandy (left) and Cobble (right). Photos: Courtesy of BEACON.

In addition to the seasonal changes to the shape of the beaches in Ventura, the changes in sediment composition have not been included in the mapping, as shown in Figure 4-3. The beaches in Ventura, particularly north of the Ventura Harbor, are composed of mixed sand and cobble grain sizes. As part of the seasonal cycle shifting into winter, much of the sand is moved offshore, leaving the cobbles exposed. The exposed cobbles form berms that reduce wave runup elevations due to the increased friction of coarser cobbles.

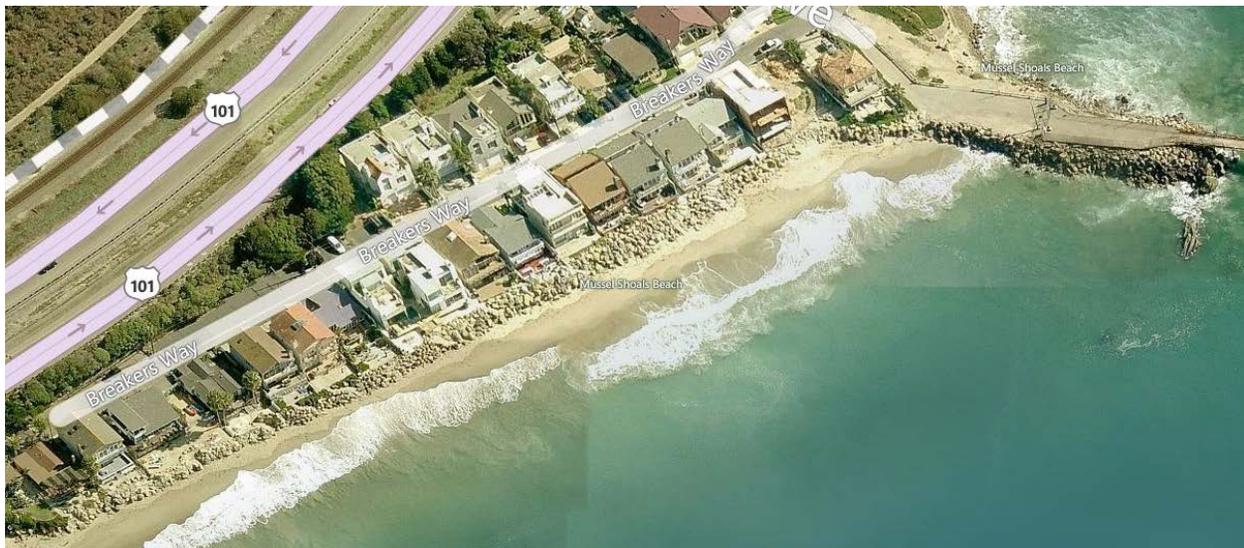
Figure 5-3: Oblique Image at Transect 4 (Bing 2017)

Transect 4 is located along a mild sloped dry sandy beach, which helps dissipate wave energy and reduce runup elevations, as shown in Figure 5-3. At this transect, it is assumed that waves will break on the sandy beach and the revetment/bluff crest at the back of the beach is not overtopped. If an eroded beach condition was assumed or the Most Likely Winter Profile was calculated, at this transect, waves would likely break on the back beach at the revetment (intact condition) or sandy bluff (failed condition) and wave runup would be greater and the BFE would increase. Runup parameters are shown on the transect profile in Figure 5-4 and further discussed in the following section.

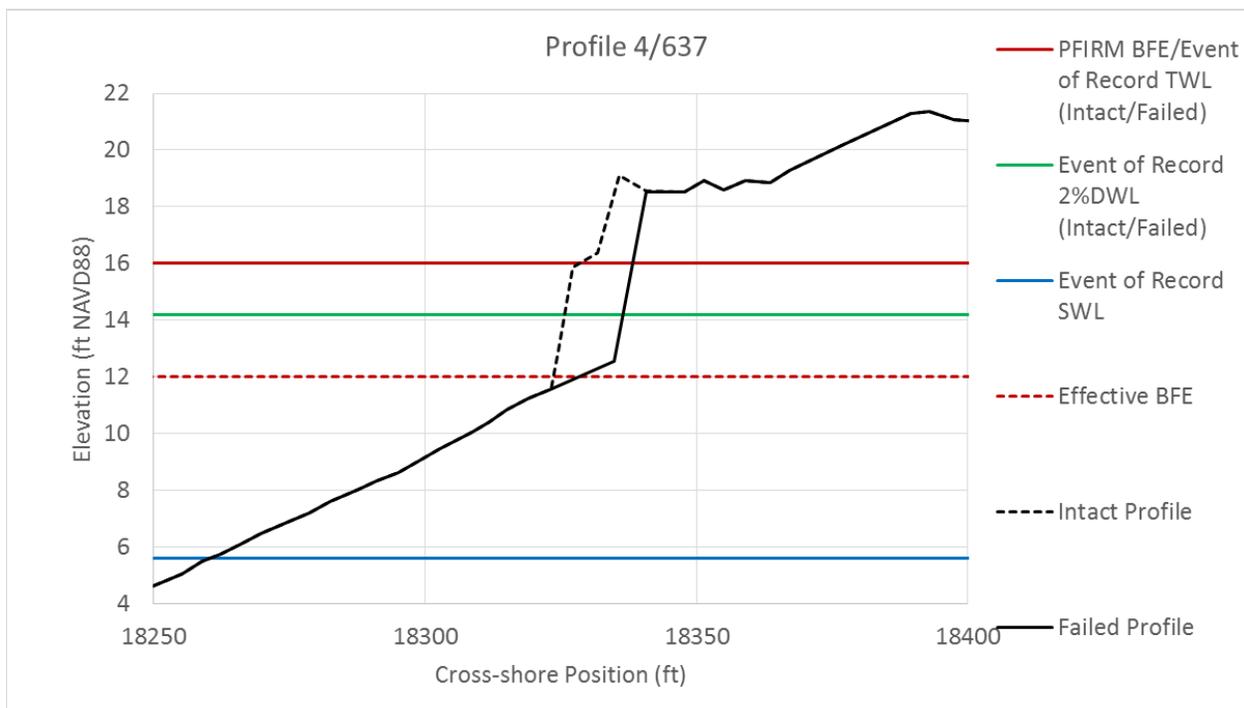
Figure 5-4: Transect 4/637 Profile and Runup Parameters

- The runup slope used seems reasonable.
- Calculated TWL results were the same for both intact and failed conditions.

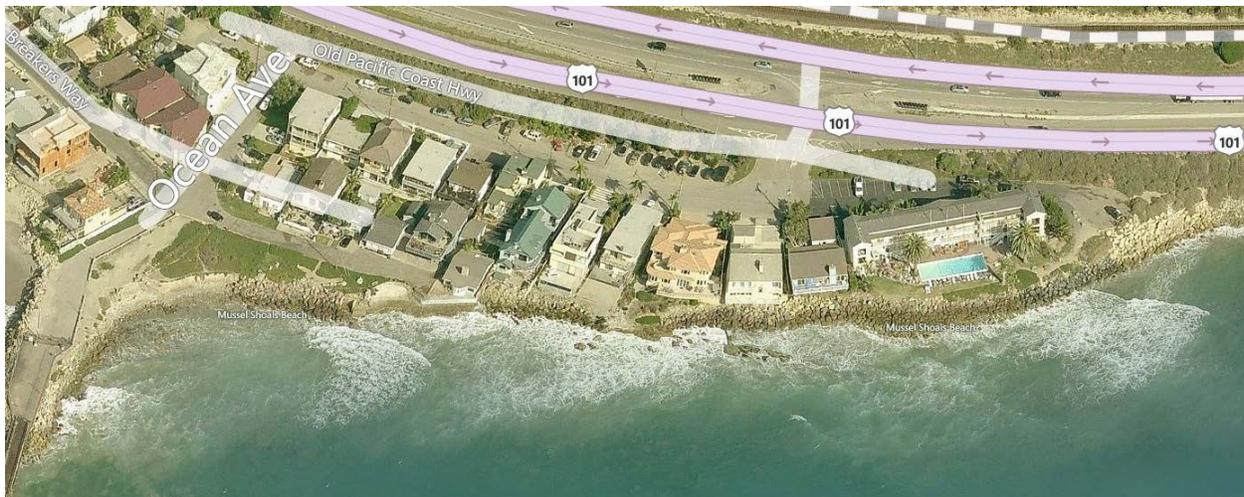
Figure 5-5: Oblique Image at Transect 5 (Bing 2017)

Transect 5 is located along a wet beach with reef, cobble, sand and rock, as shown in Figure 5-5. Although the modeled wave heights are reduced by the refraction around the point, waves break on the revetment (intact condition) or sandy bluff (failed condition) resulting in greater runup values and a higher BFE. Waves approach the beach at an oblique angle, as seen in Figure 5-5. Runup parameters are shown on the transect profile in Figure 5-6 and further discussed in the following section.

- TWLs could be reduced if a higher roughness factor was considered for the failed condition as portions of the failed revetment would remain and contribute to a rougher runup slope. Historical aerial imagery shows the revetment in place in 1972 and current aerial imagery shows reef, cobble, sand, rock, and the rock revetment along this reach.

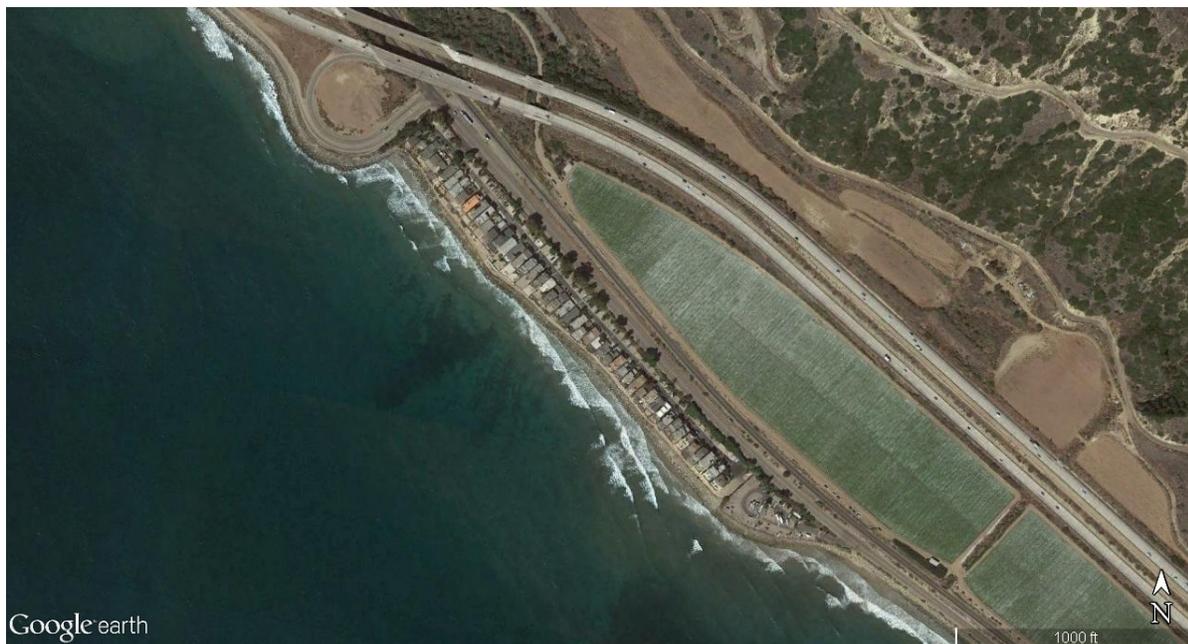
Figure 5-8: Aerial View of Site 2 – Typical Wave Patterns (Google 2017)

approach normal to the shoreline as seen in Figure 5-8. Runup parameters are shown on the transect profile in Figure 5-10 and discussed in the following section.

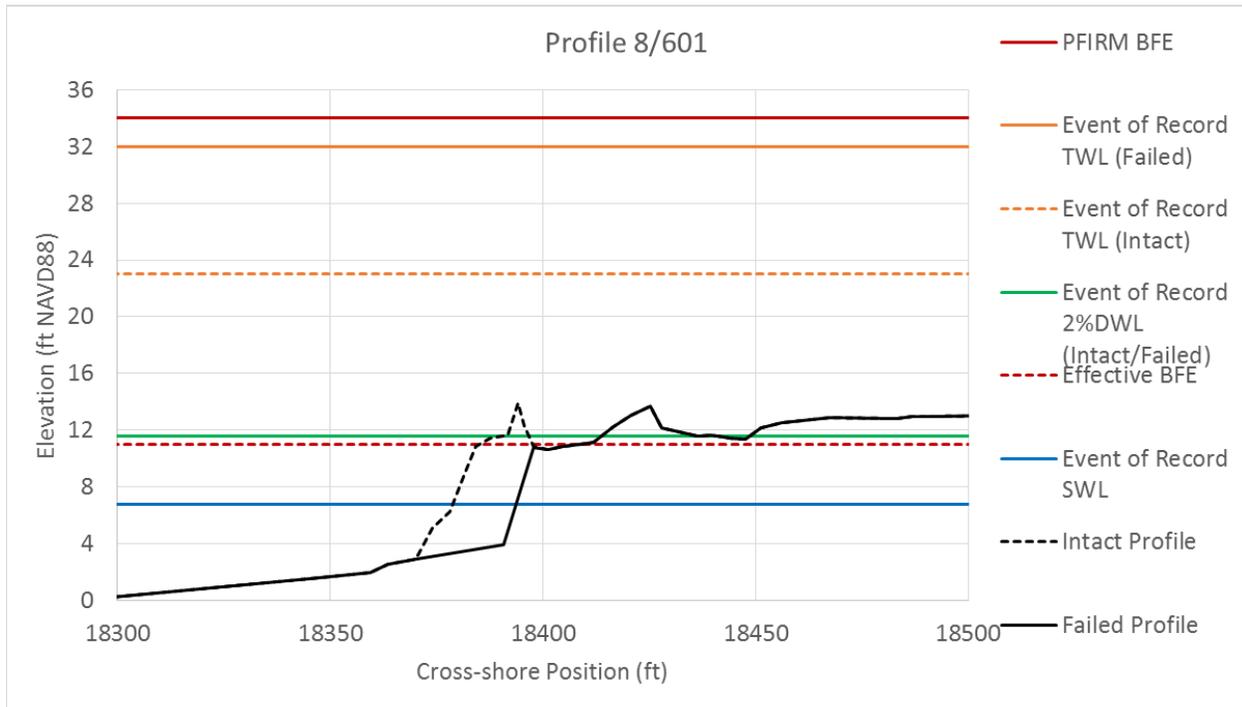
Figure 5-10: Transect 8/601 Profile and Runup Parameters

- Bore overtopping was calculated and mapped in a secondary VE zone at this transect since inland propagation exceeded 35 ft. If TWLs are reduced, overtopping would be recalculated and as a result, inland propagation and flood depths may be reduced.

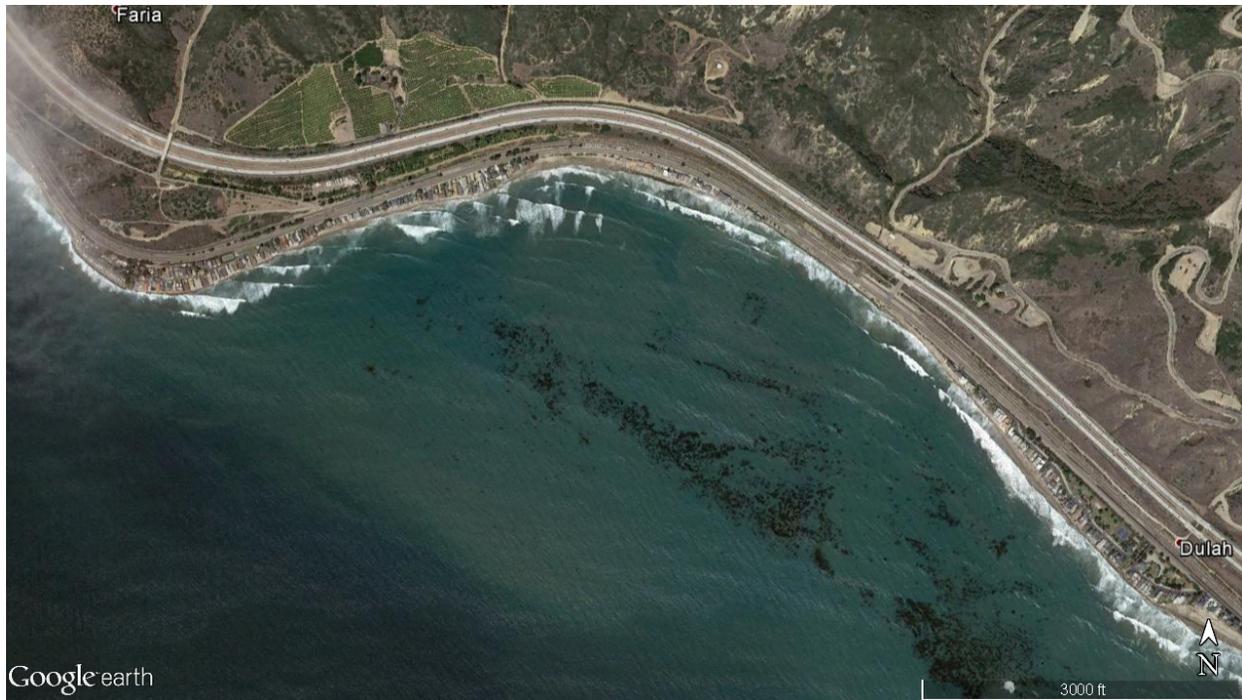
Figure 5-11: Aerial View of Site 3 – Typical Wave Patterns (Google 2014)

This site extends from Pitas Point downcoast to the Solimar Beach community. In total, this site contains 10 primary VE zones (one at each transect), which represent wave runup elevations, and a secondary VE zone at six of transects. Secondary VE zones are mapped when calculations indicate that seawater resulting from wave runup will propagate 35 ft or more inland. If this distance is less than 35 ft, the extent of inland propagation is mapped in the primary VE zone. BFEs range from 21 to 29 ft NAVD88 at this site due to the differences in shore characteristics and orientation. All these transects, due to topographic constraints and mapping limitations, have mapped as the VE zone without the AO zone due to mapping resolution requirements. An aerial view of the site and typical wave patterns is shown in Figure 5-11.

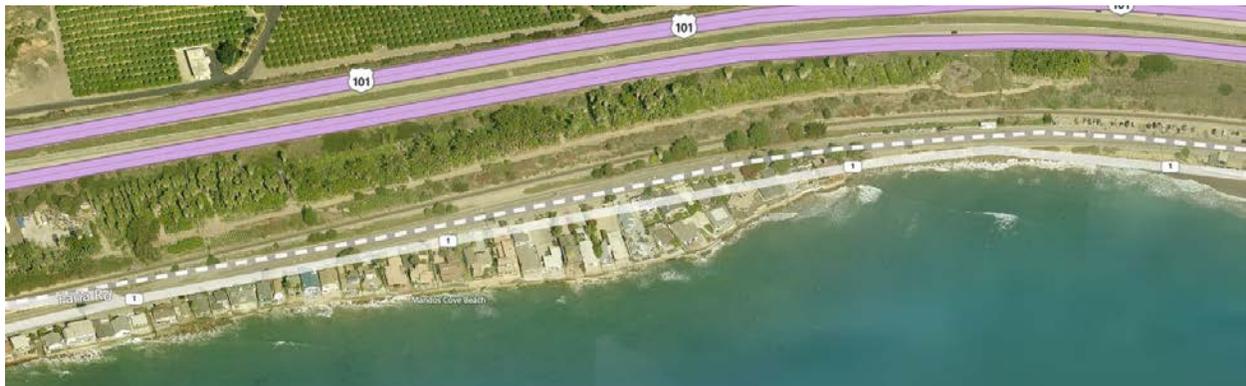
Figure 5-15: Oblique Image at Transect 15-16 (Bing 2017)

Transects 11-15 are located along a wet beach with sand, cobble, and rock; an offshore reef is apparent in aerial imagery and is popular among surfers. The beach is backed by a combination of non-continuous revetments and seawalls protecting a park and homes. At these transects it is assumed that waves will break on the coastal structures along the back beach (intact condition) or sandy bluff (failed condition). Waves approach these transects at an oblique angle. An excerpt from the PFIRM is shown in Figure 5-12 and an oblique view of the site is shown in Figure 5-13. Runup parameters are shown on the transect profiles in Figure 5-19 through Figure 5-23 and further discussed in the following section.

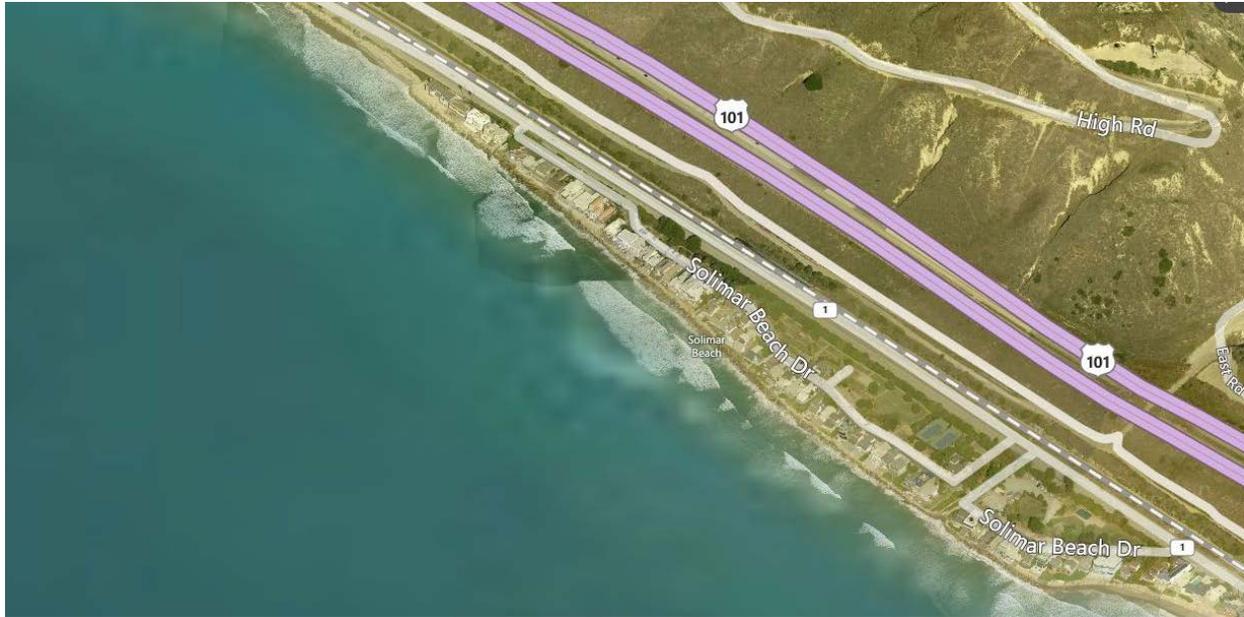
Figure 5-18: Oblique Image at Transect 19-20 (Bing 2017)

Transects 19-20 are located along a wet sand and cobble beach; an offshore reef is apparent in aerial imagery. The beach is backed by a continuous rock revetment fronting homes. At these transects it is assumed that waves will break on the revetment along the back beach (intact condition) or sandy bluff (failed condition). An excerpt from the PFIRM is shown in and an oblique view of the site is shown in Figure 5-17. Runup parameters are shown on the transect profiles in Figure 5-27 and Figure 5-28 with further discussion in the following section.

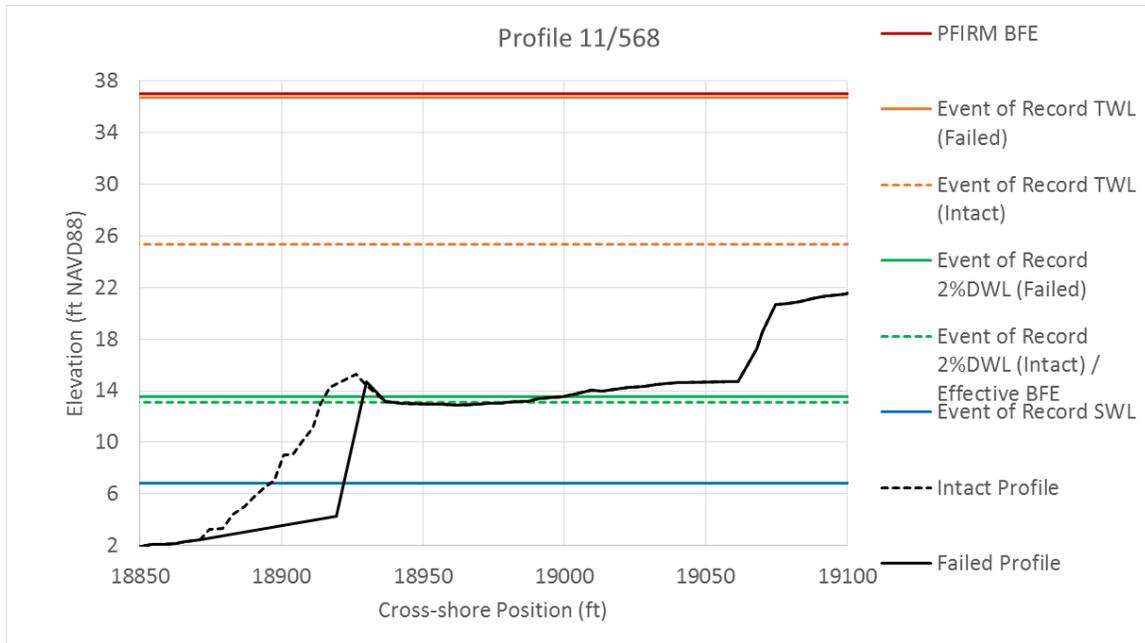
Figure 5-19: Transect 11/568 Profile and Runup Parameters

- Bore overtopping was calculated and mapped in a secondary VE zone at this transect since inland propagation exceeded 35 ft. If TWLs are reduced, overtopping would be recalculated and as a result, inland propagation and flood depths may be reduced.

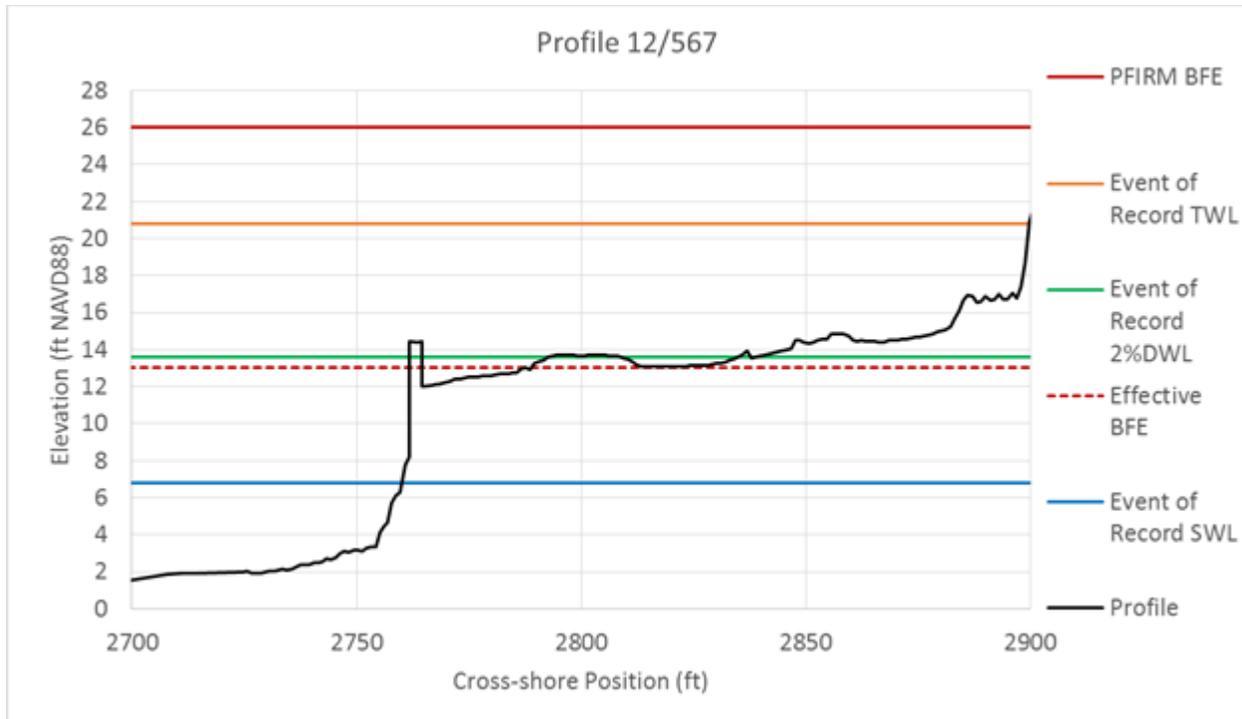
Figure 5-20: Transect 12/567 Profile and Runup Parameters

- BFE (26 ft NAVD88) exceeds the event of record TWL (20.8 ft NAVD88 1/18/88).
- SWL of 6.8 ft NAVD88 is the same as Transect 11, H_o of 14.6 ft is 12% less than Transect 11, and T_p of 15.9 seconds is the same as Transect 11.
- Wave approach angle is oblique and may warrant a small TWL reduction.
- SWL is above toe; therefore, TAW runup method is appropriate.
- Transect geometry includes a vertical face of a seawall. The condition and maintenance of this structure is unknown, and it may not be representative of the entire zone where some seawalls have a recurved face.
- Aerial imagery shows the presence of cobble, rock, and sand at the base of seawalls. There may be potential for a small TWL reduction if a revised roughness factor is

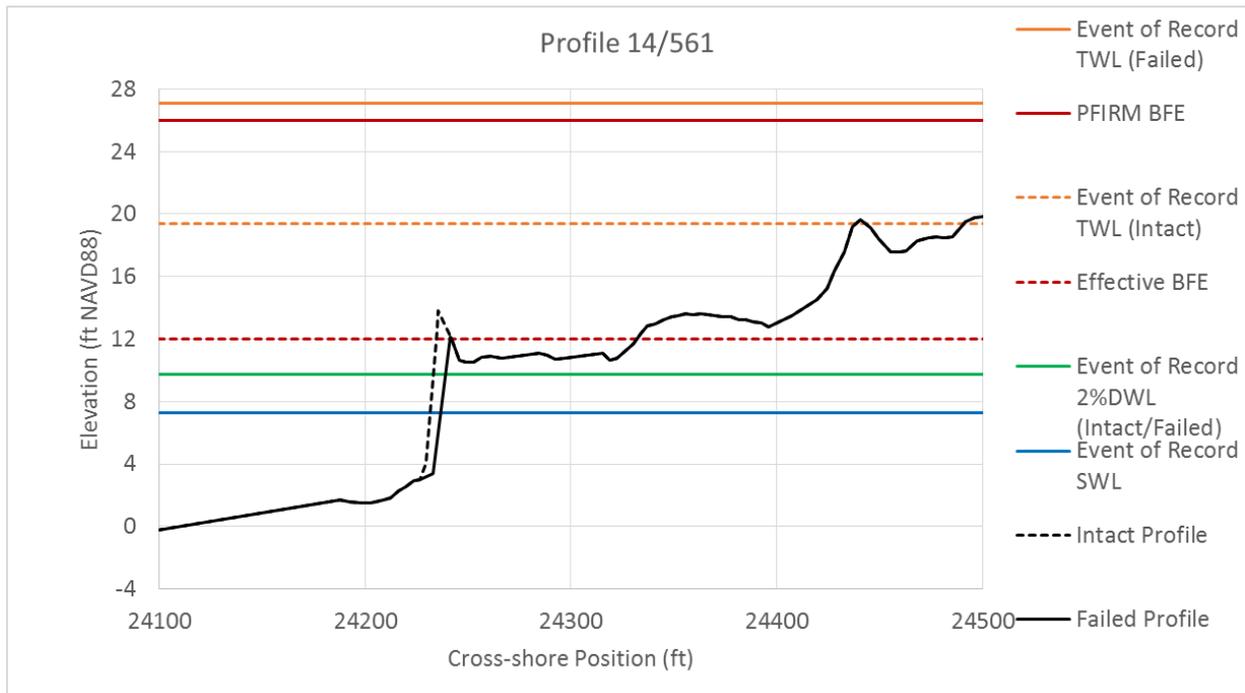
Figure 5-22: Transect 14/561 Profile and Runup Parameters

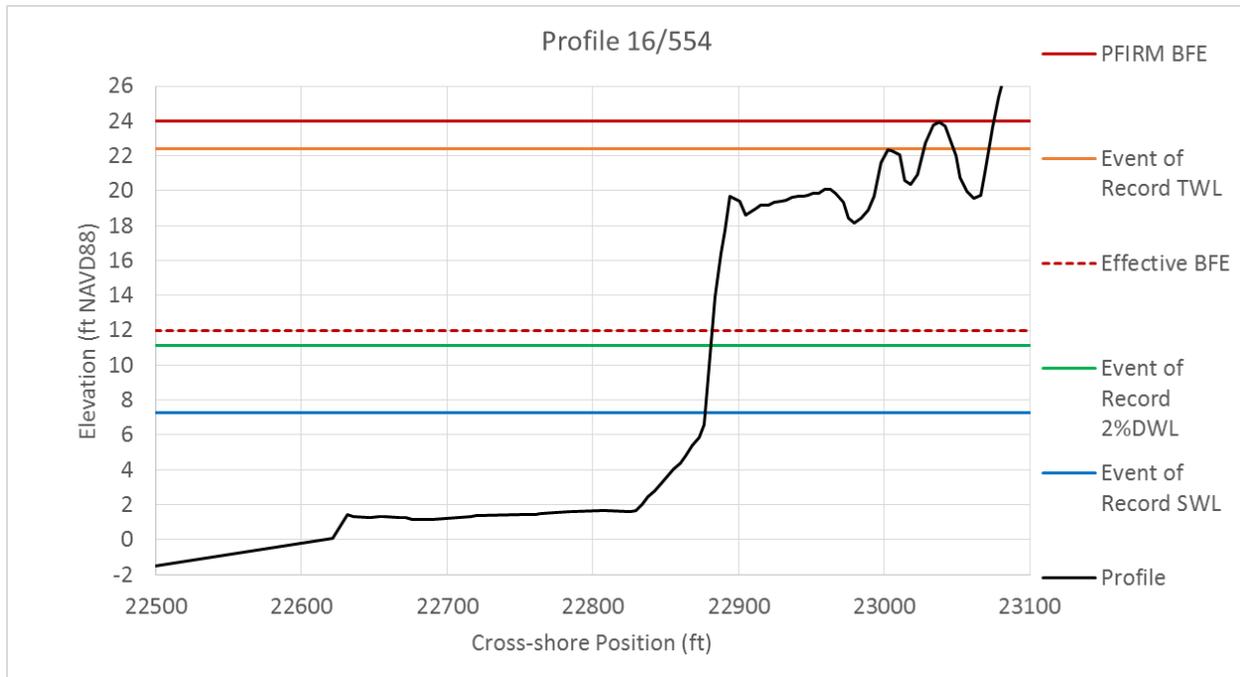
Figure 5-24: Transect 16/554 Profile and Runup Parameters

- Splash overtopping was calculated and mapped in the primary VE zone at this transect since inland propagation was less than 35 ft. If TWLs are reduced, overtopping would be recalculated and as a result, inland propagation may be reduced.

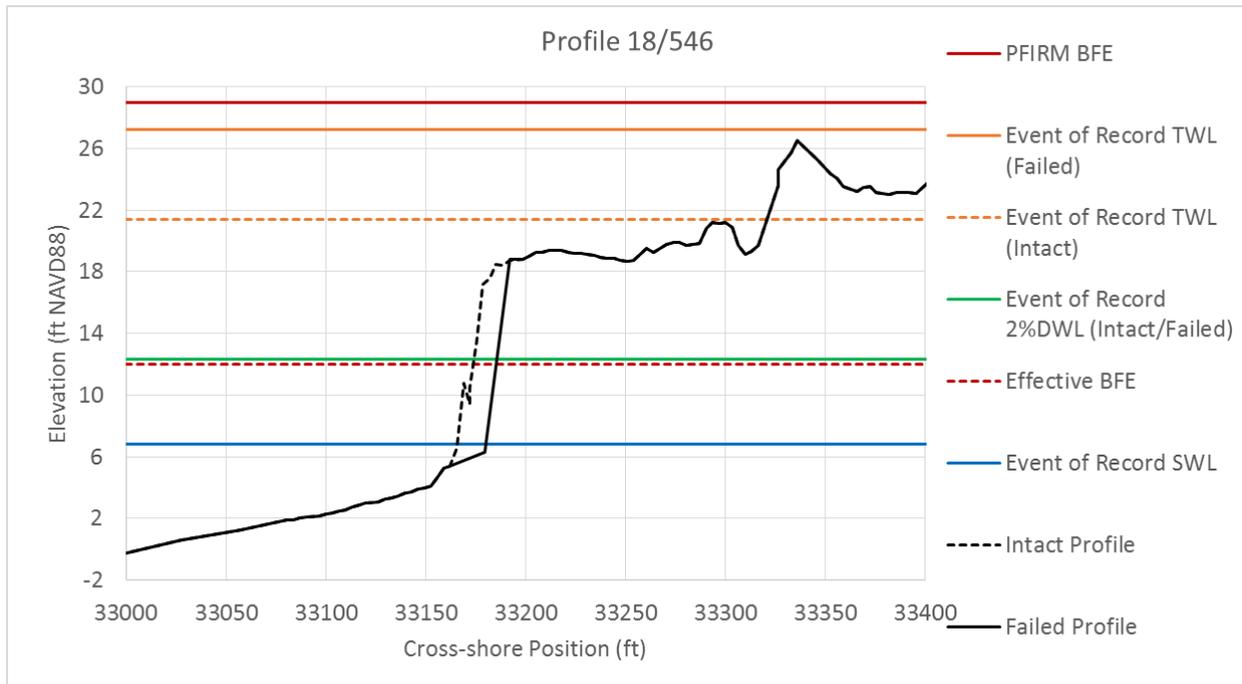
Figure 5-26: Transect 18/546 Profile and Runup Parameters

- Bore overtopping was calculated and mapped in the primary VE zone at this transect since inland propagation was less than 35 ft. If TWLs are reduced, overtopping would be recalculated and as a result, inland propagation may be reduced.

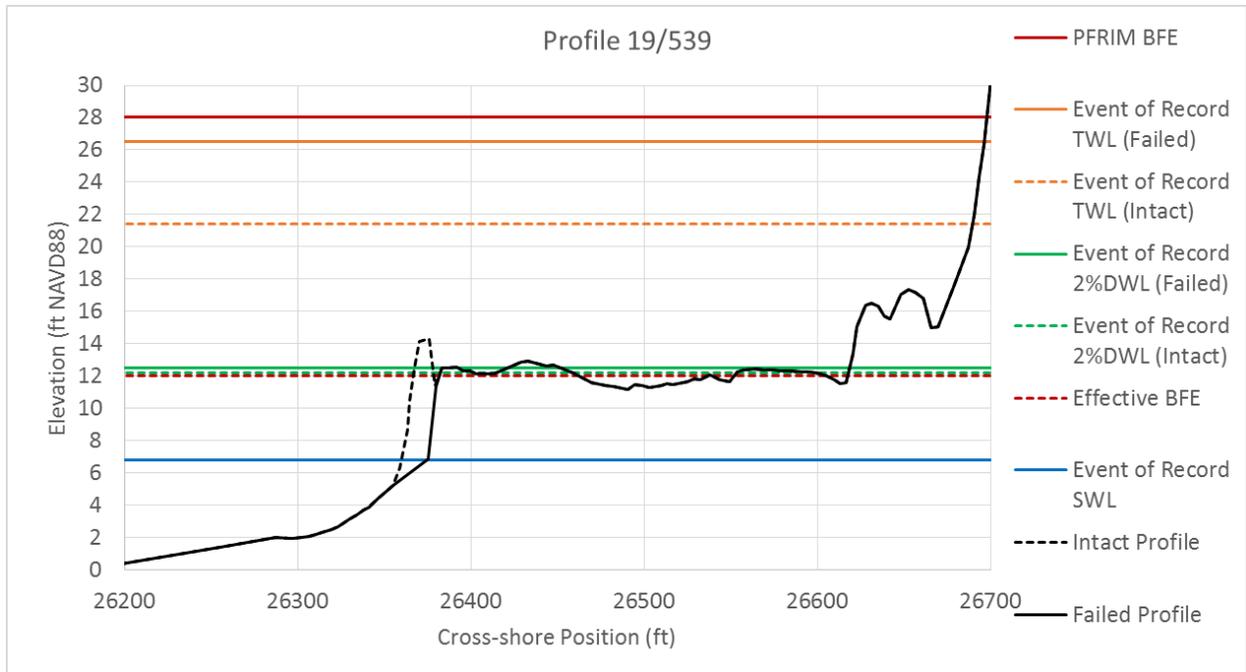
Figure 5-27: Transect 19/539 Profile and Runup Parameters

- Bore overtopping was calculated and mapped in a secondary VE zone at this transect since inland propagation exceeded 35 ft. If TWLs are reduced, overtopping would be recalculated and as a result, inland propagation and flood depths may be reduced.

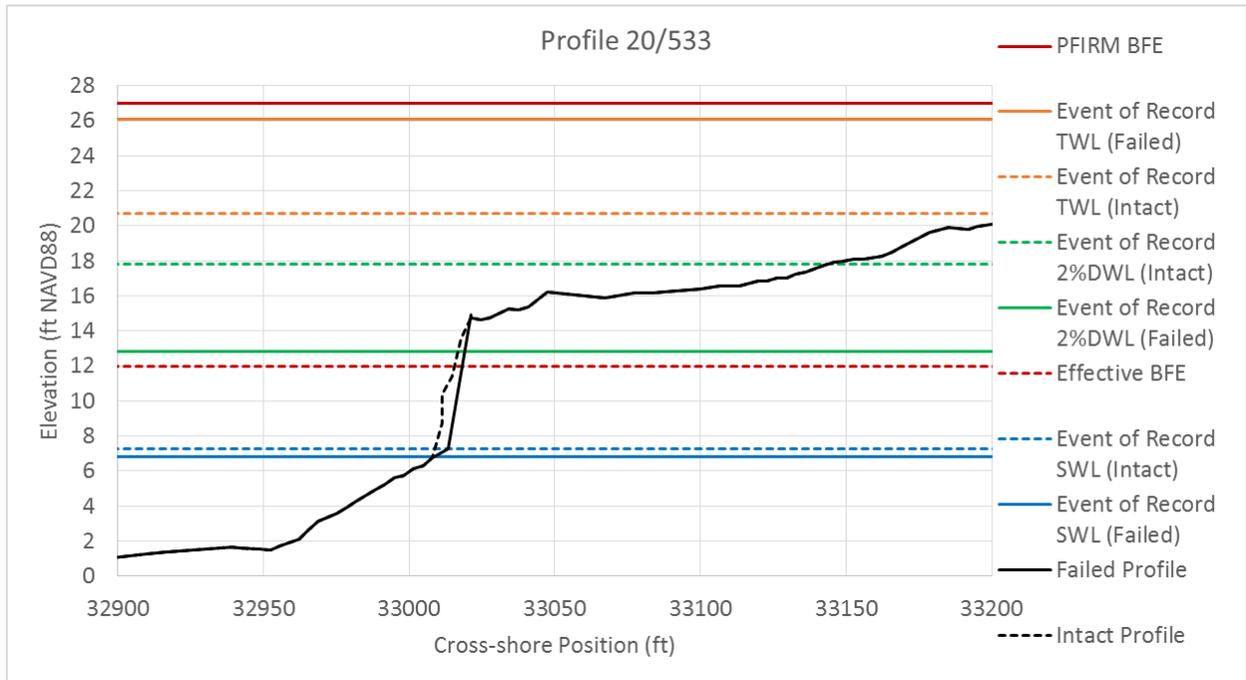
Figure 5-28: Transect 20/533 Profile and Runup Parameters

- Bore overtopping was calculated and mapped in a secondary VE zone at this transect since inland propagation exceeded 35 ft. If TWLs are reduced, overtopping would be recalculated and as a result, inland propagation and flood depths may be reduced.

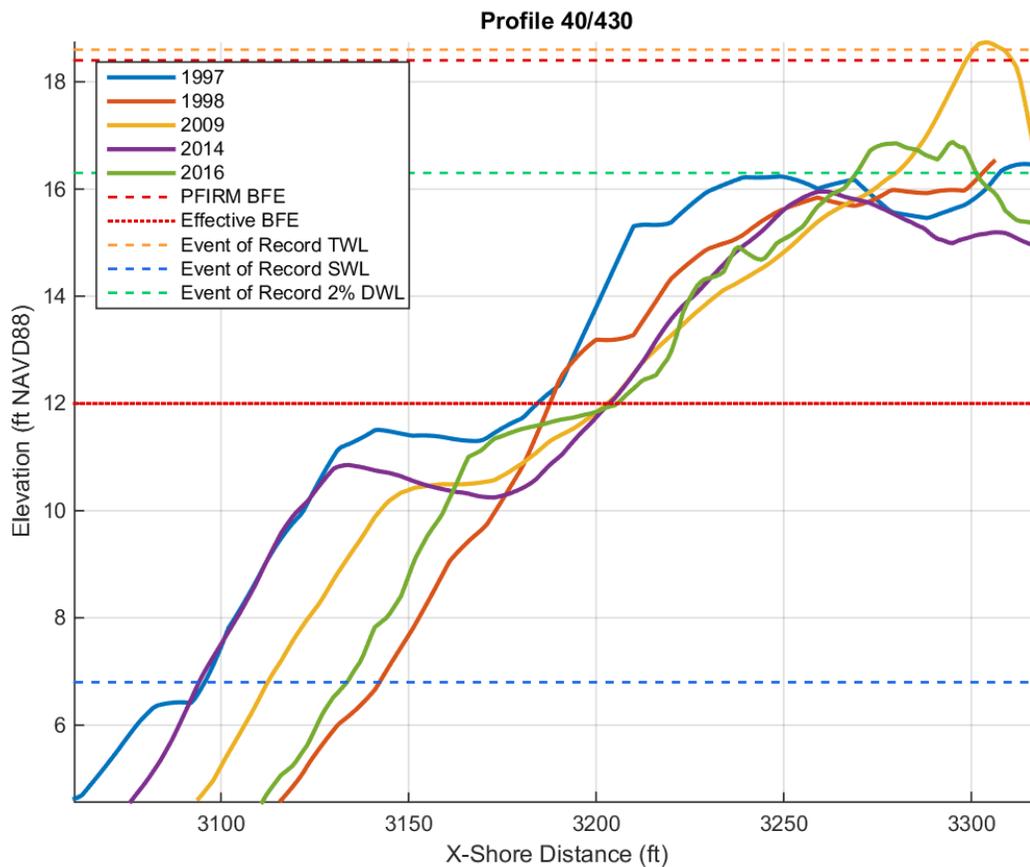
Figure 5-35 : Cross Shore Beach Profiles at Transect 40

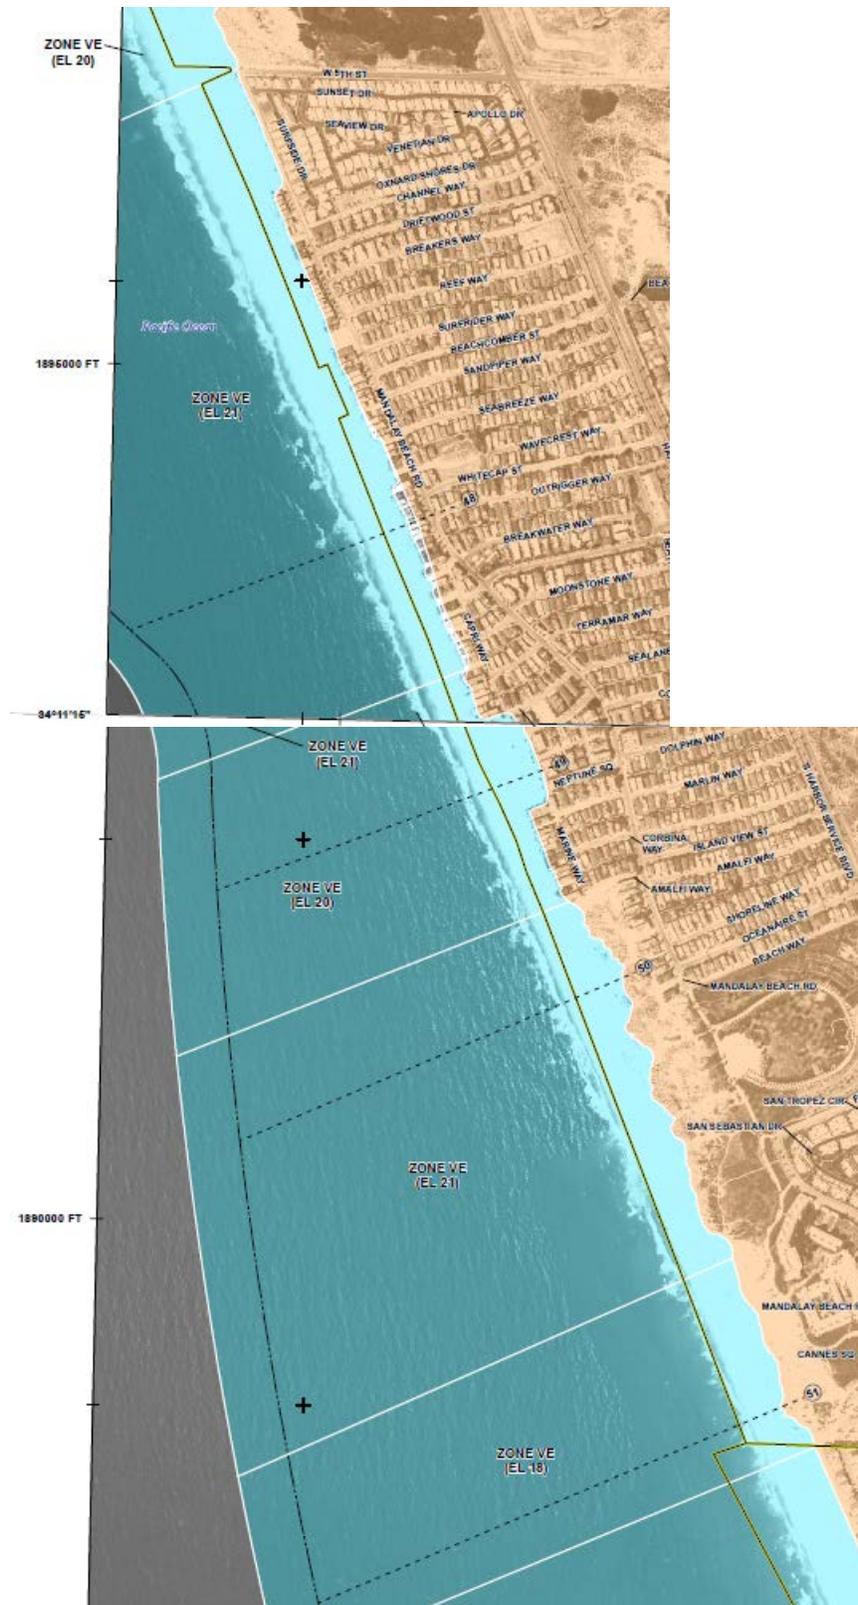
Figure 5-38: Site 5 PFIRM Panel 903F & 911F Excerpt (FEMA 2016)

The preliminary FIRMs (Figure 5-37 through Figure 5-39) show a substantial increase between 5 and 8 feet in BFE compared to effective FIRMs with a BFE of 13 feet. The increase varies alongshore with the largest increase at Transect 50 of 8.3 feet. Adjacent transects show substantial variability with a 3-foot difference between Transects 50 and 51. Across this site, there are differences in storm events, differences in the wave period and still water level used from the same storm event, as well as geomorphic variability in beach slopes through which subtle differences affect wave runup elevations. These differences are highlighted by individual transects below and explain the ranges in preliminary BFEs. In the residential development along Oxnard Shores, these distinct differences in the BFE make future planning and permitting decisions difficult.

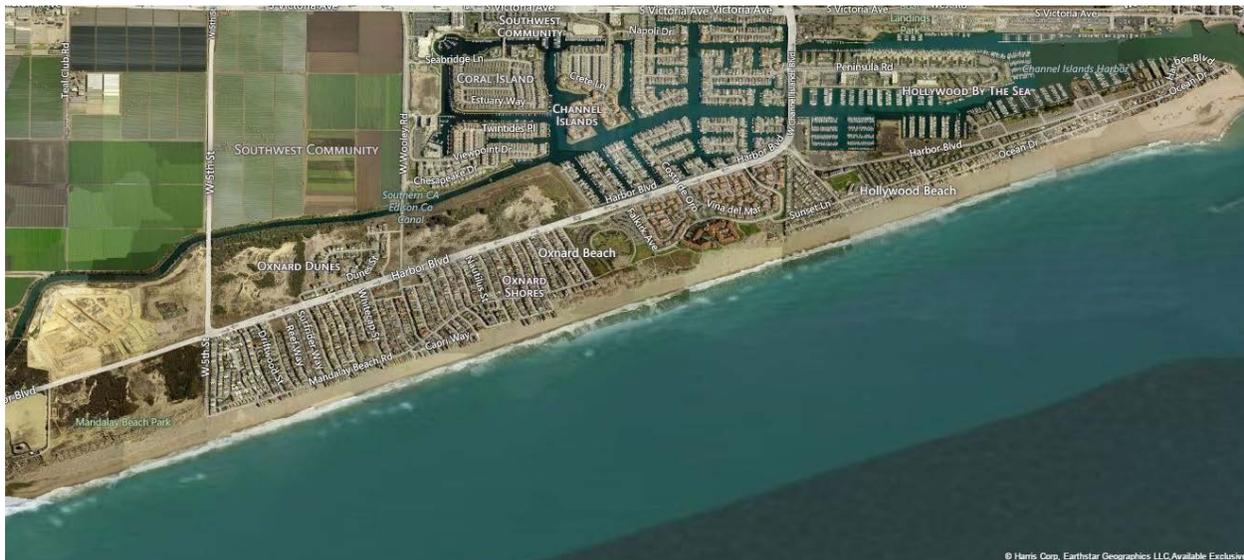
Figure 5-41: Oblique Image at Site 5 (Bing 2017)

The Oxnard shores study site has a similar shoreline orientation throughout between the Santa Clara River and the Channel Islands Harbor. Wave observations and wave model outputs have shown some gradients in wave heights with larger waves in the north near the Santa Clara River (Transects 46 and 47) decreasing to the south (Transect 52). Overall, this pattern of wave heights is not captured in the storm of record TWL data used in the FEMA analysis. The FEMA TWL data shows the highest waves at Transect 50. One storm of record from 1/18/1988 uses different wave periods and still water levels for the same event on the same day. Typical wave patterns at the site are shown in Figure 5-40, and an oblique view of the site is shown in Figure 5-41.

Geomorphically, this site/shoreline segment is largely controlled by sediment impounded updrift to the north of the Channel Islands Harbor and augmented by episodic discharges from the Santa Clara River. The transect-based analysis used by FEMA does not consider the widening of the beach caused by the changes in dredge volumes and frequency, instead relying solely on a single topographic data set collected in November 2009. Most of the beaches have widened since that time, as evidenced by subsequent topographic data collection. Beach slopes are largely controlled by sediment grain size and are variable and similar throughout the site. The range in beach slopes is from 0.05 to 0.13. This variability alone and its effect on wave runup calculations

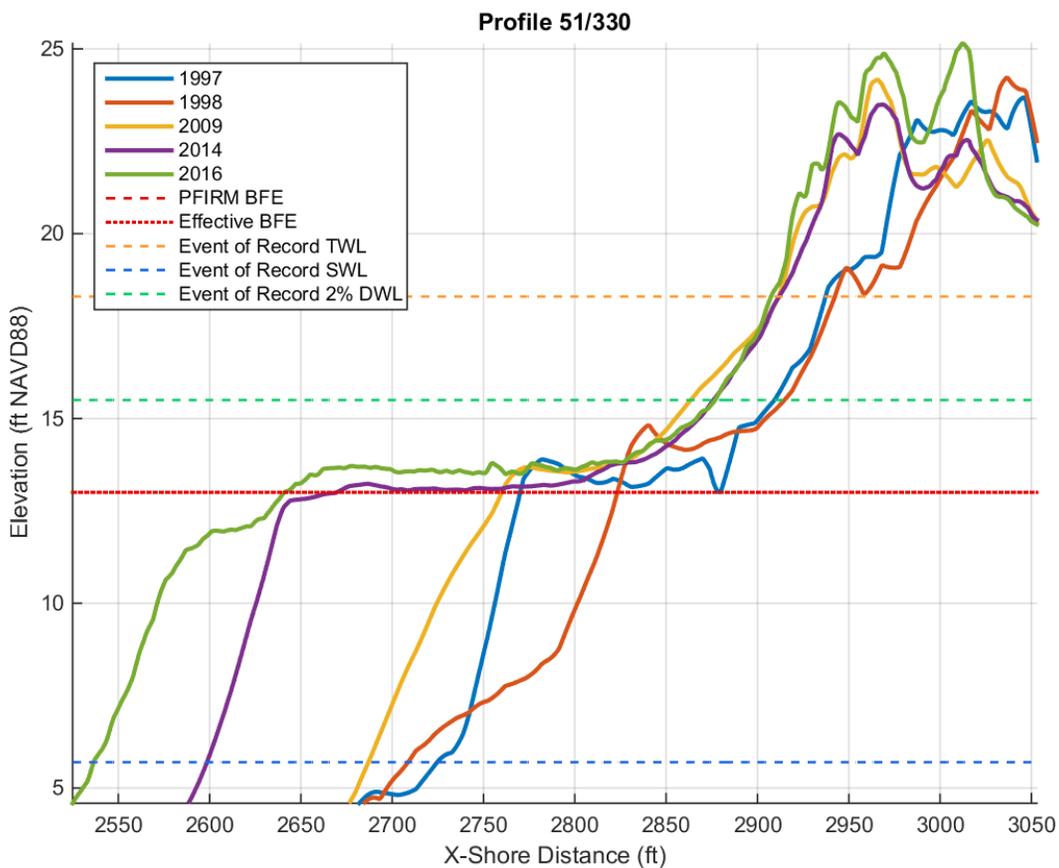
Figure 5-46: Cross Shore Beach Profiles at Transect 51. Note that PFRIM BFE and Event of Record TWL are at the same elevation, 18.3 ft.
