Final Report Technical Review of FEMA CCAMP for Ventura County

August 2017

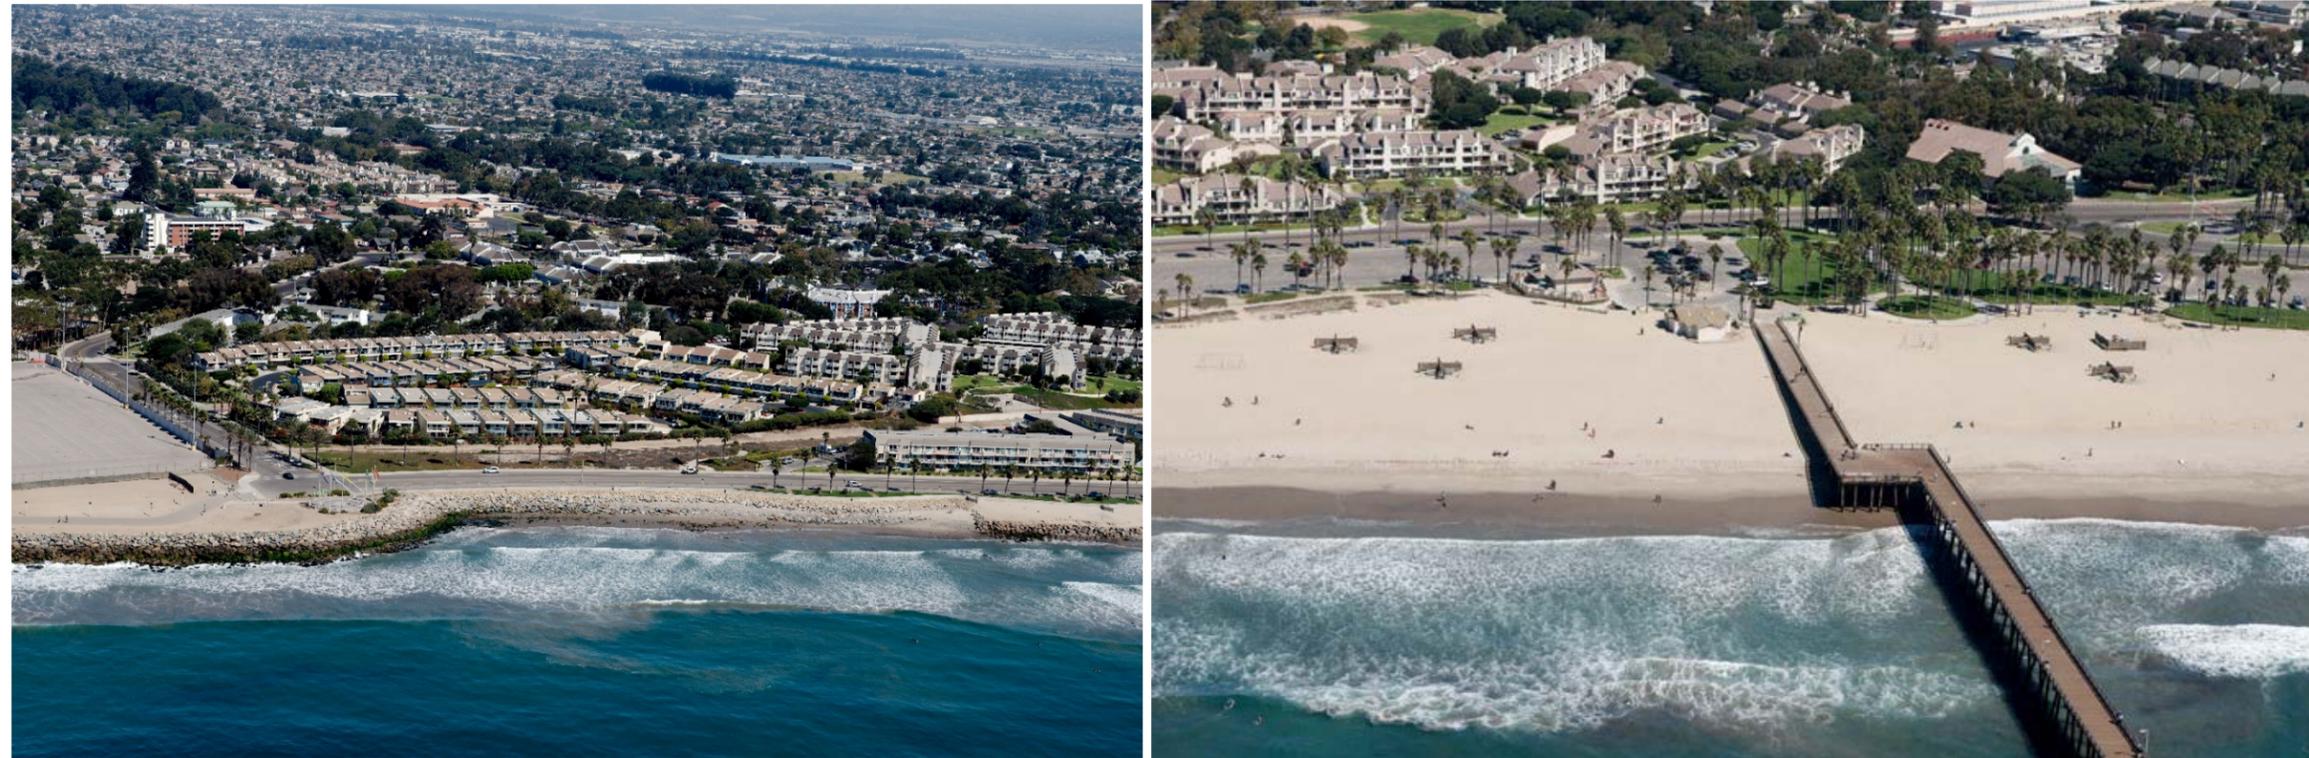
Figure 5-49: Photo at Port Hueneme Pier (California Coastal Records Project 2013)

The PFIRM for City of Port Hueneme is shown in Figure 5-48. While this site was not selected for detailed analysis, it is prudent to highlight the wide variability of the site as it clearly illustrates the presence and absence of the fronting beach. The use of Stockdon based on the 2009 LIDAR is acceptable; however, a more appropriate calculation would have been to consider an eroded profile and use potentially the TAW, as the site has been recently armored as a result of recent erosion. Examination of the beach in front of the City of Port Hueneme shows substantive changes in beach width, nearshore slopes and backshore characterization. Presently, Transects 61 and 62 apply the Stockdon wave runup equation, which is suitable for sandy beaches. Examination of some of the available photos (Figure 5-49 & Figure 5-50) and topographic LIDAR shows extreme variability at these sites with beach width changing significantly as seen in the cross shore profiles at Transect 61 in Figure 5-51. The 2009 LIDAR topography shows a beach that is approximately 600 feet wider than that in 2014 during which time the City of Port Hueneme was undergoing substantial erosion caused by the lack of harbor bypass dredging from Channel Islands Harbor.

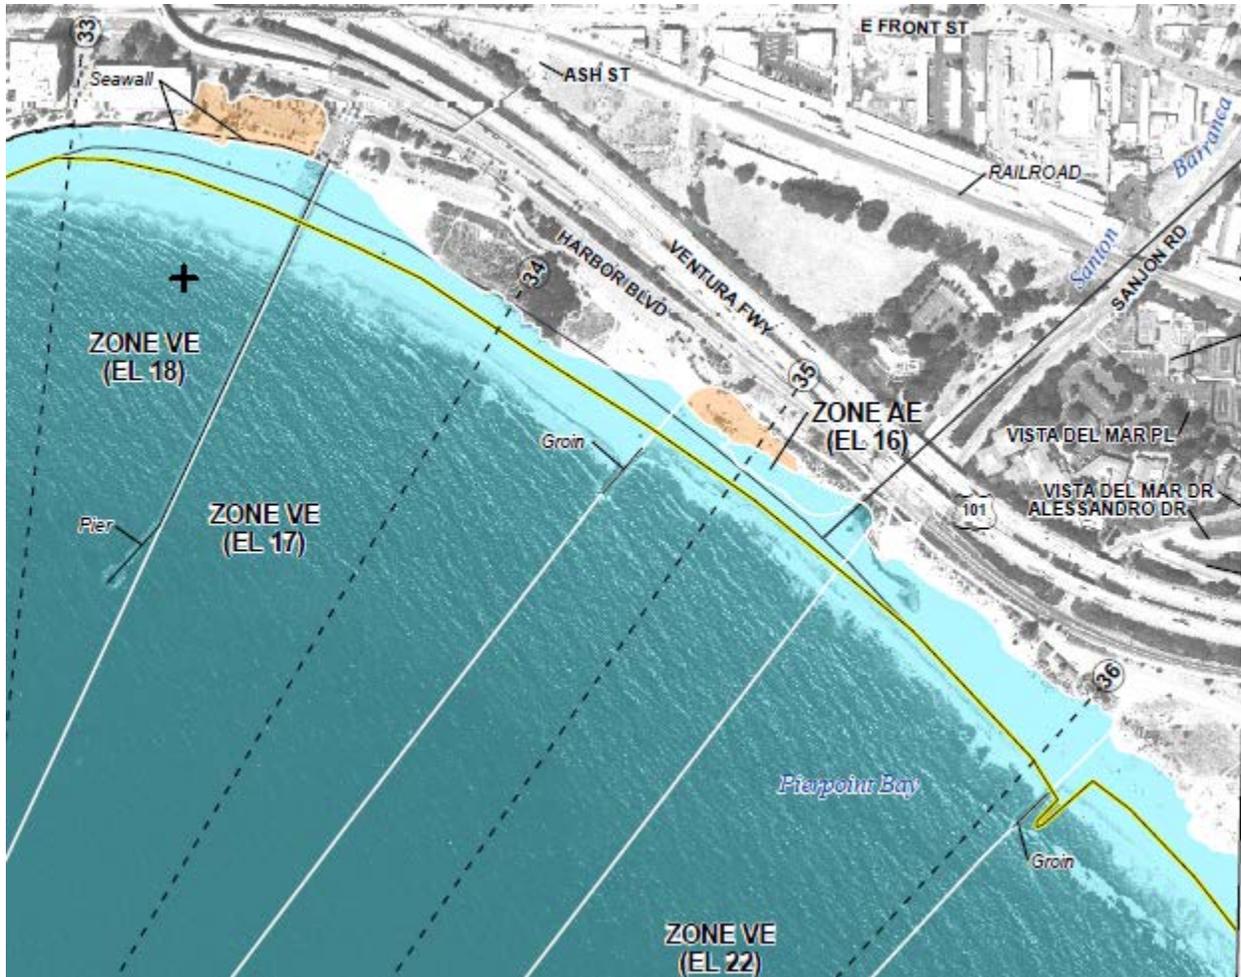
Figure 6-1: PFIRM Panel 743F Excerpt Showing Zone VE, AE and X (Tan) (FEMA 2016)
