City of Oxnard

Public Works Integrated Master Plan

**PROJECT MEMORANDUM 2.7
CATHODIC PROTECTION ASSESSMENT**

Asset Corrosion Assessment & CP Evaluation Survey

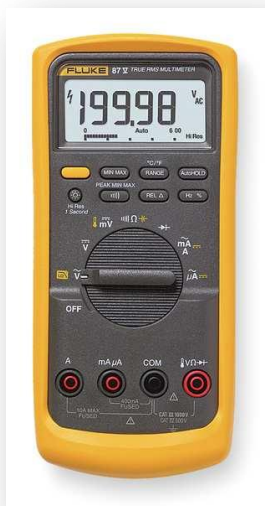
Figure 1) Fluke 87 V High-Impedance Multimeter

Pipe-to-soil potentials are measured using a Fluke 87V, high impedance multi-meter. Potentials were measured versus a copper, copper-sulfate reference electrode placed in contact with the soil at the existing test stations. The Fluke 87V is a high impedance voltmeter used to reduce the effects of contact resistance between the electrode and the soil and to prevent the electrode from polarizing.

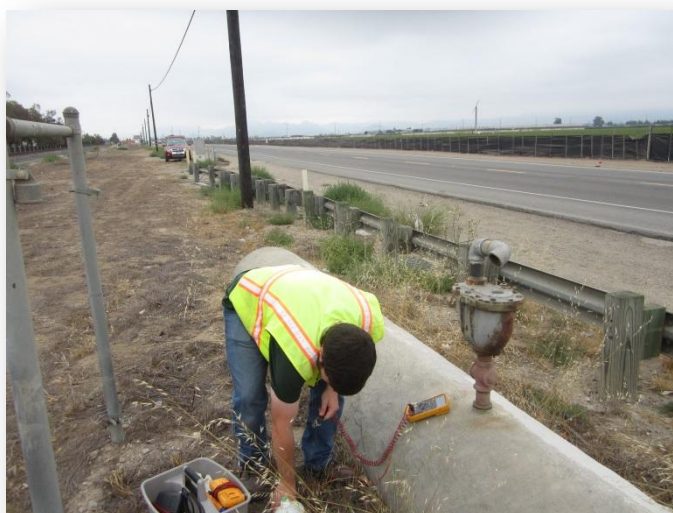
Photo 1) Measuring and Recording Pipe-to-Soil Potentials on a Pipeline

When the soil is very dry, tap water is poured on the ground and the electrode is set in the wet soil to reduce contact resistance between the reference electrode and the soil. The pipeline/structure test lead (or by directly contacting the structure) is connected to the positive terminal of the meter and the reference electrode is connected to the negative terminal of the referenced meter. See Attached Figure for an illustration of measuring pipe-to-soil potentials on a metallic pipeline.

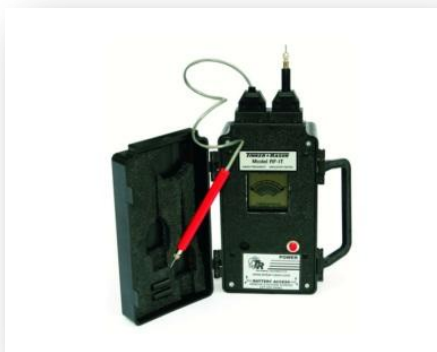
Figure 3) Tinker and Rasor Model RF-IT Insulation Tester

A Tinker and Rasor Model RF-IT Insulation Tester, manufactured by the Tinker and Rasor was also used to test the insulating effectiveness of the insulating joints installed at the facility.

The insulation checker uses radio frequency skin effect and only reads the immediate joint to determine insulating effectiveness. The insulation checker operates by placing two prongs in contact with the insulating joint, one prong on each side of the insulating element. The instrument indicates the shorted or not shorted condition of the joint and the resistance of the joint is not indicated by this instrument.

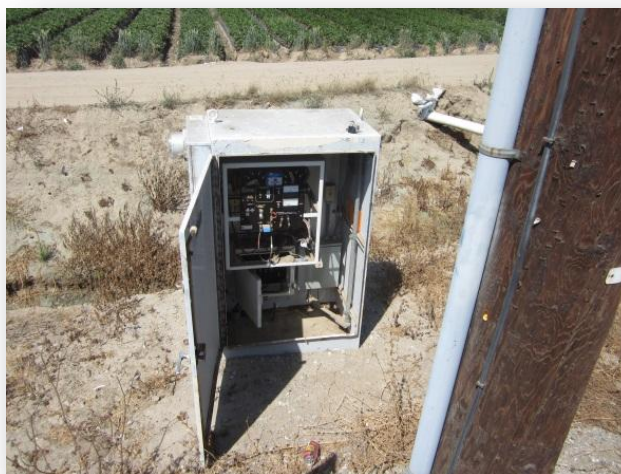
Photo 2) Cathodic Protection Rectifier on Del Norte Pipeline

Impressed current cathodic protection (ICCP) systems use an external electrical power source to provide electric current to the pipeline or structure (see figure 2). ICCP uses a rectifier to convert AC to DC and discharge the DC current through an anode. Anode materials such as high silicon cast iron, graphite or mixed metal oxide coated platinum or titanium. These anode materials are chosen to discharge large amounts of current for long periods of time at low anode consumption rates. ICCP can be designed for many types of structures and can be designed for either very high current output or relatively low current output.

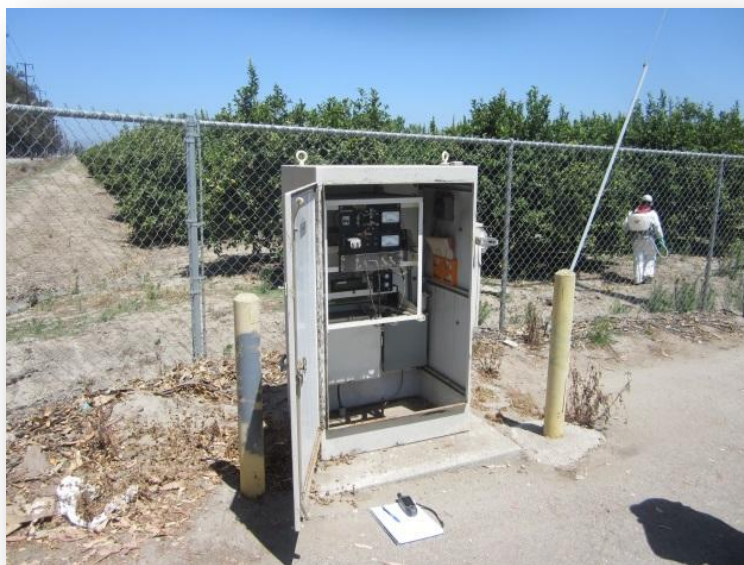
Photo 3) Cathodic Protection Rectifier #9 on Del Norte Pipeline

The cathodic protection system for this pipeline consist of four (4) impressed current CP rectifiers along with their associated, impressed current anode ground-beds. There are also a set of cathodic protection test stations (CTS) along the pipeline route for the purpose of measuring and recording pipe-to-soil potentials as part a CP survey. The CP rectifiers at these locations were still operating and providing a satisfactory amount of corrosion protection to the subject pipeline.

Many of the CP test stations (CTS) were missing. Additional cathodic test stations will need to be installed in order to provide an adequate number of test locations to represent the general information on the pipe-to-soil potentials along the entire length of the pipeline. In other words that test stations represent the pipe's potential in the general vicinity of that test station. An adequate quantity of test stations are recommended at certain frequencies along the entire length of the pipe so that the corrosion engineers can establish the cathodic protection levels along the pipeline and make necessary adjustments to the current output of the rectifiers and anode ground-beds so that the pipeline is adequately protected against soil-side corrosion.

Although the twelve (12) test locations are better than having less test stations, we recommend the design and installation of additional test stations so that there is at least one (1) cathodic test station (CTS) at every 1,000 to 2,000 feet.

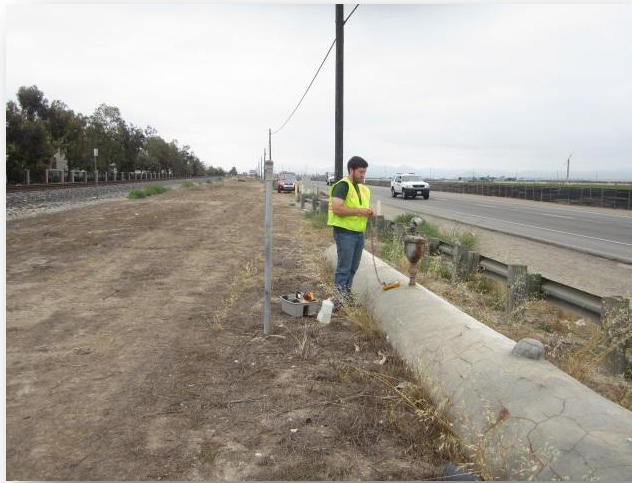
Photo 4) Cathodic Protection Testing on Oxnard Conduit

Rectifiers #1 and #2 have failed and we recommend immediate design and replacement of these rectifiers and anode ground-beds. The entire section of pipe in the vicinity of these two failed rectifier and anode ground-beds is presently not receiving any cathodic protection and therefore we do not have an active corrosion control system to mitigate soil-side corrosion activity.

Most of the cathodic test stations (CTS) on this pipeline were missing and could not be located. A cathodic protection rehabilitation project is recommended to install CTS at every 1,000 to 2,000 feet along the entire length of pipeline

The Rectifiers #1 and #2 and CTS installation project can be implemented as part of a large cathodic protection rehabilitation project for the Oxnard Conduit.

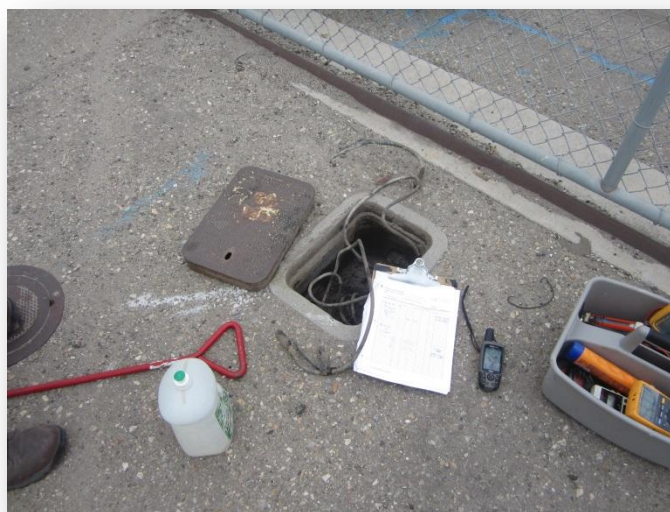
Photo 5) Cathodic Protection Test Station on Wooley Road Main/United

The cathodic protection system for this pipeline consist of one (1) impressed current CP rectifier along with its associated, impressed current anode ground-bed. There are also a set of cathodic protection test stations (CTS) along the pipeline route for the purpose of measuring and recording pipe-to-soil potentials as part a CP survey.

Although this rectifier and anode ground-bed are still operational, we recommend design and replacement of this system with a new one. The rectifier and anode ground-bed for this pipeline have been in place since the year 1977 and have far exceeded their expected operating life. We recommend a new system that would provide another 20 or more years of cathodic protection for this pipeline.

As for the test stations along the pipeline, we were able to locate some test stations at the corner of Wooley Road and Richmond Avenue. However, we did not locate any other cathodic test stations along this pipeline and recommend the design and installation of new cathodic test stations at increments of 1,000 feet.

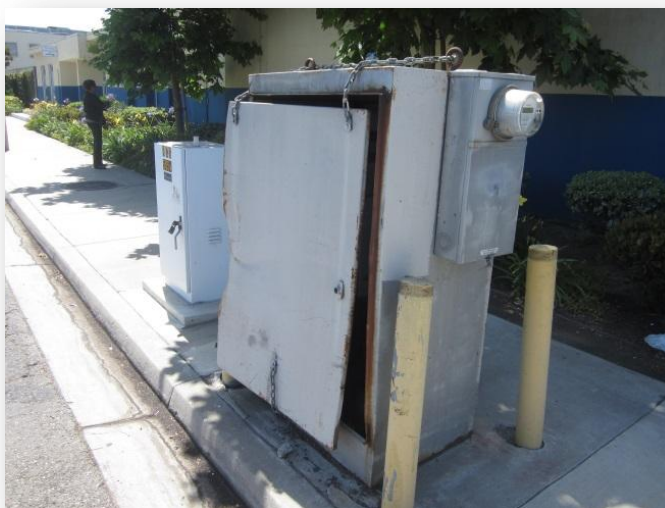
Rectifier #6 and its anode ground-bed, for these pipelines have sustained physical damage, have failed and we recommend immediate design and replacement of this rectifier and anode ground-bed. The entire section of pipe in the vicinity of this failed rectifier and anode ground-bed is presently not receiving any cathodic protection and therefore we do not have an active corrosion control system to mitigate soil-side corrosion activity.

*Photo 6) Cathodic Protection Rectifier on 3rd Street Lateral.
Rectifier and Anode Ground-Bed have Failed and Require Replacement.*

Most of the cathodic test stations (CTS) on this pipeline were missing and could not be located. A cathodic protection rehabilitation project is recommended to install CTS at every 1,000 to 2,000 feet along the entire length of pipeline.

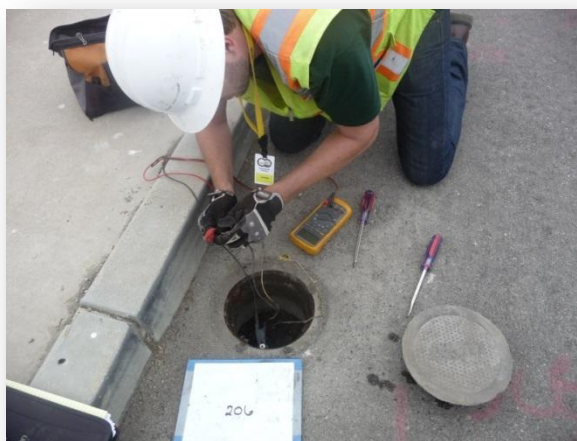
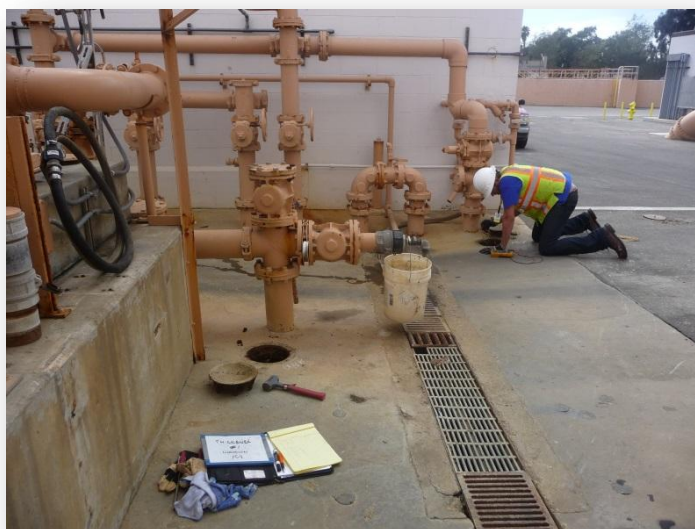
Photo 7) Cathodic Protection Testing at Waste-Water Treatment Plant

Most of the galvanic cathodic protection systems at this facility have failed and a facility-wide project is recommended to design and install a new cathodic protection system. This would require new galvanic (sacrificial) anodes at almost all of the existing anode test stations (ATS). The pipe-to-soil potentials at these failed locations did not meet the NACE International Criteria (SP 0169-13) as described above. Therefore we conclude that at these failed locations there is no mitigation of soil-side corrosion activity.

There is also another option we can consider for cathodic protection at this waste-water treatment facility and that would be to provide impressed current cathodic protection (ICCP) systems for all of the metallic, underground pipes at this facility. This would require that all of the pipes be made electrically continuous using electrical continuity bond cables and then to implement impressed current rectifier and anode ground-beds at various locations. Then the protective current from the impressed currents systems could provide soil-side corrosion mitigation to the buried metallic pipes at this facility.

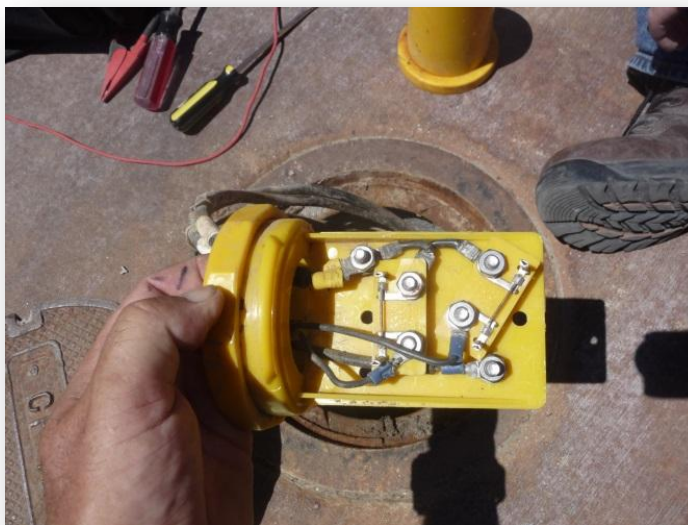
Photo 9) Cathodic Protection Anode Test Station at Water Treatment Plant

This water treatment facility has an existing cathodic protection system consisting of galvanic (sacrificial anode) test stations, which are located throughout the facility. The cathodic protection test stations were found at over eight (8) locations and tested by JDH Corrosion field personnel as part of this project. At most of these anode test stations (ATS) the pipe-to-soil potentials did not meet the NACE Criteria (SP 0169-13). Additional work will be required to design and install new, galvanic (sacrificial) anodes in order to provide adequate soil-side corrosion control.

We recommend the design and implementation of a new, internal (wetted surface) cathodic protection system for this tank. This new CP system would mitigate the corrosion activity for the submerged surfaces of this tank to include the tank internal walls and floor. The CP system, if implemented, would not only stop the corrosion activity on the tank walls and floors but would also assist in keep the internal coating system intact and providing a longer coating service life.

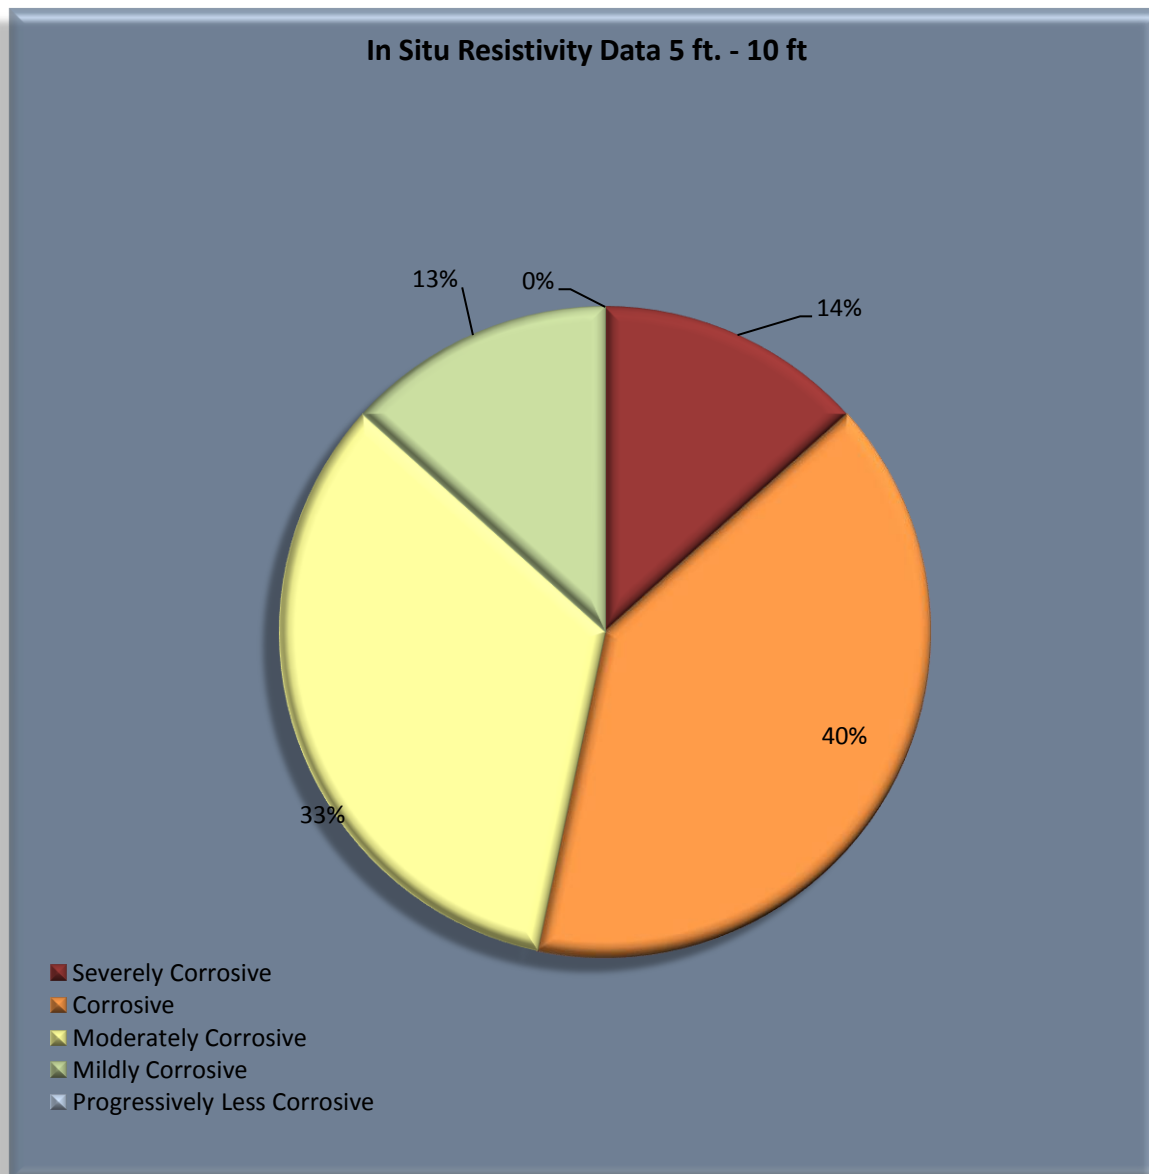
The above classifications are appropriate for the force main alignment and the results are presented in the chart below and in the Findings section of this report.

Based on the field results of the “In-Situ” soil resistivity tests throughout the City of Oxnard, 14% of the soil samples are categorized at “Severely Corrosive”, 40% “Corrosive”, 33% “Moderately Corrosive”, 13% “Mildly Corrosive” and 0% at Progressively Less Corrosive.
