Property Name : 34 - Sunrise Pt/Sunset Cove

Creator : Jose Sanchez

Date : 08/10/2020

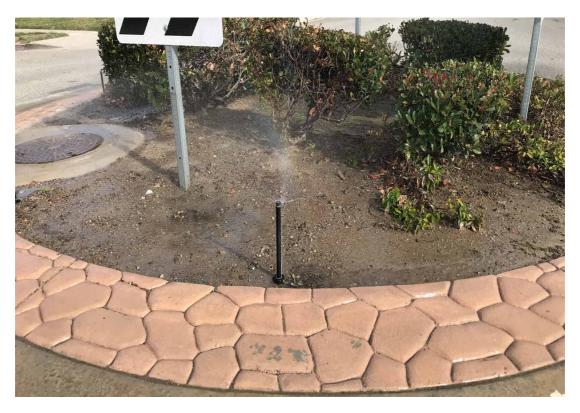
Picture: 1

UNSATIS. IRRIGATION BREAK/LEAK-UNSATIS. IRRIGATION BREAK/LEAK

Notes: Broken Rainbird 12 inch pop-up.

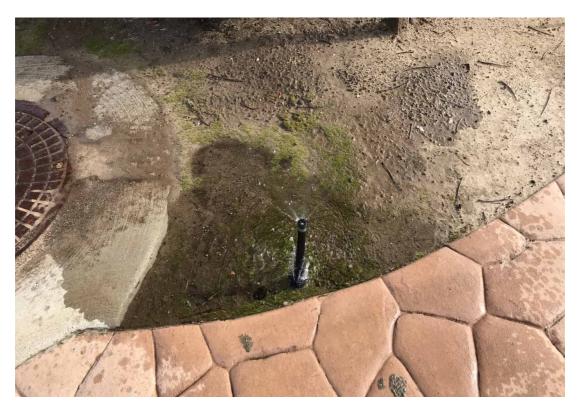
Picture: 1

UNSATIS. IRRIGATION BREAK/LEAK-UNSATIS. IRRIGATION BREAK/LEAK

Notes: Broken Rainbird 12 inch pop-up Latigo Ave.

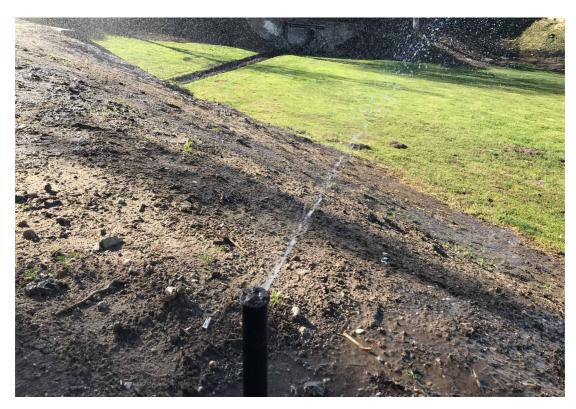
Picture: 1

UNSATIS. POOR COVERAGE-UNSATIS. POOR COVERAGE

Notes: Poor watering coverage on Rainbird rotor T 40.

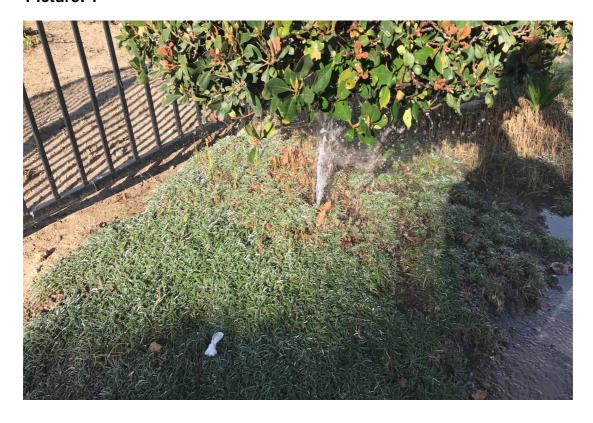
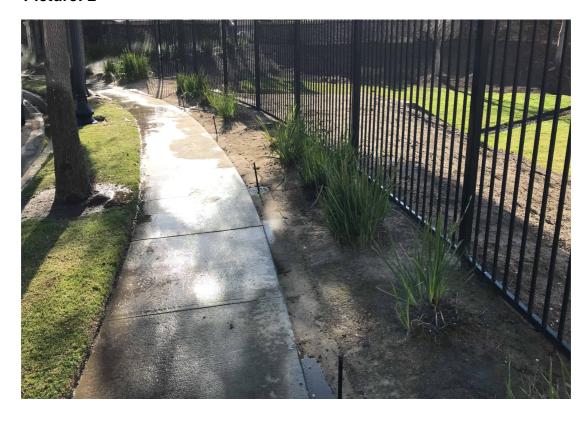
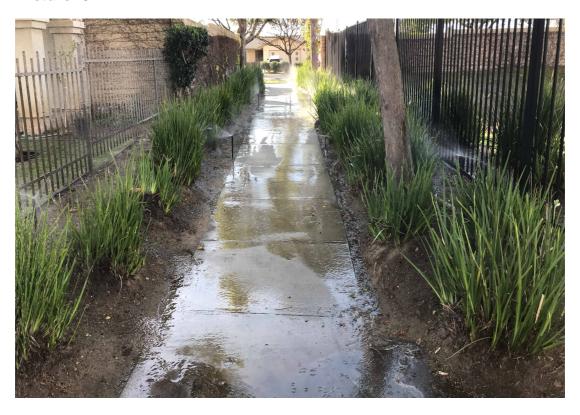
Item Name

UNSATIS. IRRIGATION BREAK/LEAK-UNSATIS. IRRIGATION BREAK/LEAK

Notes: Check irrigation in planters and the grass outside the basin. Several broken nozzles and Rainbird 12 inch pop-ups. Check water pressure and sizes of nozzles to avoid over spray to the sidewalk.

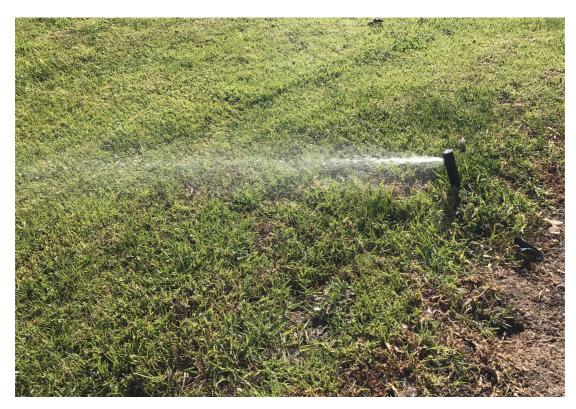
Picture: 1

UNSATIS. POOR COVERAGE-UNSATIS. POOR COVERAGE

Notes : Poor coverage - rotor watering straight downwards, rotor is tilted to the wrong position.
