## Update "No-Site-Visit" Reserve Study

### **Oxnard Community Facilities Seabridge Oxnard, CA**

**Report #: 34283-1**  
**For Period Beginning: July 1, 2020**  
**Expires: June 30, 2021**

**Date Prepared: May 20, 2020**

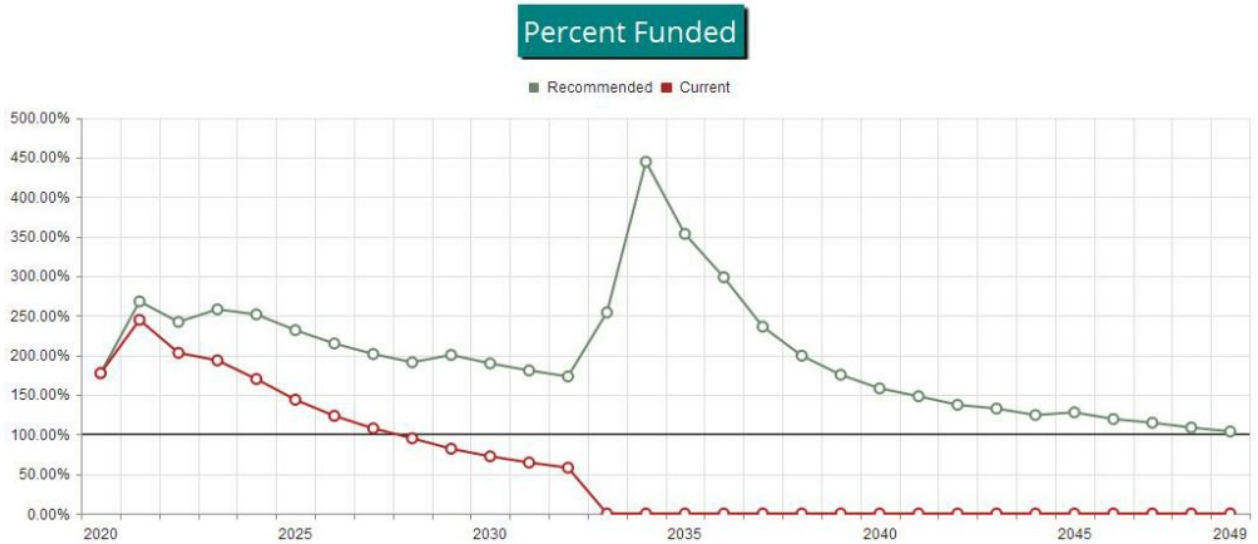
Figure 4

This figure shows the same information plotted on a Percent Funded scale. It is clear here to see how your Reserve Fund strength approaches the 100% Funded level under our recommended multi-yr Funding Plan.
