Aspire Apartments Project

Cultural Resources Technical Study

January 2024

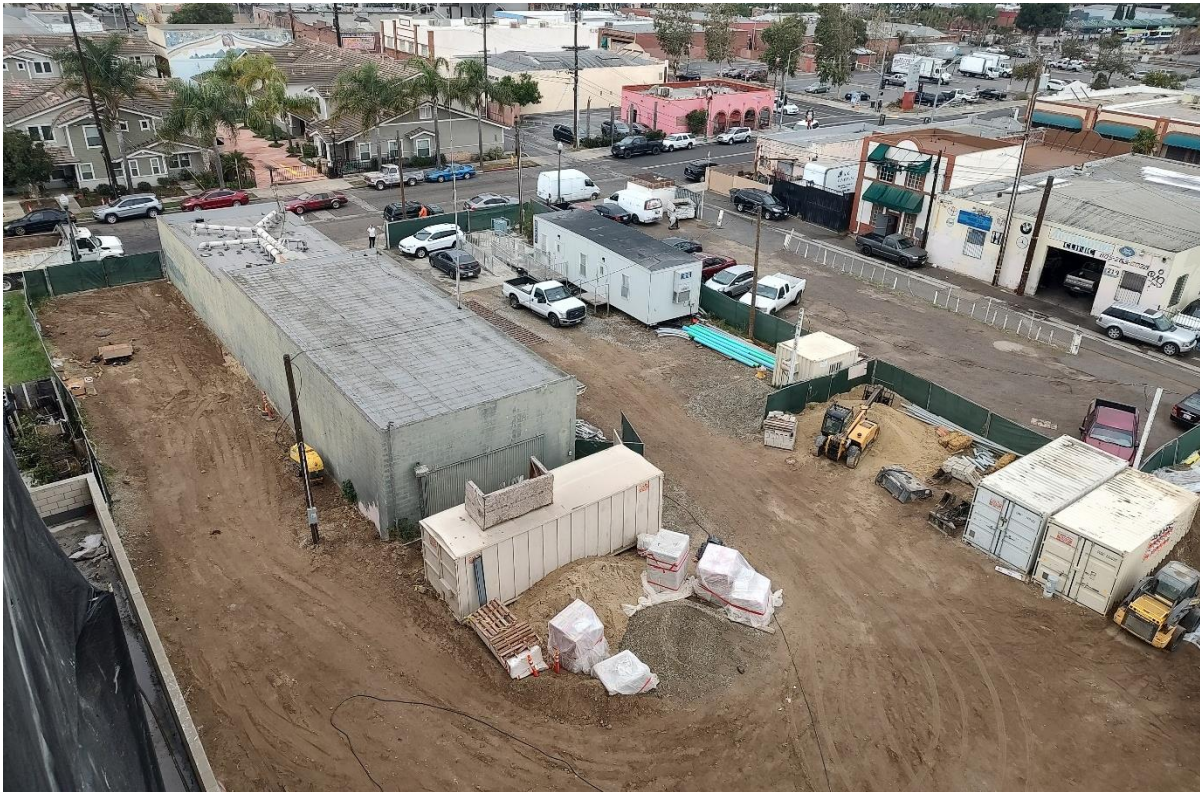
Figure 15 536 and 538 Meta Street Property Overview, Facing Northwest

536 and 538 Meta Street (subject property) is a commercial property comprised of three parcels (APNs 201-0-213-080, 201-0-213-090 and 201-0-213-010) on the east side of Meta Street in Oxnard, California. The rectangular parcels feature a one-story commercial building at the southwestern corner and paved parking lots and driveways occupying the northern and western sections of the property in addition to a gravel parking lot at the eastern end (Figure 15). The property is surrounded by commercial properties to the north along East 5th Street, residential properties to the west and south, and industrial properties to the east.

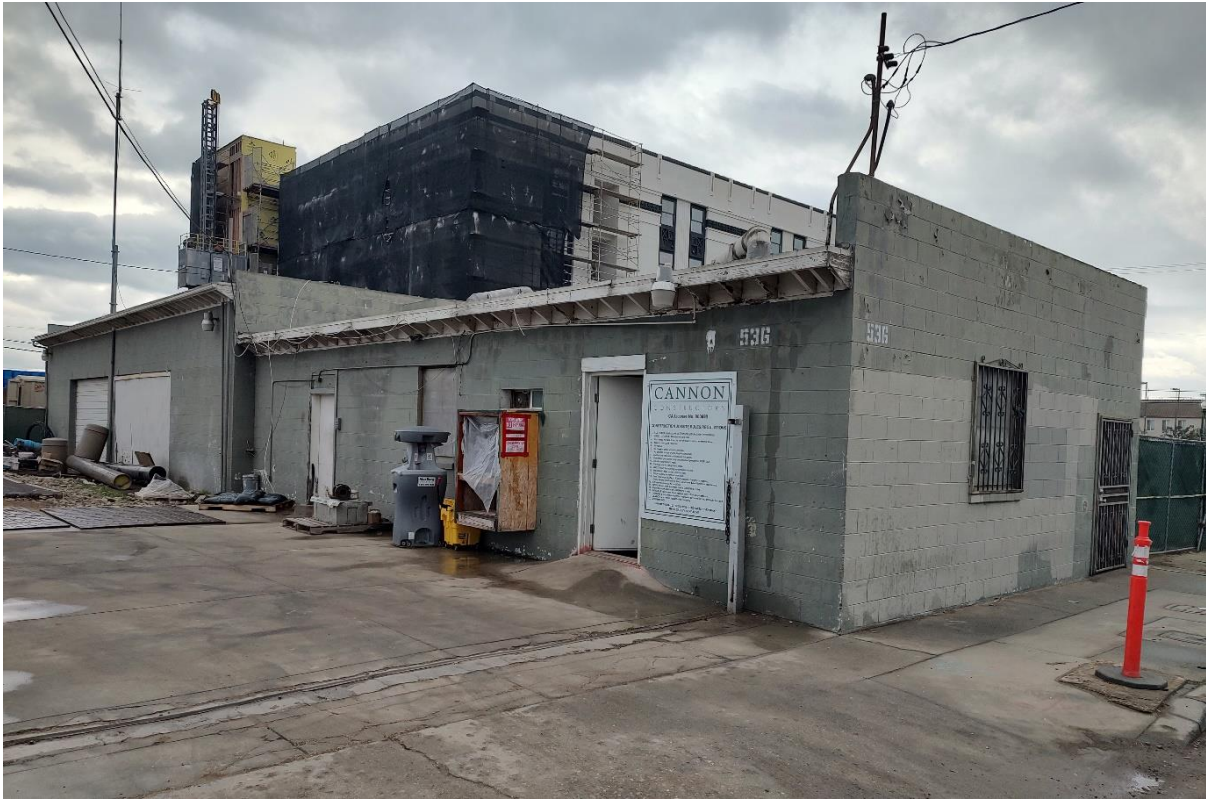
Figure 16 536 and 538 Meta Street North and West Elevations, Facing Southeast

The one-story commercial building on the subject property features a rudimentary vernacular design with minimal design elaborations, likely due to its utilitarian use as an automobile maintenance shop. Sited on a concrete foundation, the building is constructed of CMU. The flat roof has a CMU parapet along the west and east elevations and a wood frame cornice with wood brackets along the north elevation (Figure 16). Located on the north elevation are two entrances featuring flush wood doors, one elevated slightly above ground with a concrete ramp; an additional former entrance, now enclosed, and a small horizontal sliding sash window is located in between the entrances. At the eastern end of the north elevation are two large openings featuring wood paneled tilt-up doors. The west elevation has an additional entrance with a metal screen door and an enclosed window with security bars. The south elevation is void of fenestration and integrates no design elements (Figure 17).

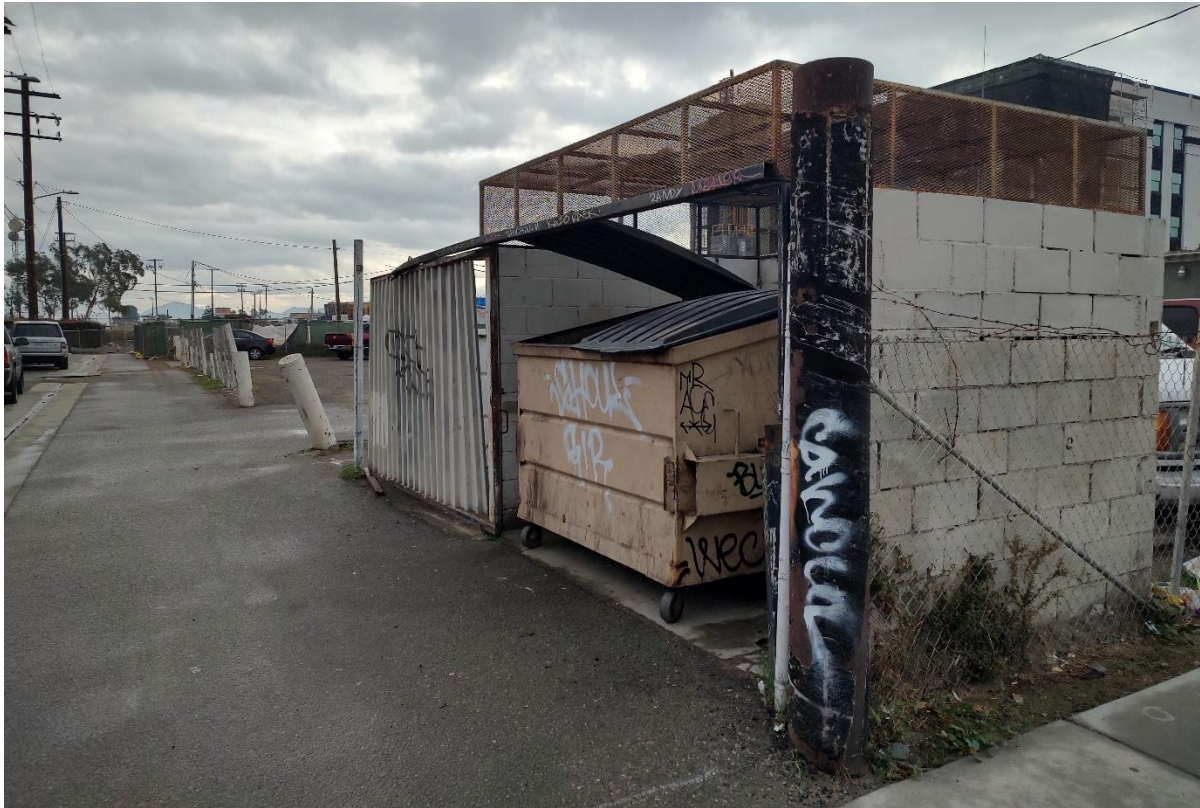
Figure 18 536 and 538 Meta Street South Trash Enclosure, Camera Facing Southeast

At the northwest corner of the property is a trash enclosure constructed of CMUs on a concrete foundation (Figure 18). The enclosure has an opening on the north elevation with a sliding

corrugated metal door on a track to access the interior. The enclosure is topped by a metal framed structure infilled with metal mesh covers.
