City of Oxnard

Public Works Integrated Master Plan

PROJECT MEMORANDUM 2.7
CATHODIC PROTECTION ASSESSMENT

FINAL DRAFT
December 2015

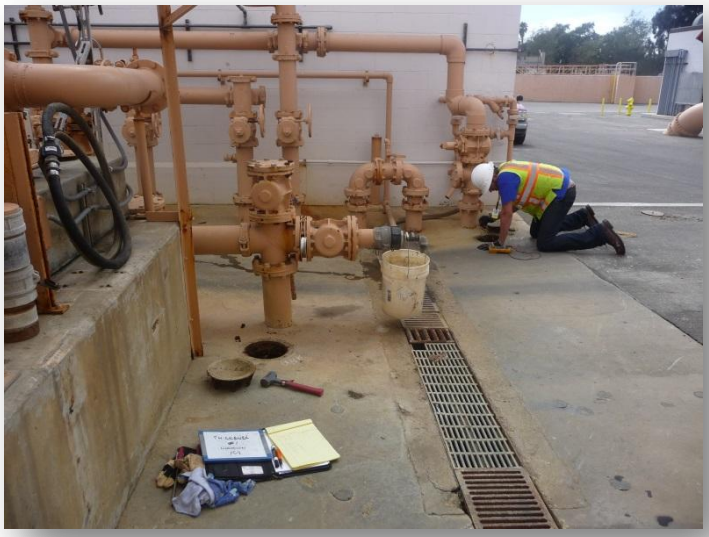
Most of the galvanic cathodic protection systems at this facility have failed and a facility-wide project is recommended to design and install a new cathodic protection system. This would require new galvanic (sacrificial) anodes at almost all of the existing anode test stations (ATS). The pipe-to-soil potentials at these failed locations did not meet the NACE International Criteria (SP 0169-13) as described above. Therefore we conclude that at these failed locations there is no mitigation of soil-side corrosion activity.

Photo 8) Cathodic Protection Testing at Waste-Water Treatment Plant

There is also another option we can consider for cathodic protection at this waste-water treatment facility and that would be to provide impressed current cathodic protection (ICCP) systems for all of the metallic, underground pipes at this facility. This would require that all of the pipes be made electrically continuous using electrical continuity bond cables and then to implement impressed current rectifier and anode ground-beds at various locations. Then the protective current from the impressed currents systems could provide soil-side corrosion mitigation to the buried metallic pipes at this facility.

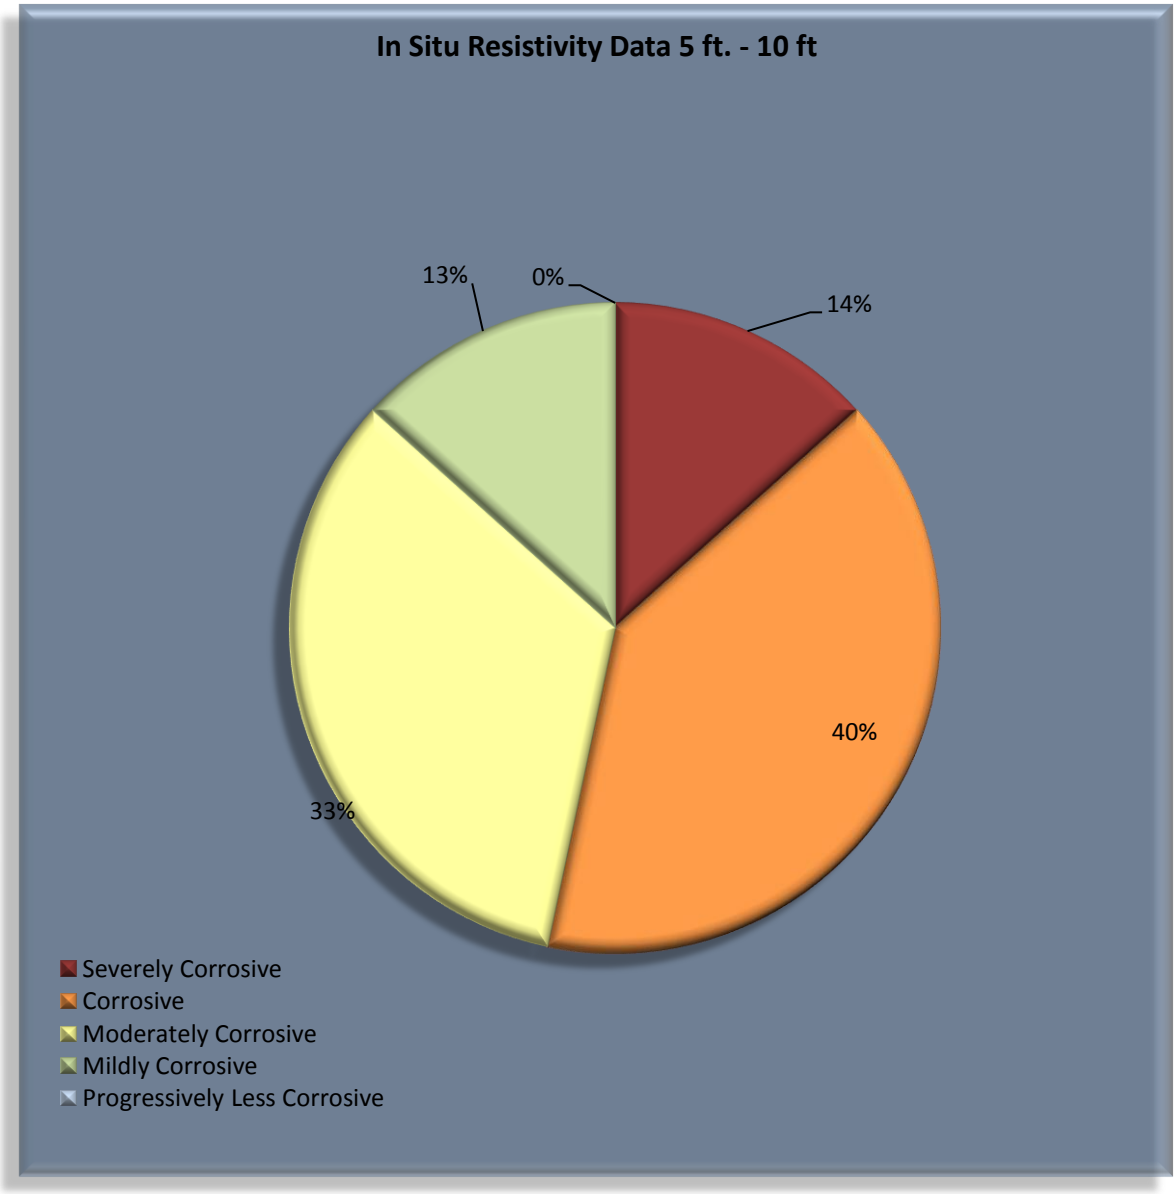
Based on the field results of the "In-Situ" soil resistivity tests throughout the City of Oxnard, 14% of the soil samples are categorized at "Severely Corrosive", 40% "Corrosive", 33% "Moderately Corrosive", 13% "Mildly Corrosive" and 0% at Progressively Less Corrosive.
