City of Oxnard

Public Works Integrated Master Plan

**PROJECT MEMORANDUM 5.3
CONDITION ASSESSMENT**

CITY OF OXNARD STORM DRAINAGE CONDITION ASSESSMENT

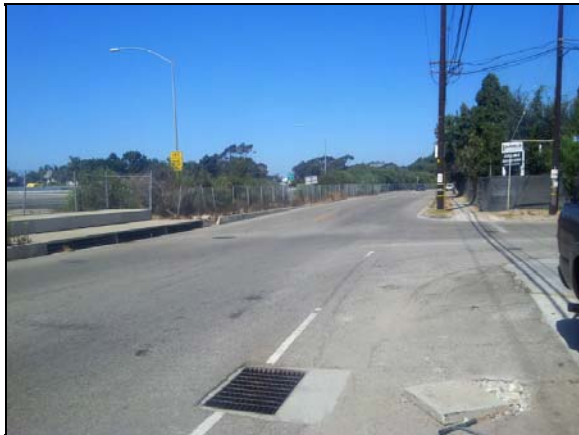
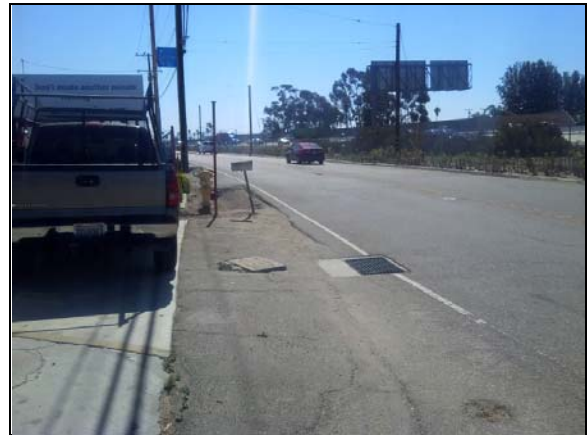
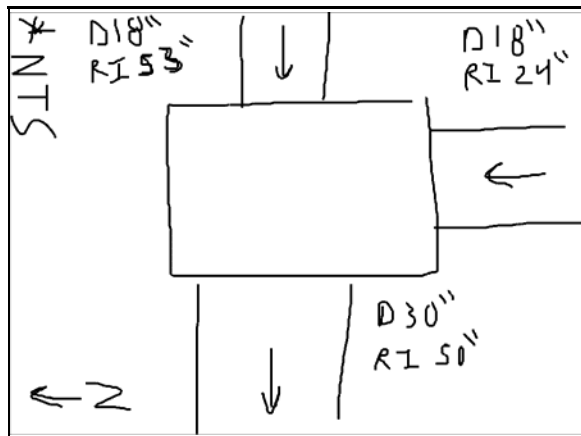
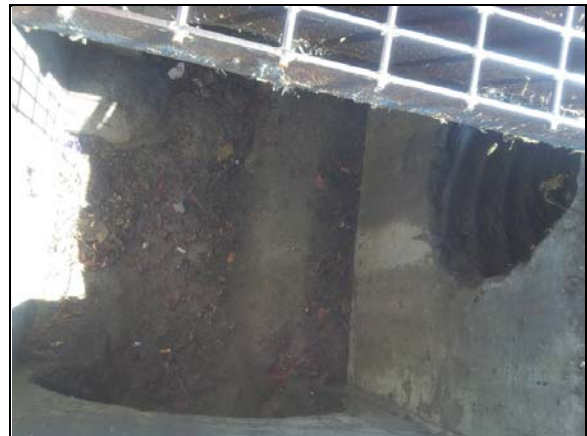
Pipe	Dir.	Hdn g	Dia. (in.)	Mat'l	Rim-inv (ft.)	Wtr Lvl (%)	Sed. (%)	Sed. Type	Infiltration	Obs/Dfl. (%)	VANDA Rating	Priority Rating	Priority Rationale	Notes
S Inlet	In	N	18	CMP	4.4	0	100	Silt/Grave/IRock	None	0	Level 2 - Minor Damage	Level 5 - Immediate Attention	Condition/Sediment	Blocked with sediment. Coating missing at various places and minor corrosion on CMP.

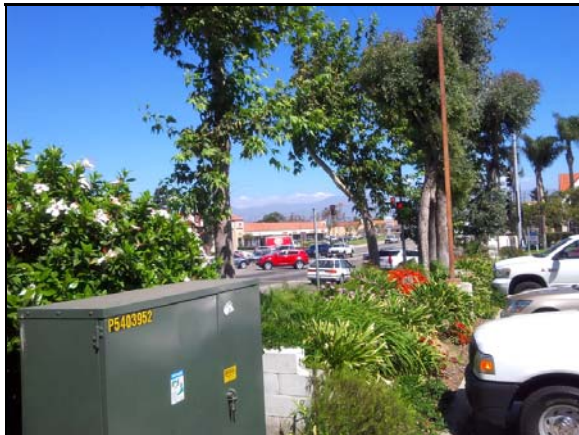
Location View

Unable to locate. May actually be a pipe and be buried.

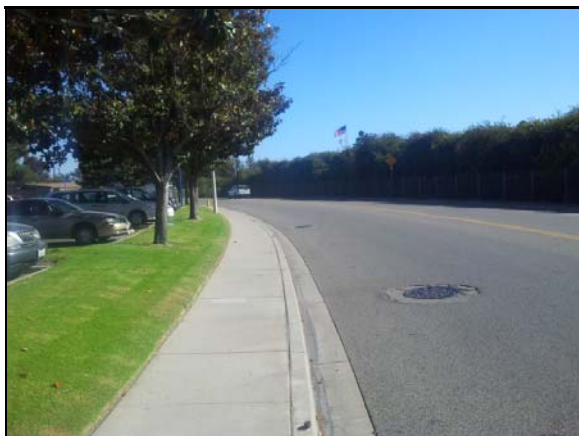
Location View

Road appears to slope south and east. Area has history of flooding.

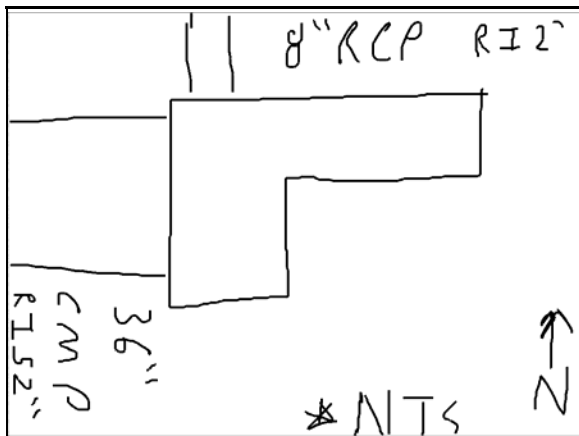
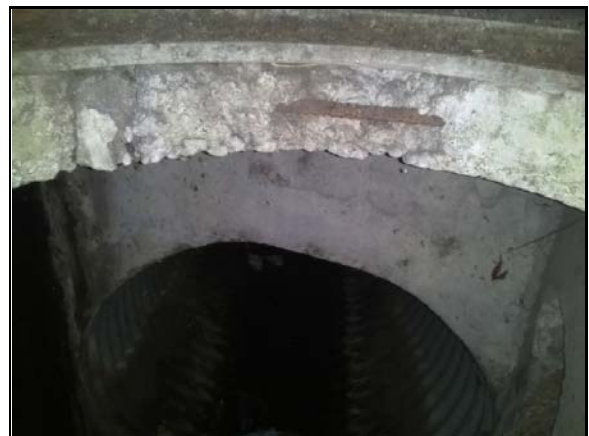
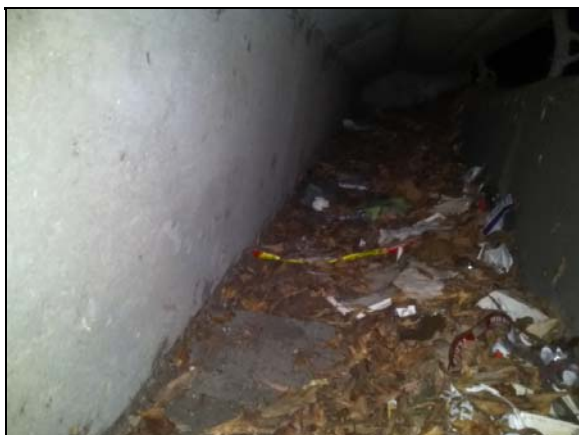
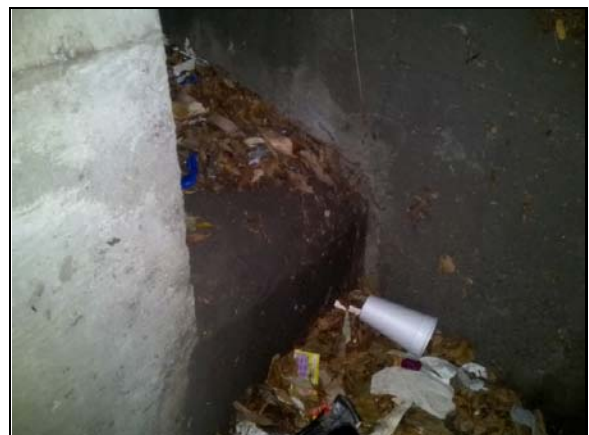
Catch Basin CB-L27-306

Concrete missing and exposed reinforcing steel at chimney.

Pipe	Dir.	Hdn g	Dia. (in.)	Mat'l	Rim-inv (ft.)	Wtr Lvl (%)	Sed. (%)	Sed. Type	Infiltration	Obs/Dfl. (%)	VANDA Rating	Priority Rating	Priority Rationale	Notes
CB-L27-306_GB-L27-801	Out	W	36	CMP	4.3	5	5	Trash/Vegetation	None	0	Level 4 - Severe/Significant Damage	Level 4 - Poor	Condition/Location	Under roadway.

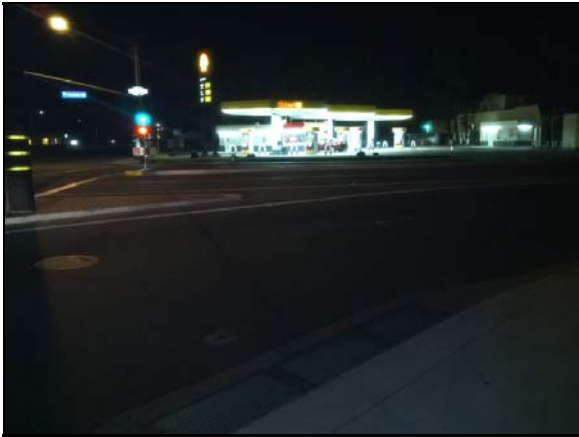
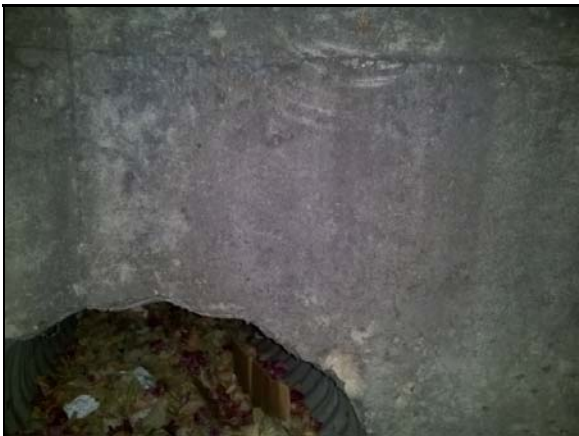
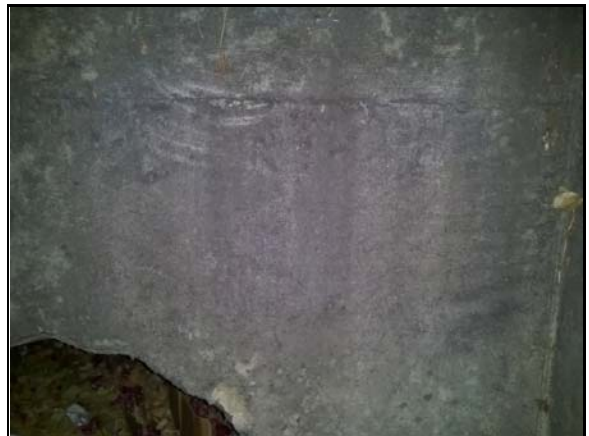
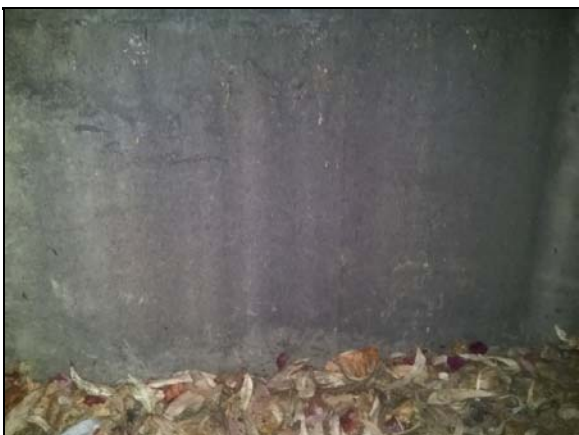
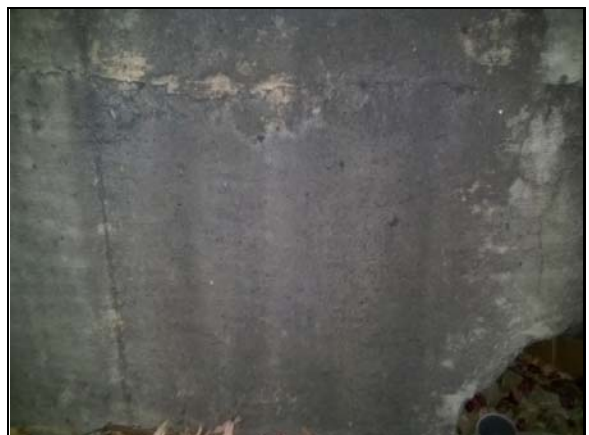
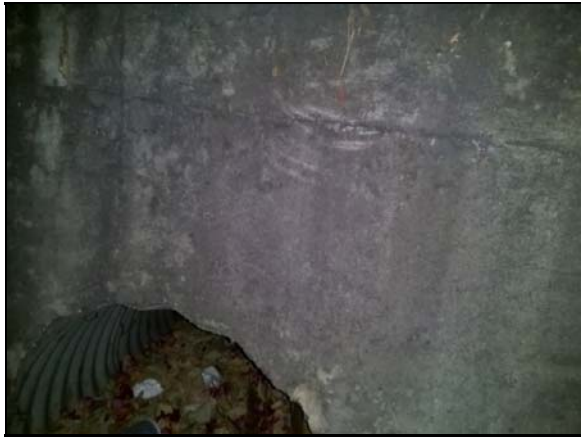
Catch Basin CB-L27-308

Susceptible to burial/overgrowth: No
Susceptible to ponding/flooding: No
Sediment/debris depth (%): 5
Type of sediment/debris: Vegetation/Trash
Infiltration in structure: None
Obstruction/deflection: 0.0
VANDA Condition Rating: Level 1 - No Damage
Prioritization Rating: Level 1 - Excellent
Prioritization Rationale: Condition
Illegal dumping evidence: No

Pipe	Dir.	Hdn g	Dia. (in.)	Mat'l	Rim-inv (ft.)	Wtr Lvl (%)	Sed. (%)	Sed. Type	Infil- tration	Obs/Dfl. (%)	VANDA Rating	Priority Rating	Priority Rationale	Notes
CB-L27-308_JS-L27-501	Out	NW	12H x 18W	CMP	4	0	25	Vegetation/Trash	None	0	Level 2 - Minor Damage	Level 3 - Fair	Condition/Location/Sediment	Under roadway.

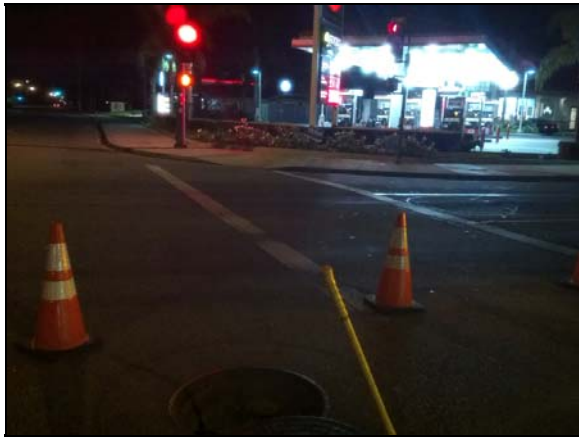
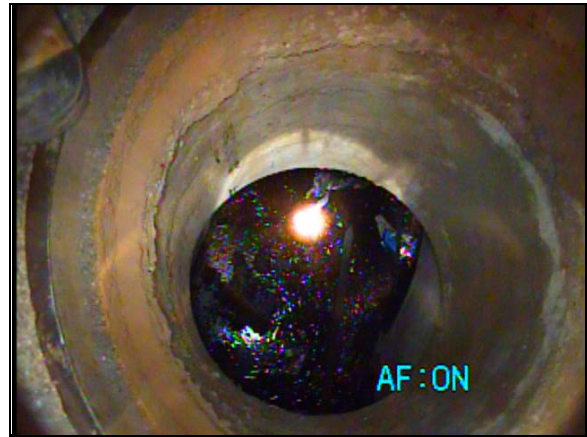
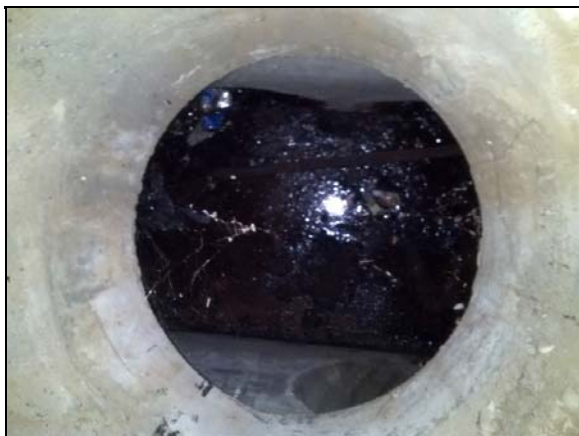
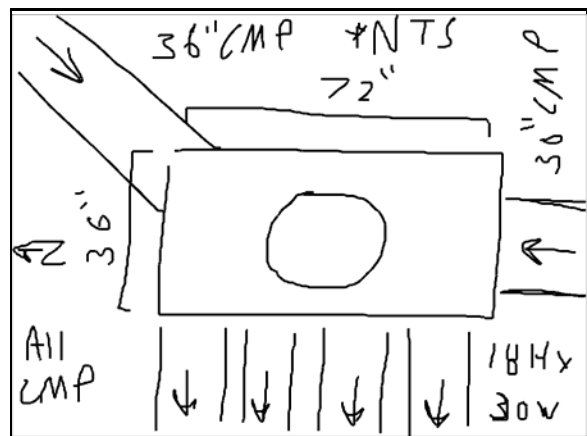
Culvert MH-L27-100

Susceptible to burial/overgrowth: No
Susceptible to ponding/flooding: No
Sediment/debris depth (%): 0
Type of sediment/debris: None
Infiltration in structure: None
Obstruction/deflection: 15.0
VANDA Condition Rating: Level 1 - No Damage
Prioritization Rating: Level 1 - Excellent
Prioritization Rationale: Condition
Illegal dumping evidence: No

Pipe	Dir.	Hdn g	Dia. (in.)	Mat'l	Rim-inv (ft.)	Wtr Lvl (%)	Sed. (%)	Sed. Type	Infil- tration	Obs/Dfl. (%)	VANDA Rating	Priority Rating	Priority Rationale	Notes
GB-L27-801_MH-L27-100	In	W	36	CMP	6.4	5	5	Gravel/Rock/Trash	None	0	Level 3 - Moderate Damage	Level 4 - Poor	Condition/Location	Significant corrosion and perforations at invert of all pipes. Under roadway.
JS-L27-503_MH-L27-100	In	S	36	CMP	6	5	0	None	None	0	Level 3 - Moderate Damage	Level 4 - Poor	Condition/Location	Significant corrosion and perforations at invert of all pipes. Under roadway.

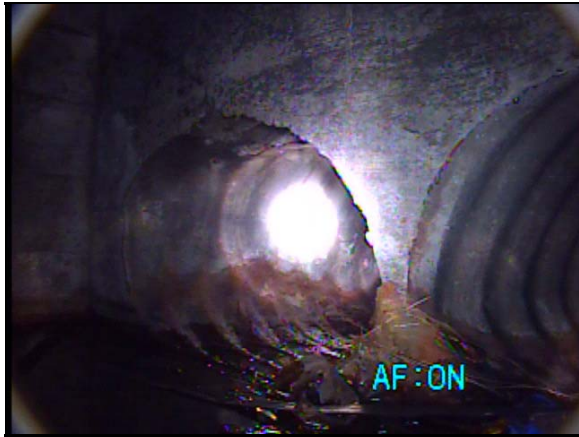
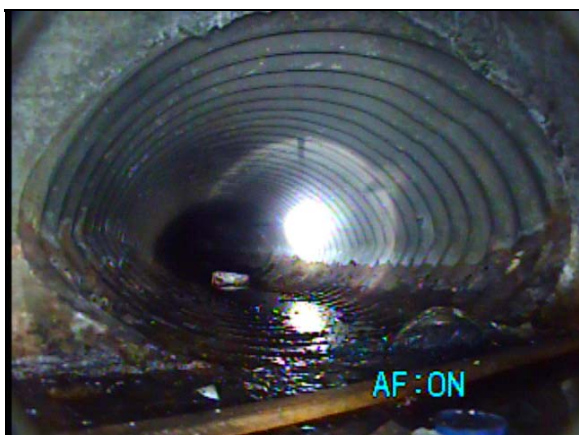
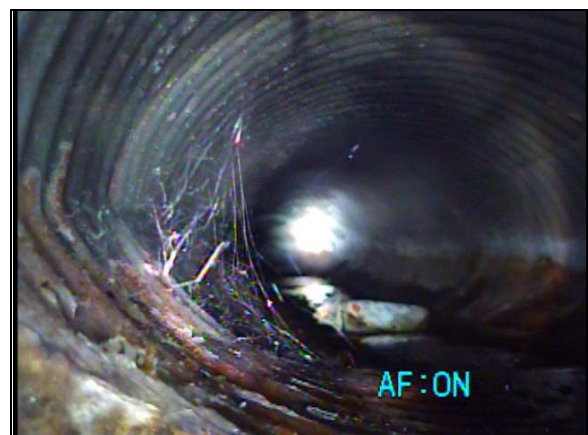
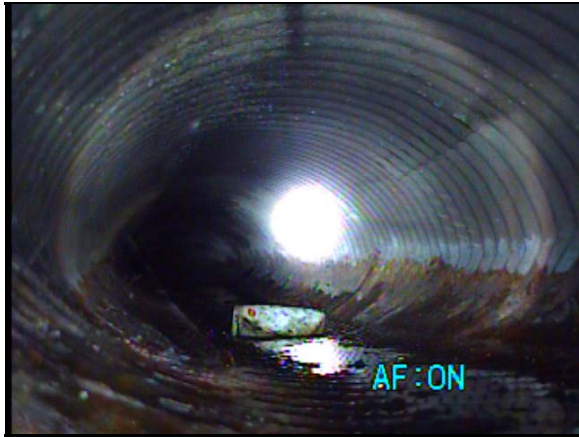
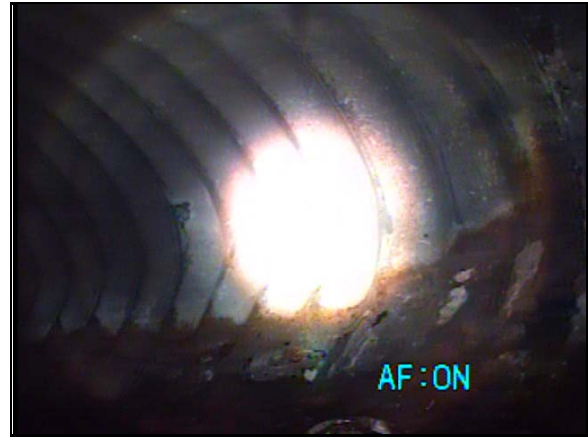
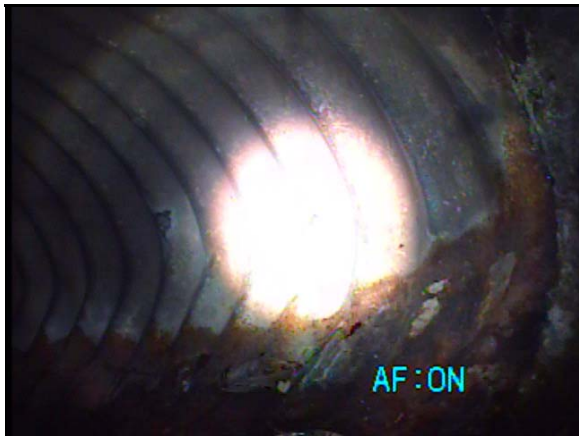
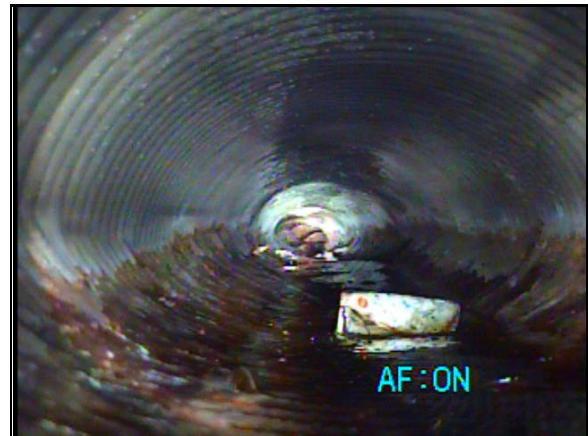
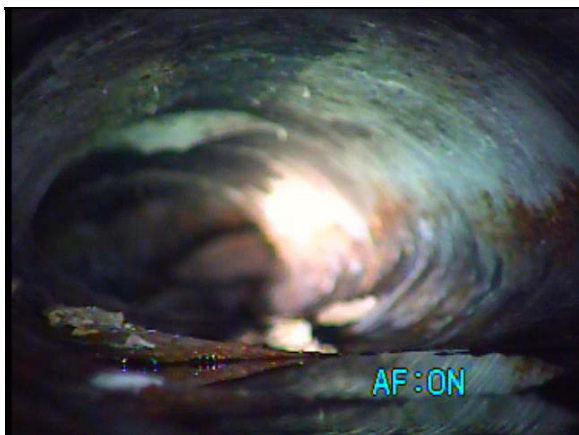
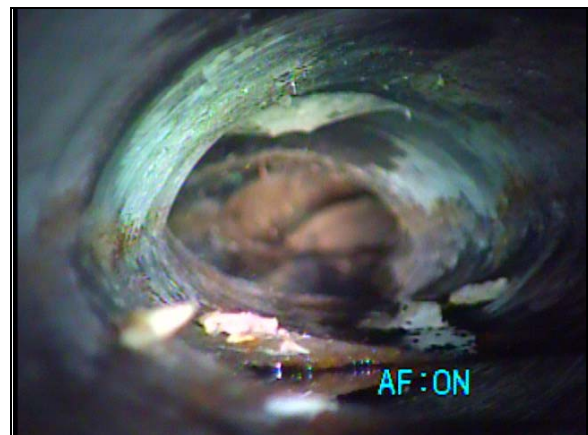
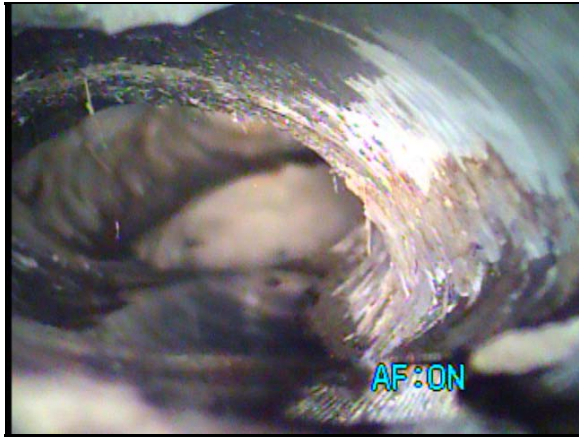
Pipe	Dir.	Hdn g	Dia. (in.)	Mat'l	Rim-inv (ft.)	Wtr Lvl (%)	Sed. (%)	Sed. Type	Infiltration	Obs/Dfl. (%)	VANDA Rating	Priority Rating	Priority Rationale	Notes
MH-L27-100_TS-L27-800	Out	W	18H x 30W	CMP	6.4	5	0	None	None	15	Level 4 - Severe/Significant Damage	Level 4 - Poor	Condition/Location	Four outlet CMPs with same shape and dimensions. Significant corrosion and perforations at invert of all pipes. Outlet B is deflected 15%.

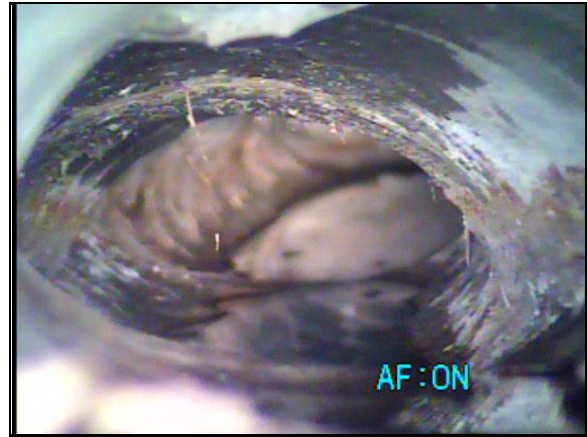
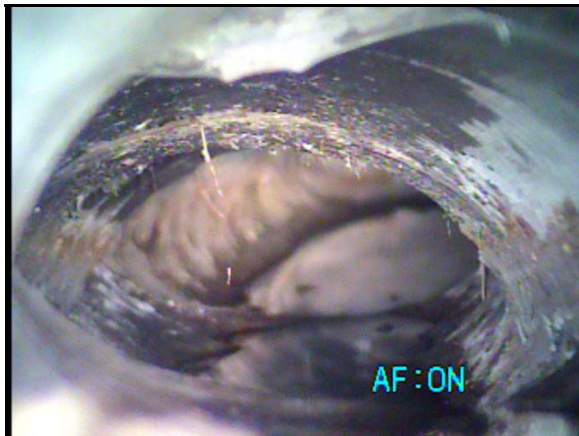
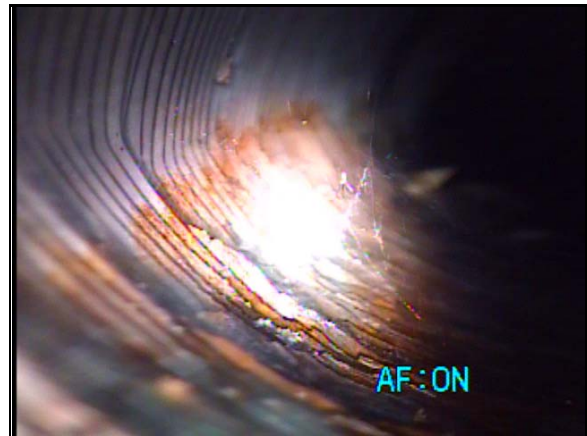
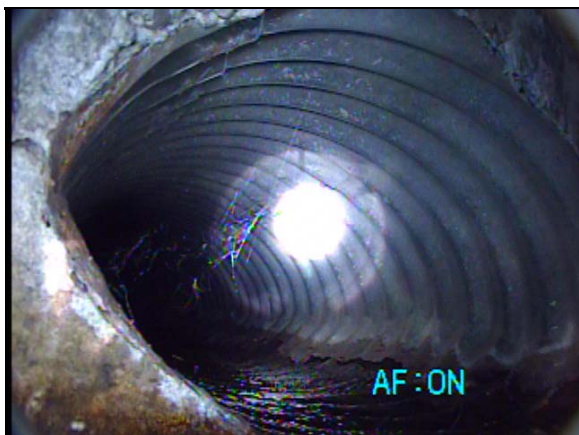
View inside outlet C

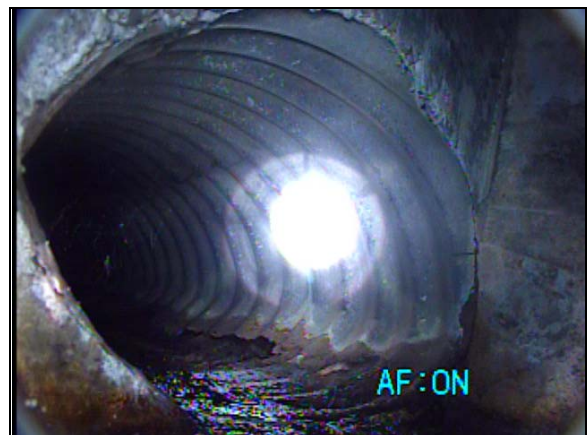
View of outlet D

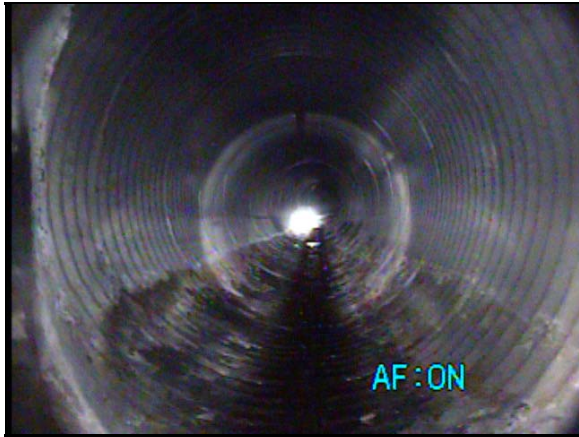
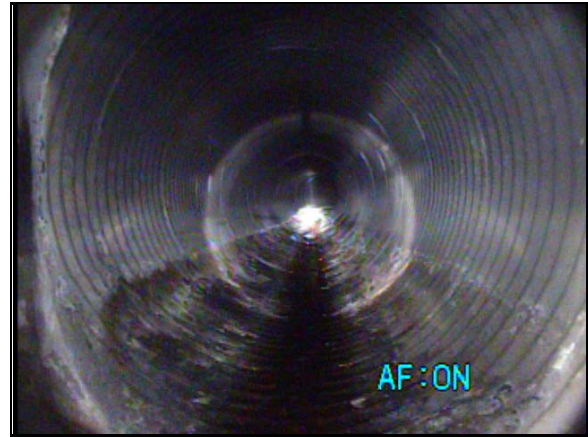
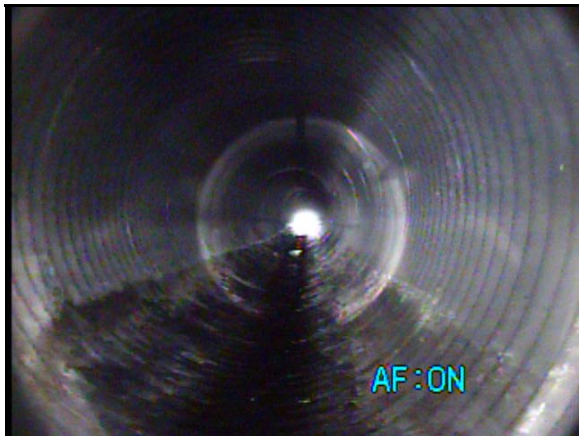
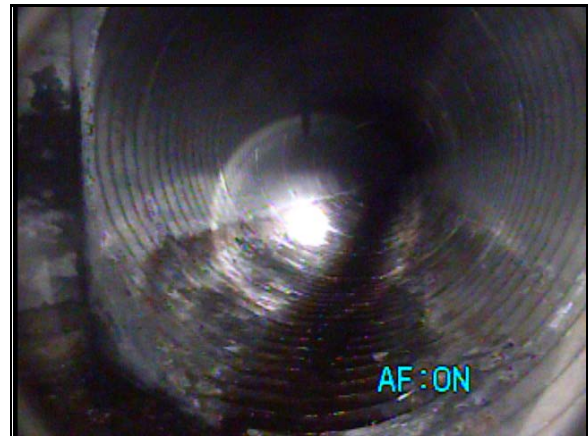
View of E inlet

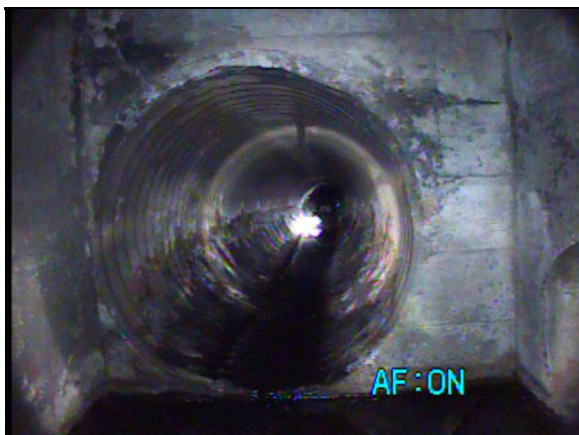
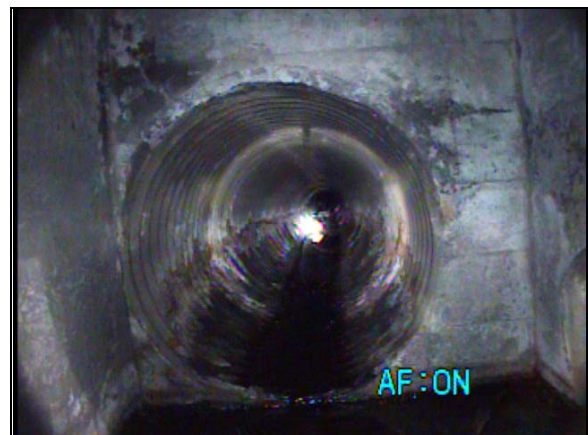
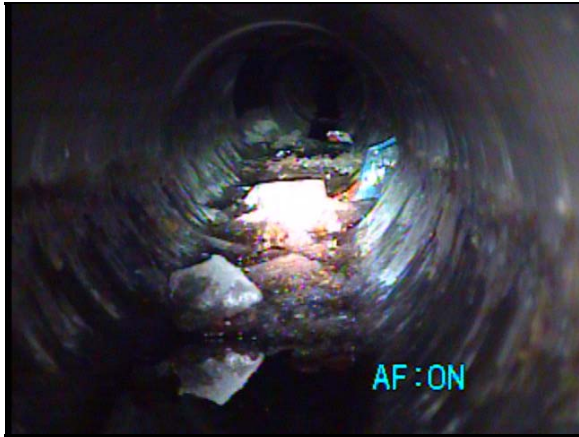
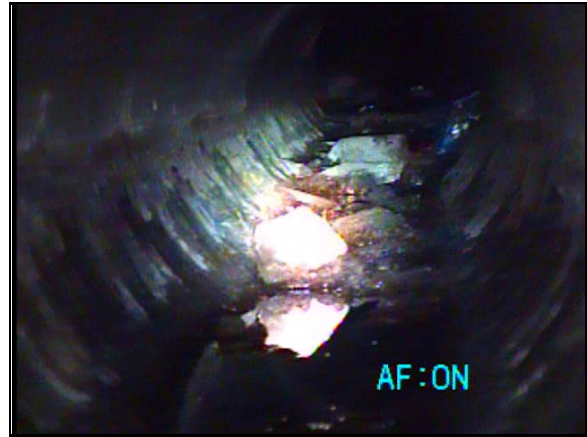
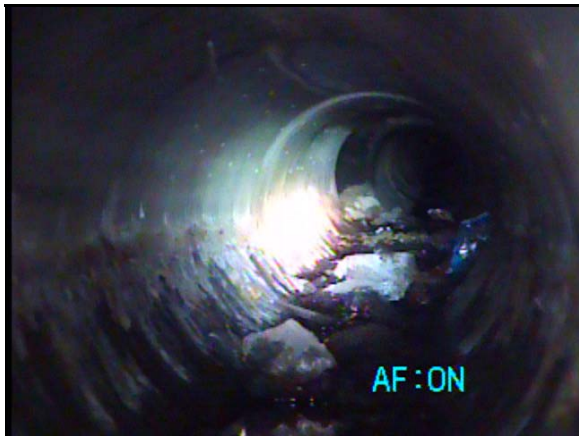
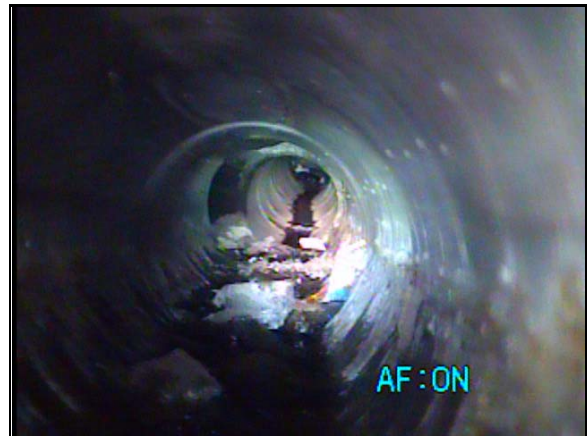
View of S inlet

Area has history of flooding. Outlets may be under sized to handle flow. Inlet pipes are large in comparison.

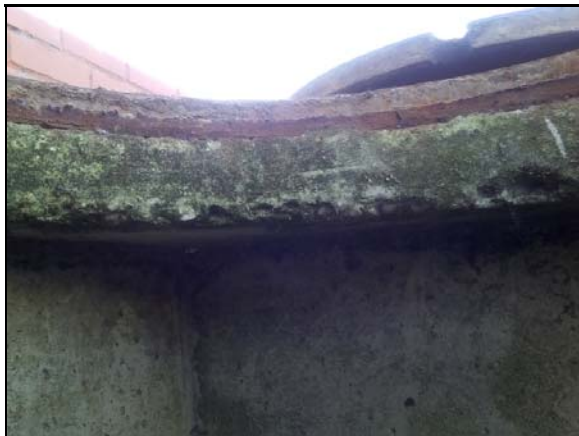
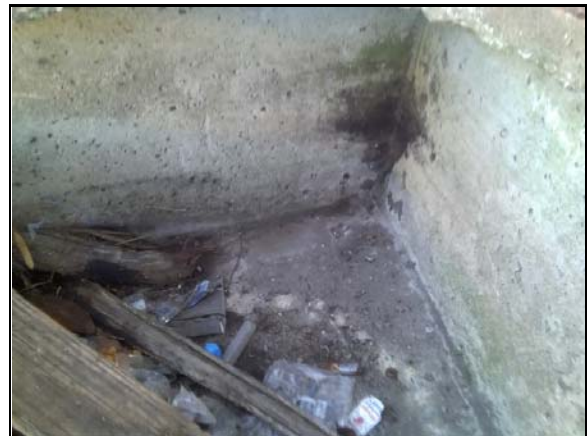
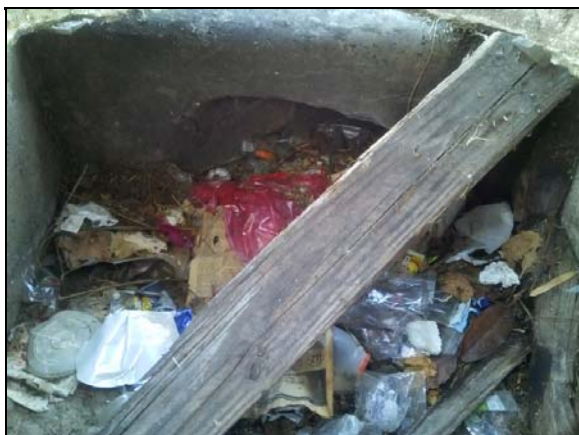
Lid was corroded shut.

View inside catch basin

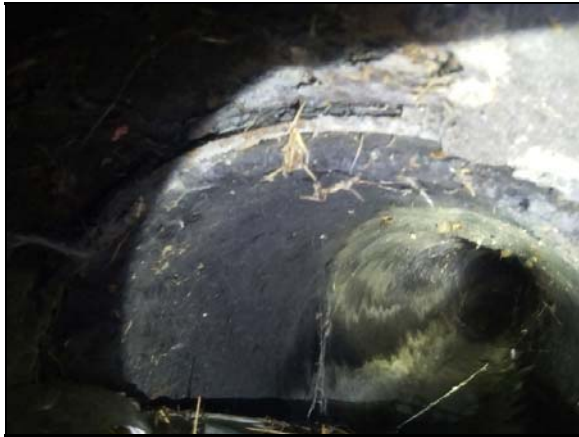
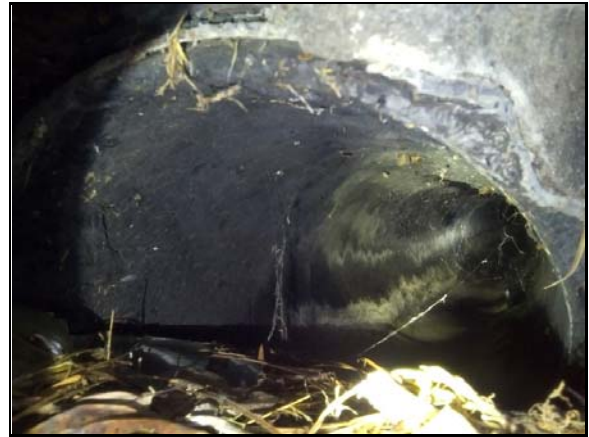
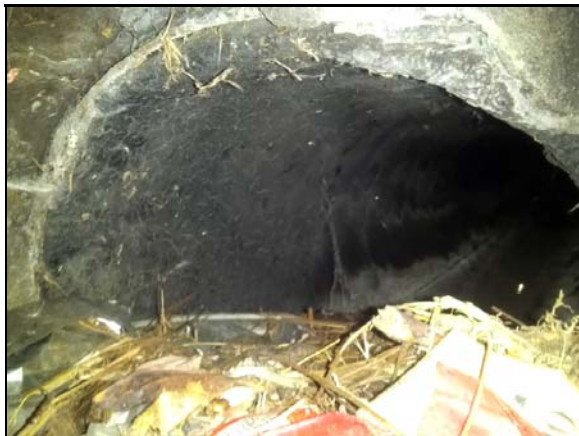
Pipe	Dir.	Hdn g	Dia. (in.)	Mat'l	Rim-inv (ft.)	Wtr Lvl (%)	Sed. (%)	Sed. Type	Infil-tration	Obs/Dfl. (%)	VANDA Rating	Priority Rating	Priority Rationale	Notes
CB-M27-304_MH-M27-102	Out	SE	10H x 12W	CMP	2.1	0	0	None	None	0	Level 1 - No Damage	Level 1 - Excellent	Condition	Coating in good condition, but appears there may be external corrosion on the CMP. Under roadway.

View inside outlet pipe

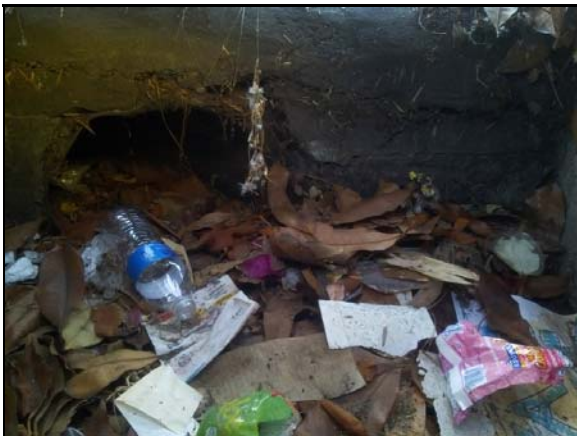
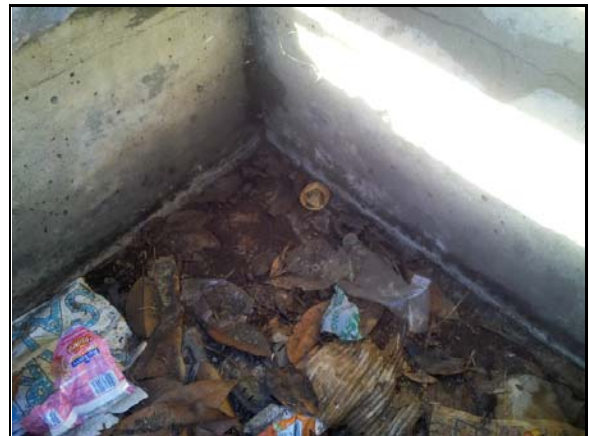
Cracking in concrete walls of catch basin. Connected to 10H x 12W CMP. Significant buildup of trash and debris.

View inside catch basin

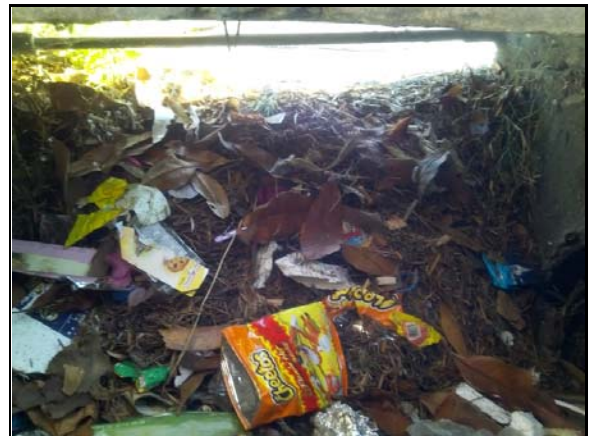
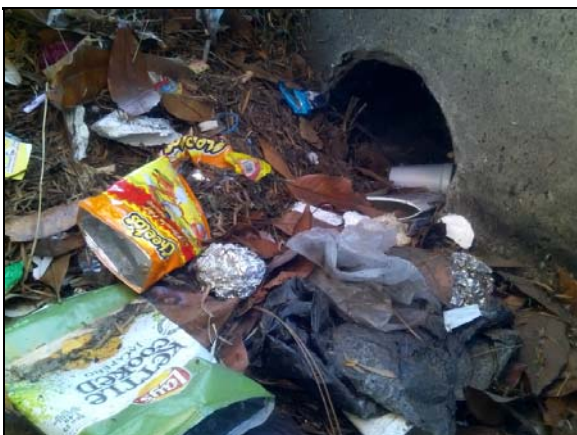
View inside catch basin

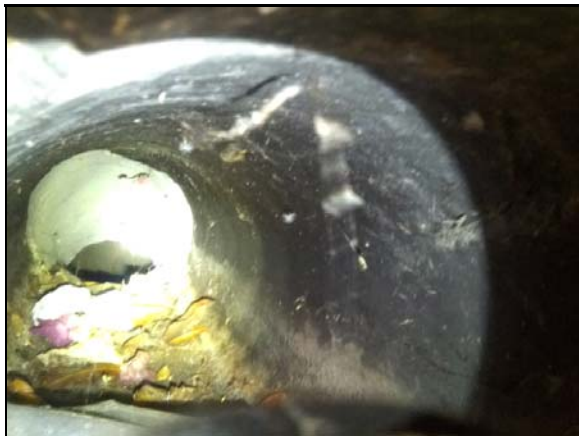
View inside outlet pipe

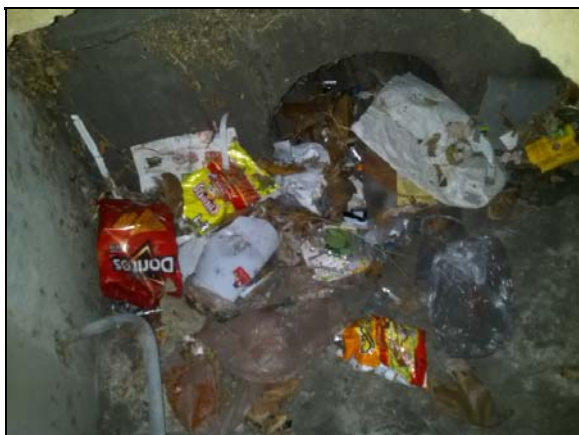
Minor cracking in catch basin structure wall.

View inside catch basin

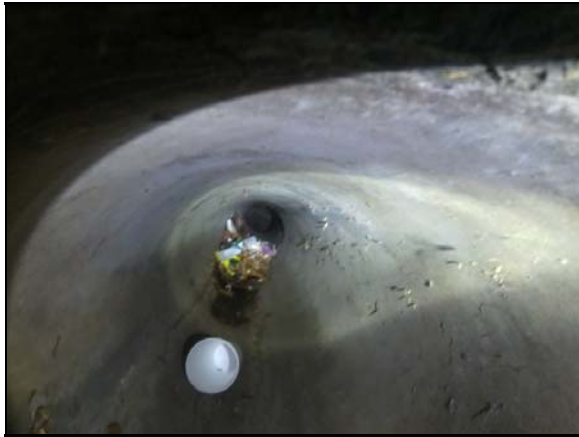
Catch Basin CB-M28-302

View inside outlet pipe

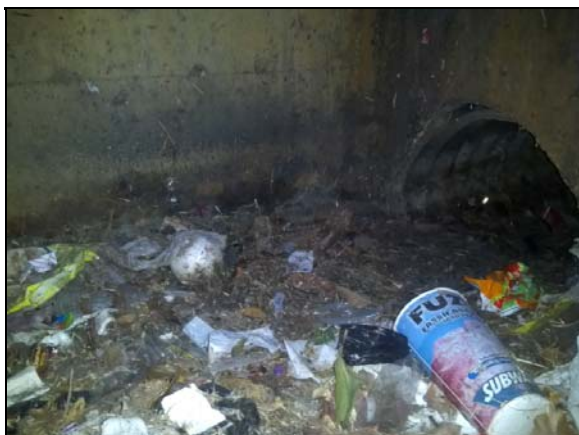
Pipe	Dir.	Hdn g	Dia. (in.)	Mat'l	Rim-inv (ft.)	Wtr Lvl (%)	Sed. (%)	Sed. Type	Infil- tration	Obs/Dfl. (%)	VANDA Rating	Priority Rating	Priority Rationale	Notes
CB-M28-304_JS-M28-503	Out	SE	10H x 12W	CMP	2.1	0		Unknown	Unknown	0	Level 2 - Minor Damage	Level 3 - Fair	Condition/Location	Under roadway.

View of outlet

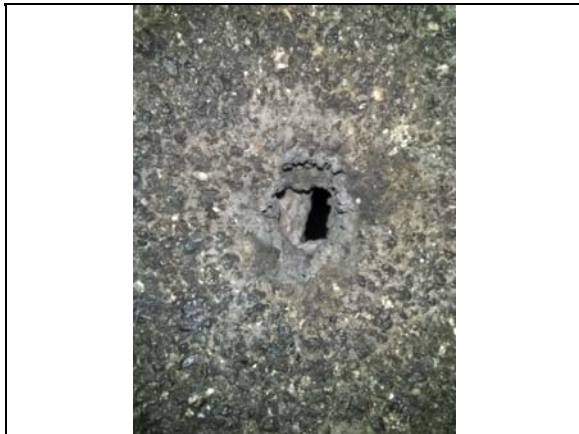
Hole

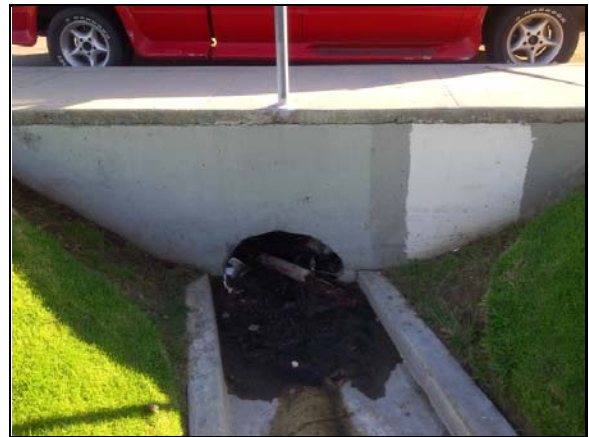
Culvert HW-U30-800_JS-U30-502

Susceptible to burial/overgrowth: No
Susceptible to ponding/flooding: Yes
Sediment/debris depth (%): 15
Type of sediment/debris: Silt/Vegetation/Trash
Infiltration in structure: None
Obstruction/deflection: 0
VANDA Condition Rating: Level 3 - Moderate
Damage
Prioritization Rating: Level 4 - Poor
Prioritization Rationale: Condition/Location
Illegal dumping evidence: No

View of inlet

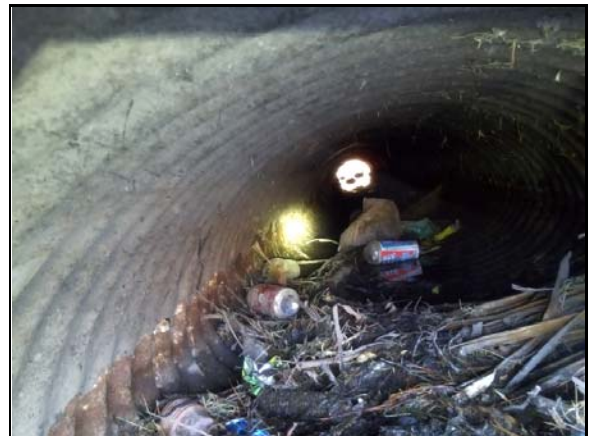
Under roadway. Moderate corrosion on pipe invert.

View inside pipe from inlet

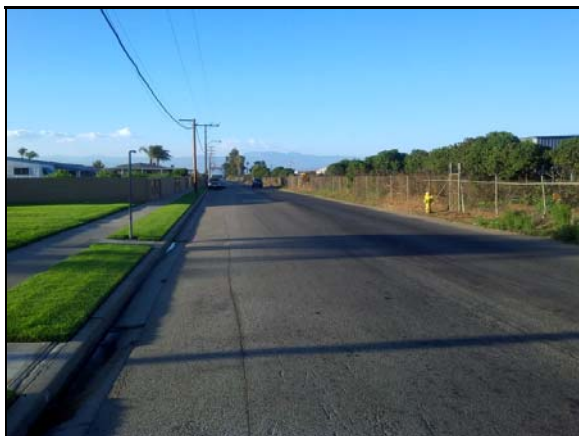
Location View

Area has history of flooding. Open channel may be undersized.

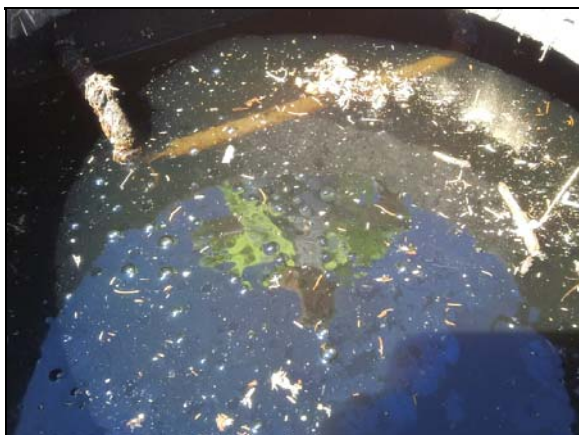
Catch basin flooded

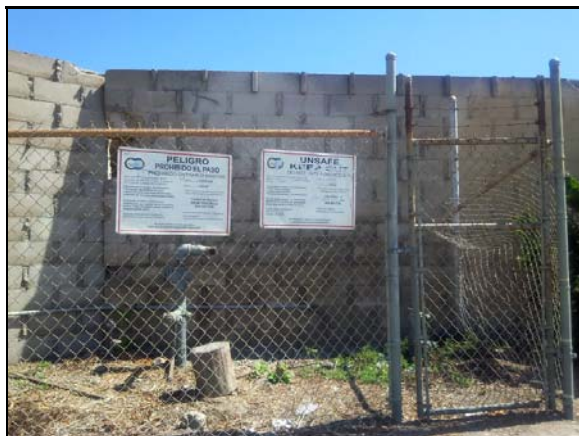
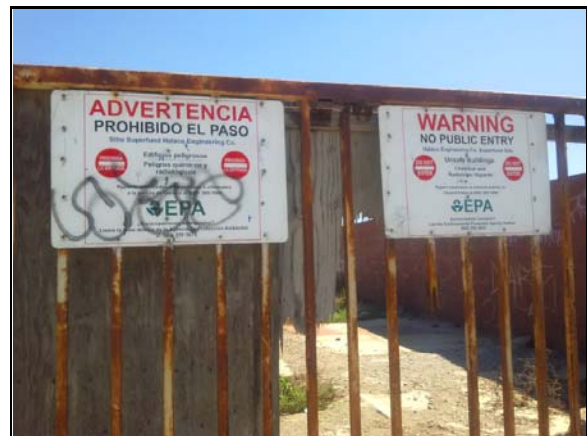
Unable to locate. May be within condemned area.

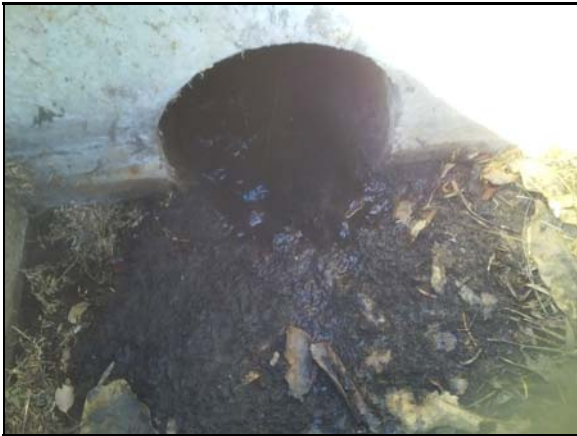
View of outlet

Cracking at pipe inlet. Possible odor issues due to sediment.

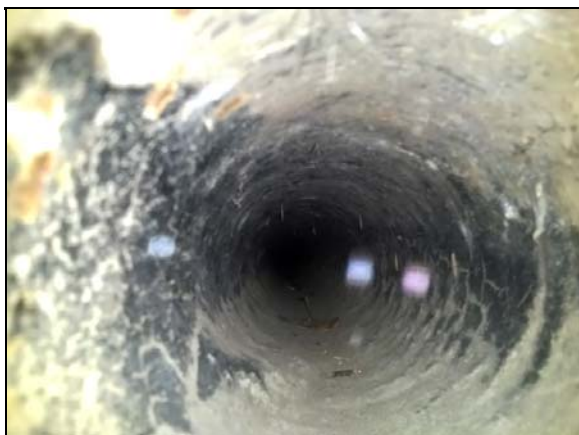
View inside inlet pipe

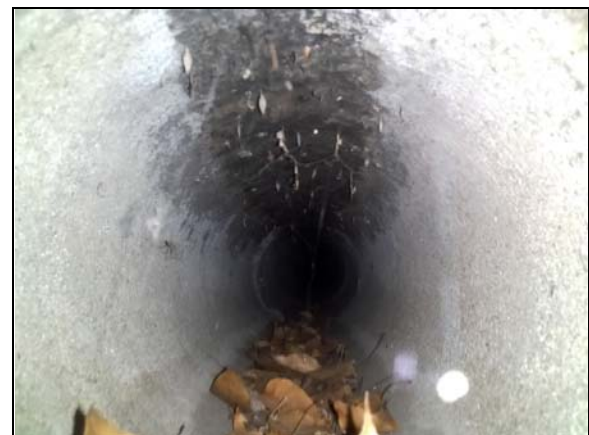
View inside outlet pipe

Cracking at inlet pipe. Connected to two 18-inch RCP.

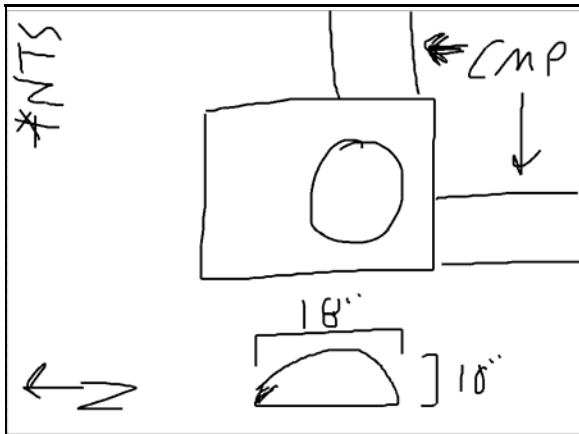
Catch basin

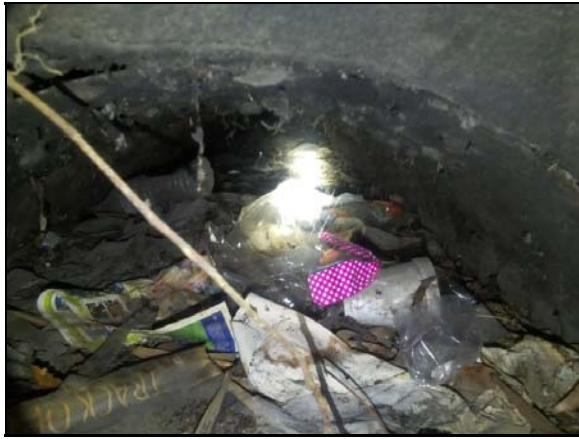
Catch Basin CB-O24-300

View inside outlet pipe

Pipe	Dir.	Hdn g	Dia. (in.)	Mat'l	Rim-inv (ft.)	Wtr Lvl (%)	Sed. (%)	Sed. Type	Infil-tration	Obs/Dfl. (%)	VANDA Rating	Priority Rating	Priority Rationale	Notes
CB-O24-302_CB-O24-300	Out	W	10H x 18W	CMP	1.1	0	50	Trash/Vegetation	None	0	Level 1 - No Damage	Level 4 - Poor	Sediment/Loc ation	Under roadway.

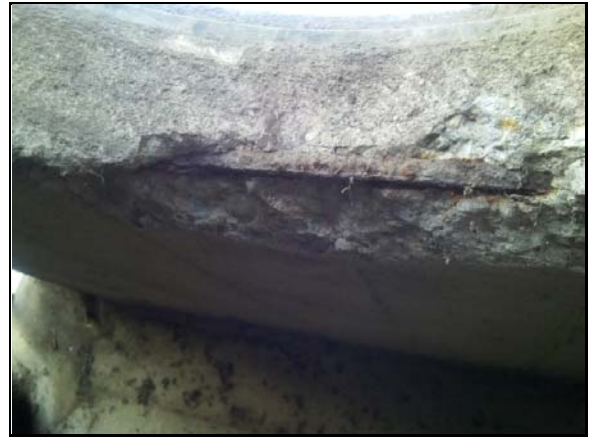
Catch Basin CB-024-304

Invert of CMP missing. Concrete missing and exposed reinforcing steel at chimney.

Exposed reinforcing steel

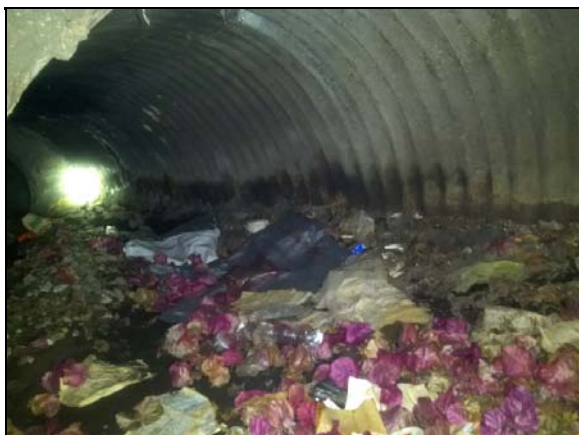
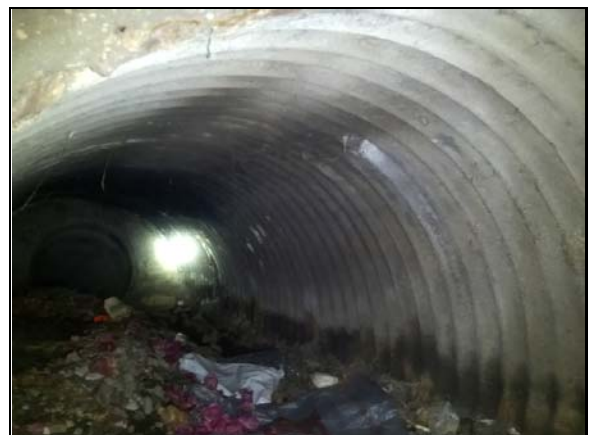
Pipe	Dir.	Hdn g	Dia. (in.)	Mat'l	Rim-inv (ft.)	Wtr Lvl (%)	Sed. (%)	Sed. Type	Infiltration	Obs/Dfl. (%)	VANDA Rating	Priority Rating	Priority Rationale	Notes
CR-024-801_MH-024-100	Out	SW	18H x 30W	CMP	3.1	0	10	Silt/Vegetation/Trash	Unknown	0	Level 4 - Severe/Significant Damage	Level 4 - Poor	Condition	Under roadway.

View inside outlet pipe

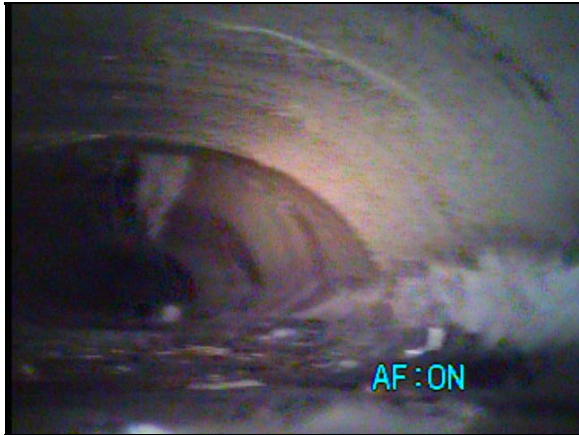
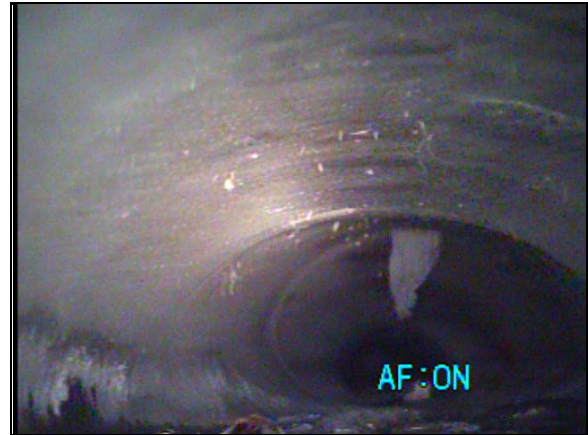
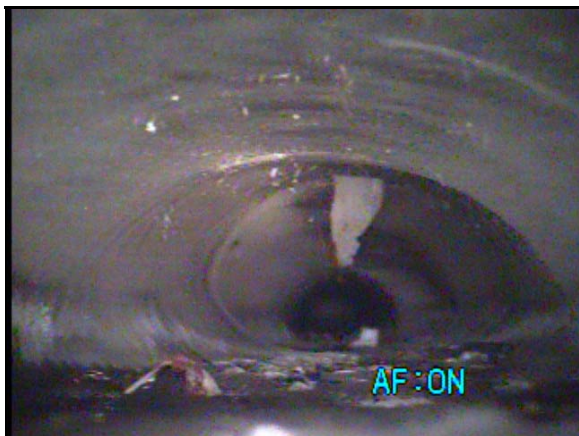
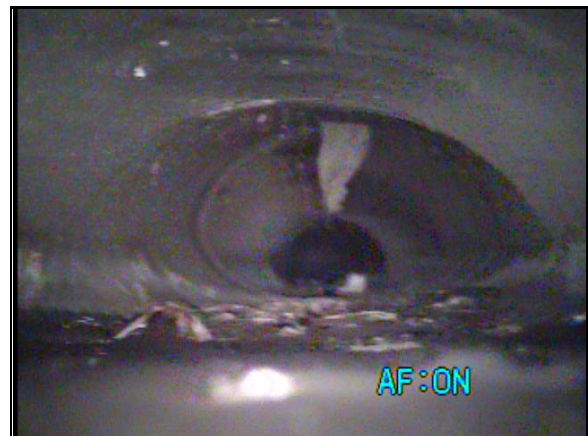
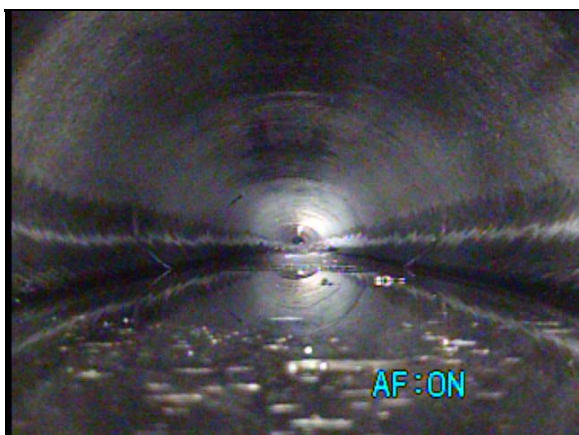
Culvert MH-O24-103

Significant corrosion at pipe invert at manhole. Rest of pipe appears in good condition with coal tar coating.
Connected to arched CMP 30H x 36W.

View of W pipe

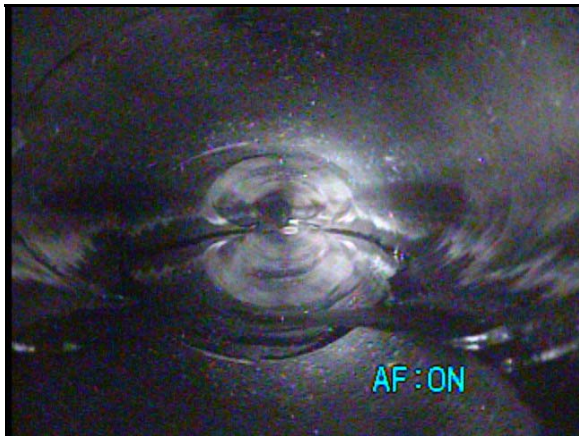
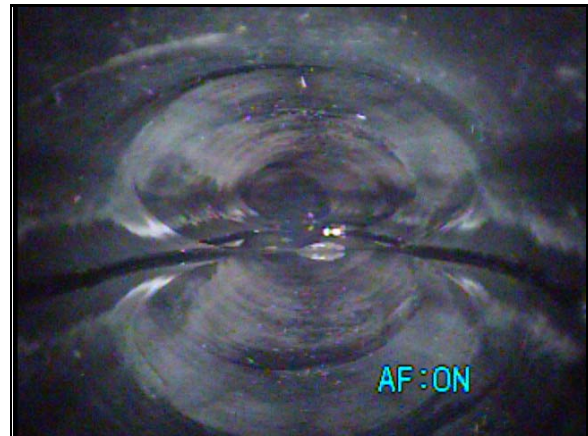
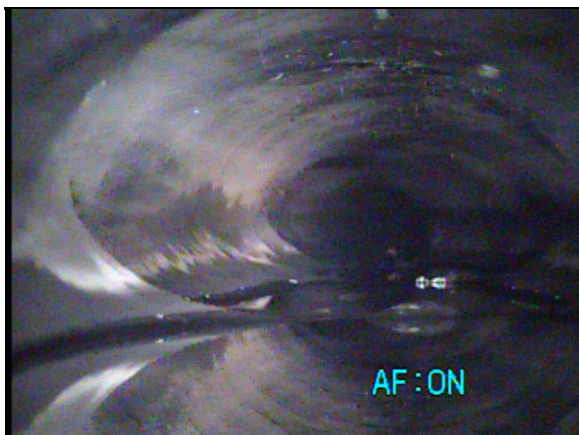
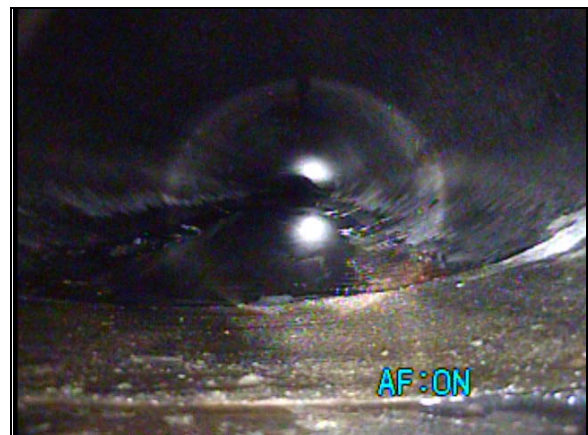
View of E pipe
