City of Oxnard

Public Works Integrated Master Plan

**PROJECT MEMORANDUM 5.3
CONDITION ASSESSMENT**

CITY OF OXNARD STORM DRAINAGE CONDITION ASSESSMENT

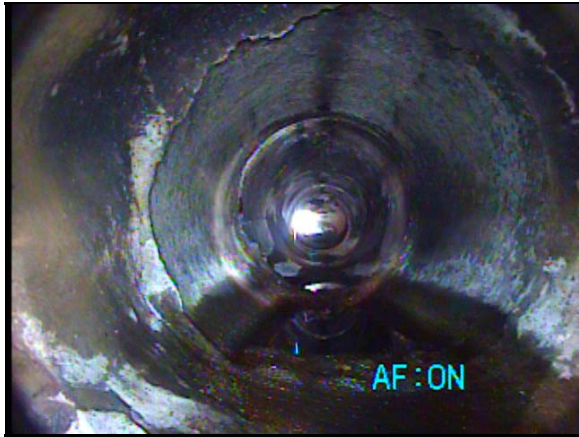
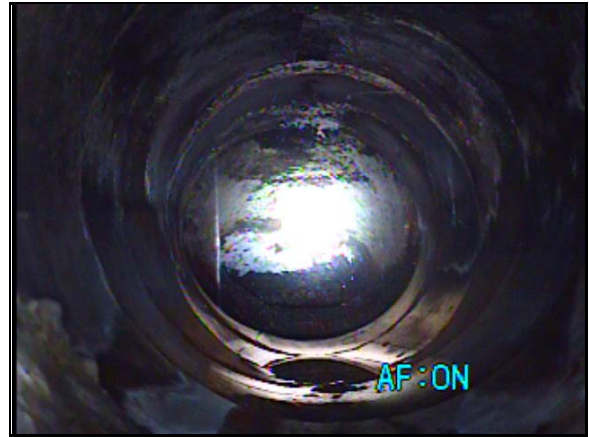
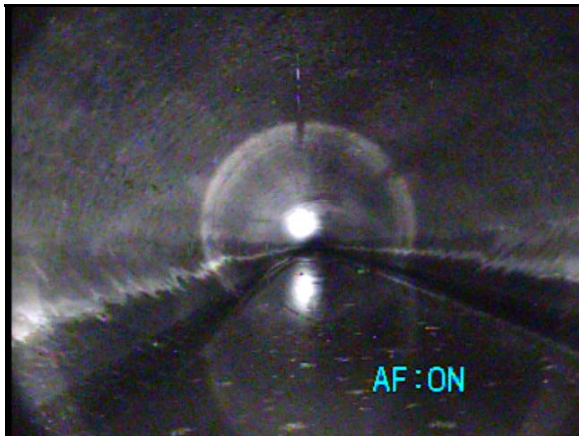
Culvert MH-O24-103

View of inlet

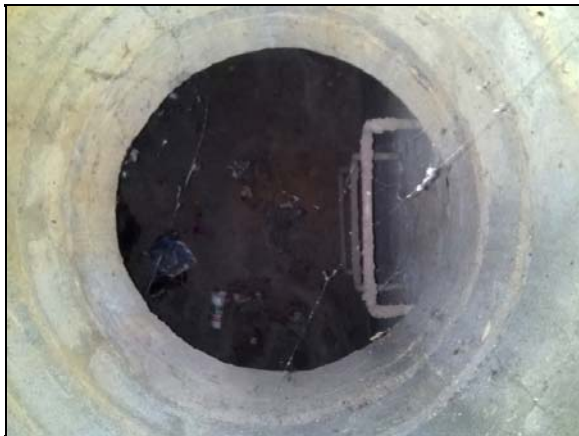
View inside manhole

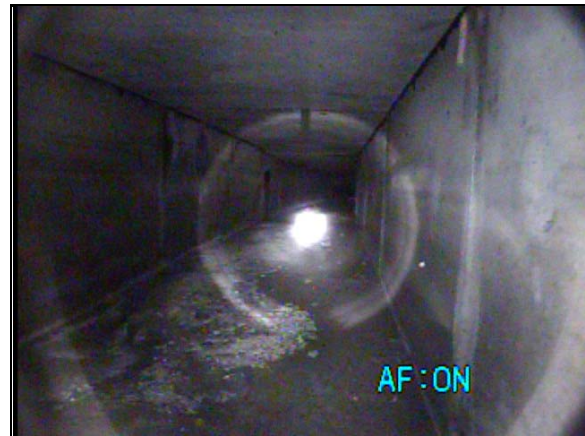
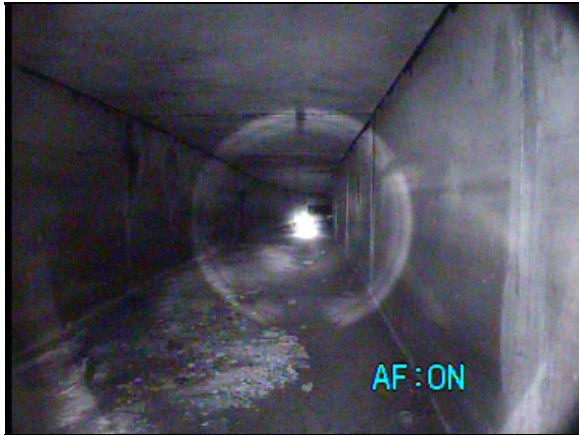
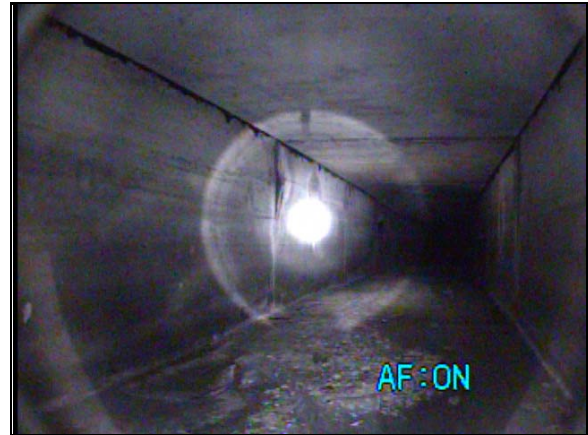
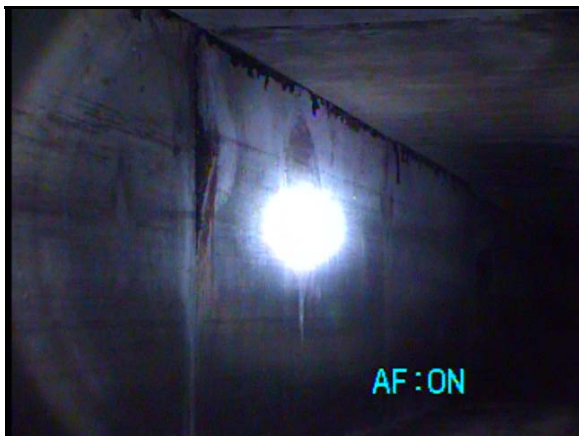
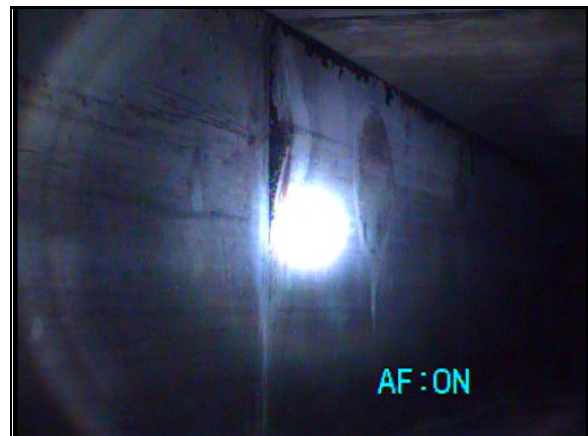
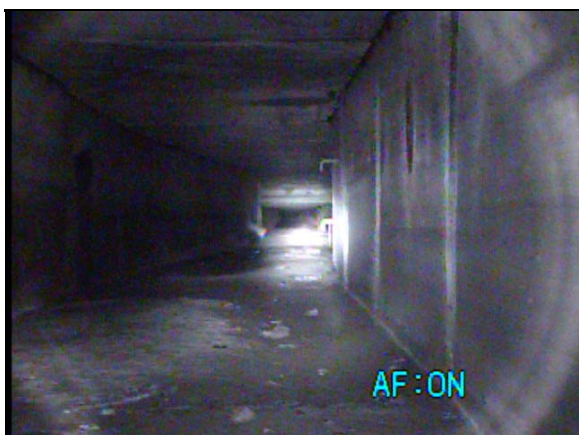
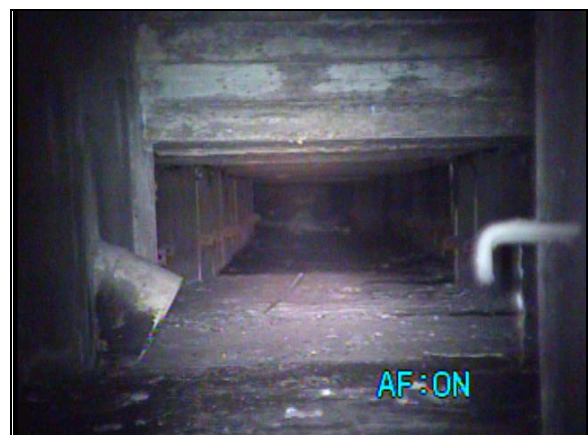
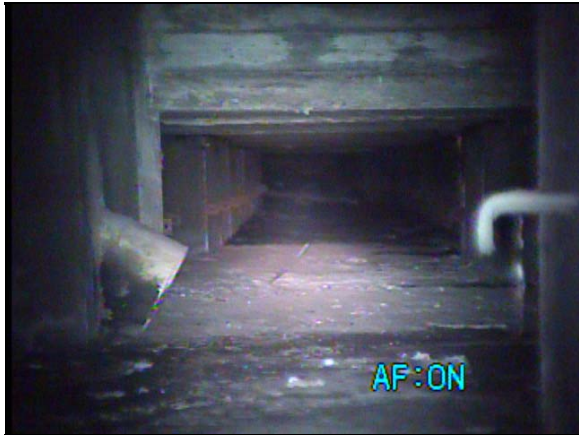
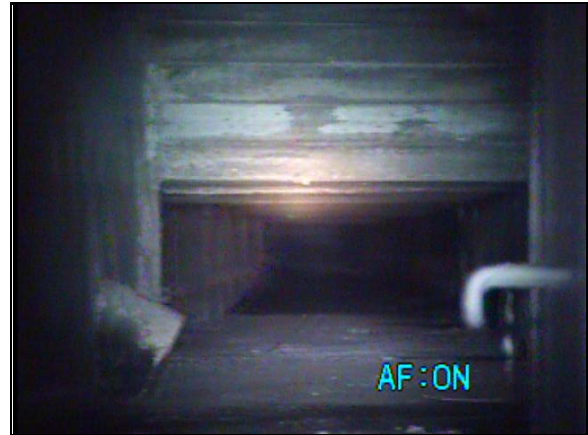
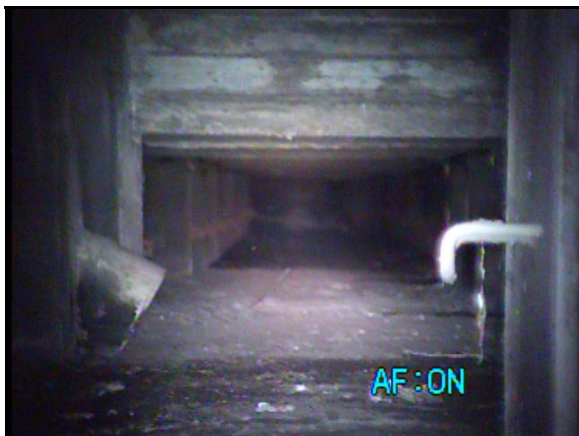
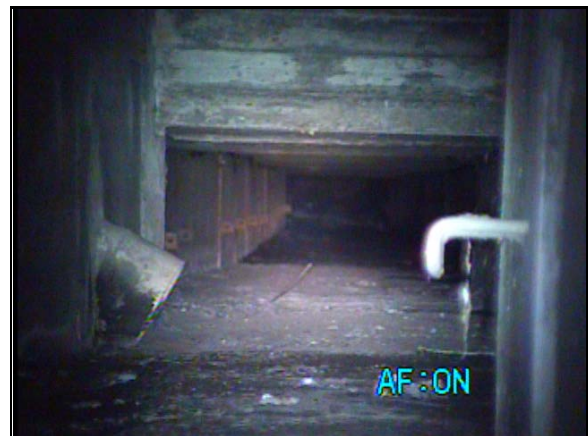
Culvert MH-P28-106

Pipe	Dir.	Hdn g	Dia. (in.)	Mat'l	Rim-inv (ft.)	Wtr Lvl (%)	Sed. (%)	Sed. Type	Infiltration	Obs/Dfl. (%)	VANDA Rating	Priority Rating	Priority Rationale	Notes
MH-P28-107_MH-P28-106	Unknown	Unknown	36H x 36W	RCB	8.3	0	5	Silt	None	0	Level 1 - No Damage	Level 1 - Excellent	Condition	Under roadway.

View of E box culvert

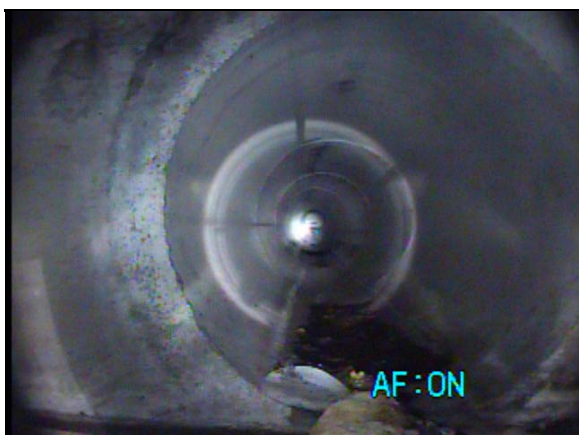
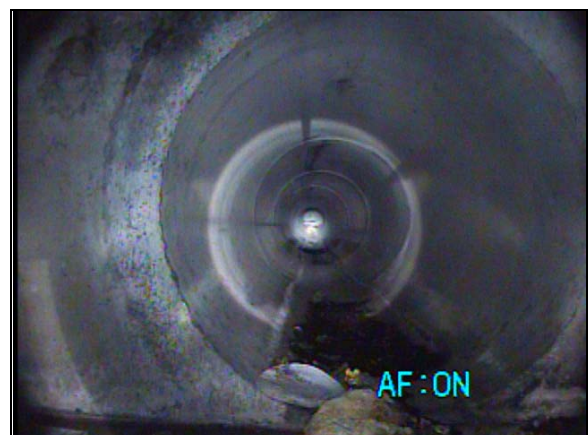
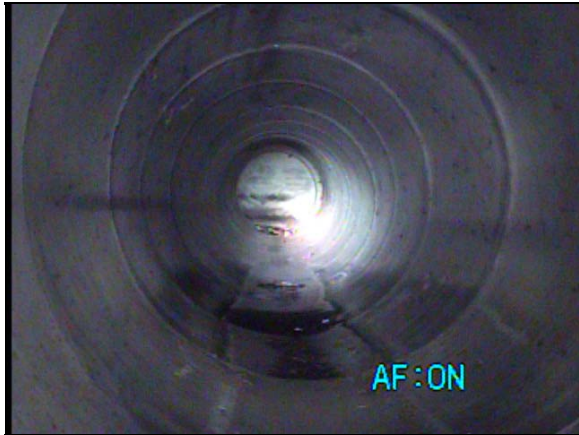
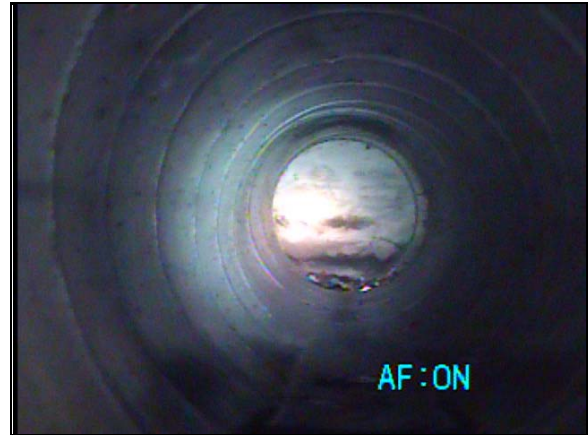
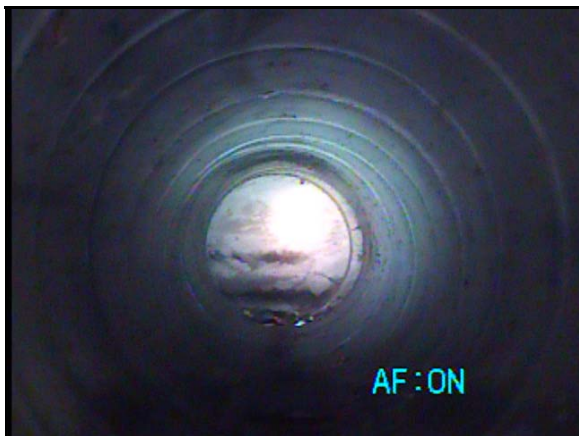
Pipe	Dir.	Hdn g	Dia. (in.)	Mat'l	Rim-inv (ft.)	Wtr Lvl (%)	Sed. (%)	Sed. Type	Infil- tration	Obs/Dfl. (%)	VANDA Rating	Priority Rating	Priority Rationale	Notes
JS-P28-500_MH-P28-106	In	S	Unkn own	RCP	8.3	0	0	None	None	0	Level 1 - No Damage	Level 1 - Excellent	Condition	Under roadway.
MH-P28-106_MH-P28-105	Unkn own	Unkn own	36H x 36W	RCB	8.3	0	5	Silt	Stain	0	Level 2 - Minor Damage	Level 2 - Good	Condition	Under roadway.

View of inlet pipe

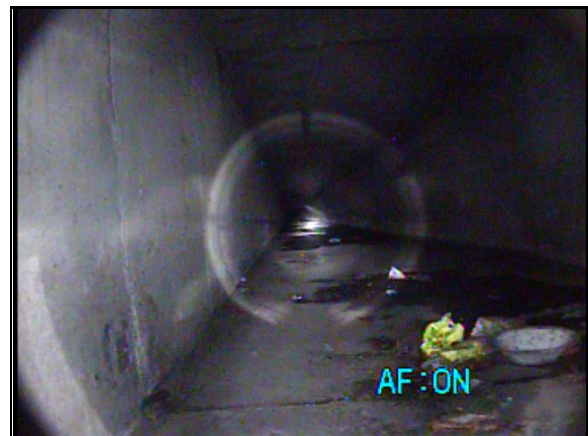
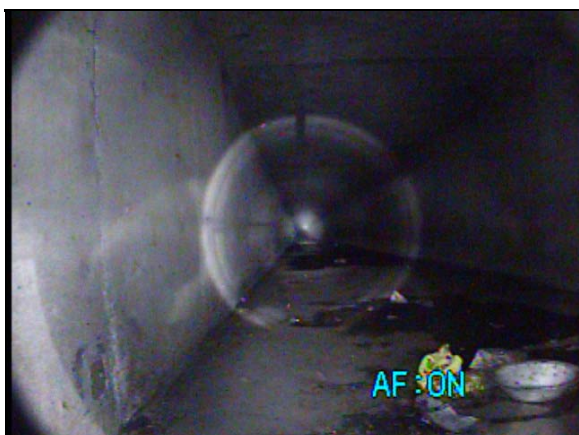
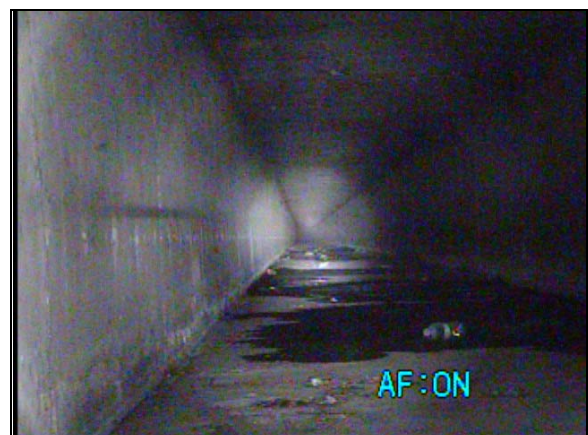
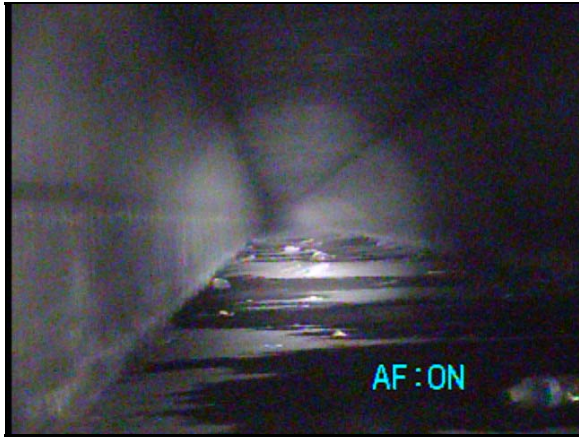
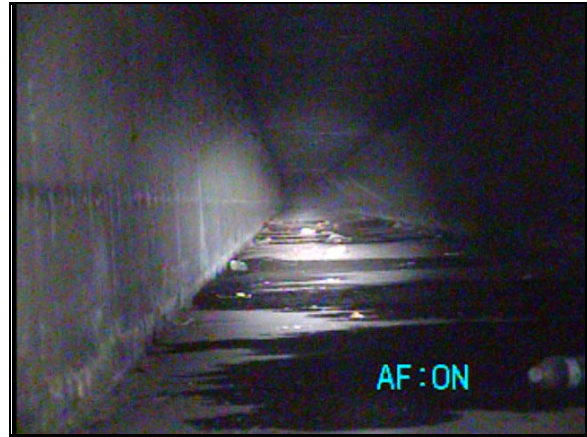
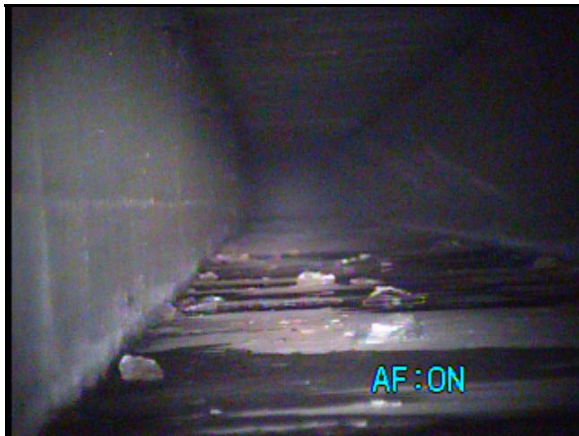
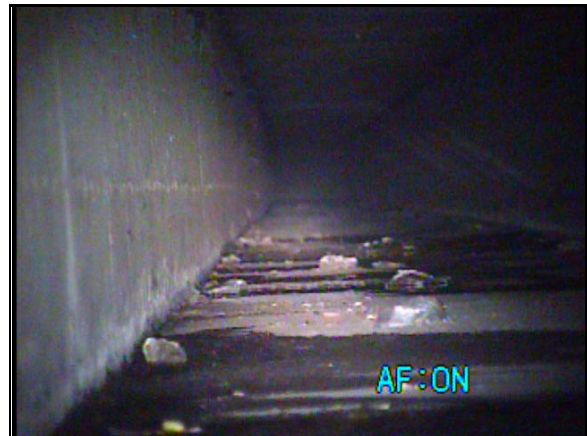
View of W box culvert

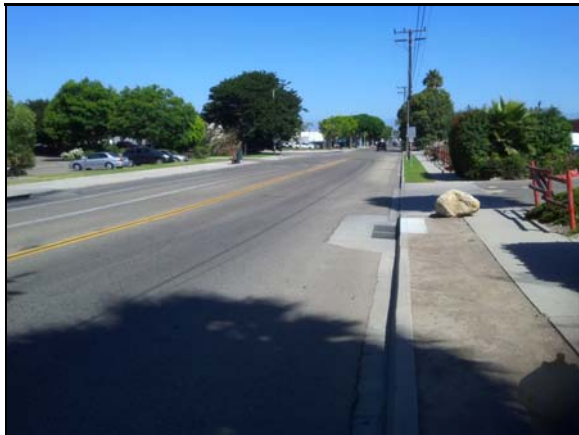
Location View

Area has history of flooding. Slight higher grade at manholes. Street appears to go downhill.

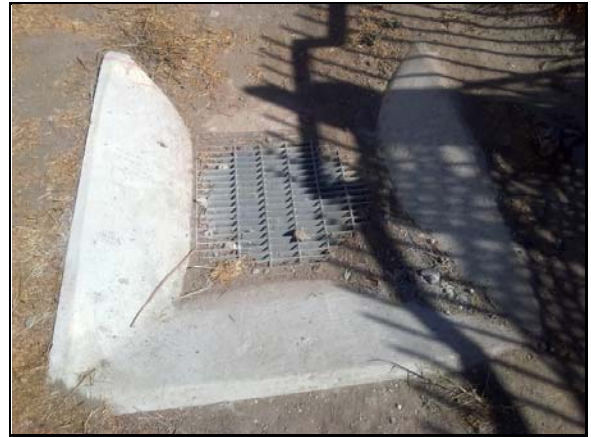
Catch Basin CB-P32-308

Catch basin

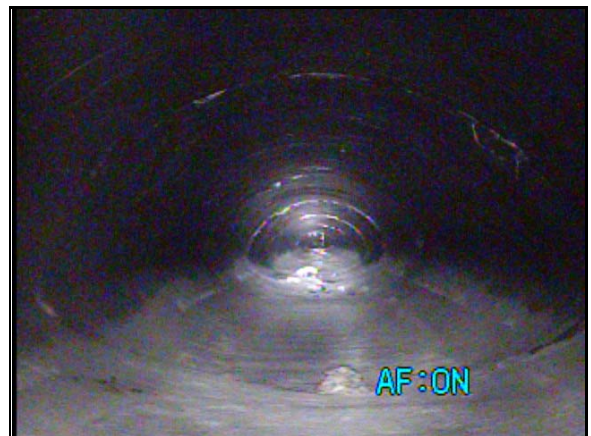
Pipe	Dir.	Hdn g	Dia. (in.)	Mat'l	Rim-inv (ft.)	Wtr Lvl (%)	Sed. (%)	Sed. Type	Infil-tration	Obs/Dfl. (%)	VANDA Rating	Priority Rating	Priority Rationale	Notes
CB-P32-308_MH-P33-101	Out	S	30H x 48W	CMP	3	0	0	None	None	0	Level 1 - No Damage	Level 1 - Excellent	Condition	Coal tar epoxy coating in good condition.
TS-P32-802_CB-P32-308	In	S	30H x 48W	CMP	3	0	0	None	None	0	Level 1 - No Damage	Level 1 - Excellent	Condition	Coal tar epoxy coating in good condition.

View inside outlet pipe

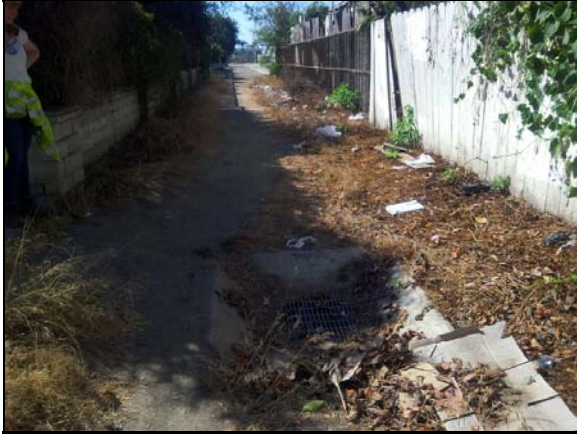
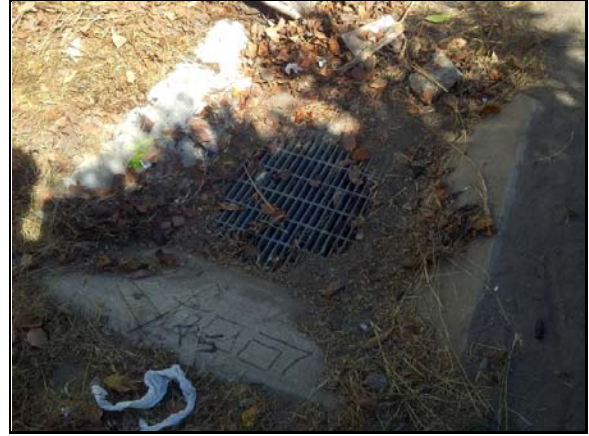
Catch Basin CB-P33-305

Susceptible to burial/overgrowth: Yes
Susceptible to ponding/flooding: No
Sediment/debris depth (%):
Type of sediment/debris: Unknown
Infiltration in structure: Unknown
Obstruction/deflection:
VANDA Condition Rating: Level 1 - No Damage
Prioritization Rating: Level 1 - Excellent
Prioritization Rationale: Condition
Illegal dumping evidence: No

Pipe	Dir.	Hdn g	Dia. (in.)	Mat'l	Rim-inv (ft.)	Wtr Lvl (%)	Sed. (%)	Sed. Type	Infil-tration	Obs/Dfl. (%)	VANDA Rating	Priority Rating	Priority Rationale	Notes
CB-P33-305_JSM-P33-504	Out	S	30H x 48W	CMP	3	0	0	None	None	0	Level 1 - No Damage	Level 1 - Excellent	Condition	Coal tar epoxy coating in good condition.
MH-P33-101_CB-P33-305	In	S	30H x 48W	CMP	3	0	0	None	None	0	Level 1 - No Damage	Level 1 - Excellent	Condition	Coal tar epoxy coating in good condition.

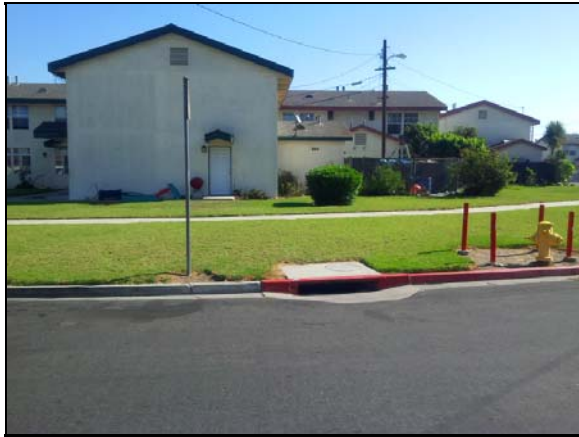
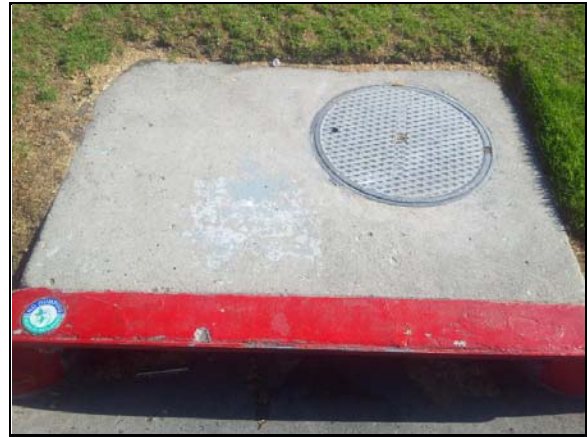
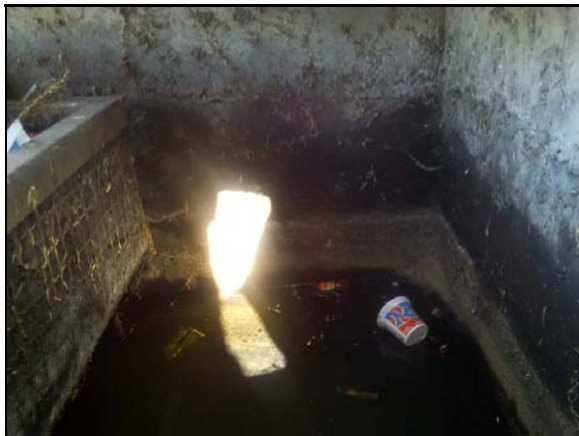
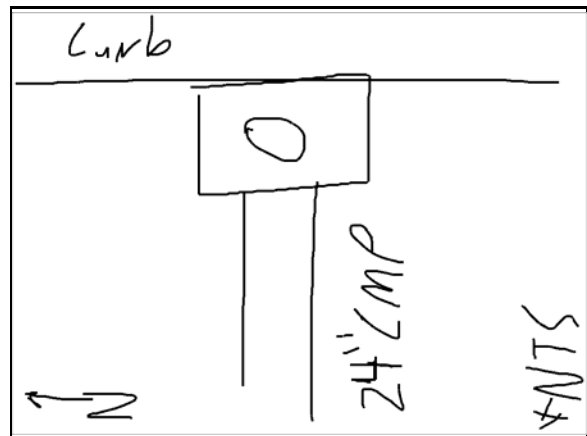
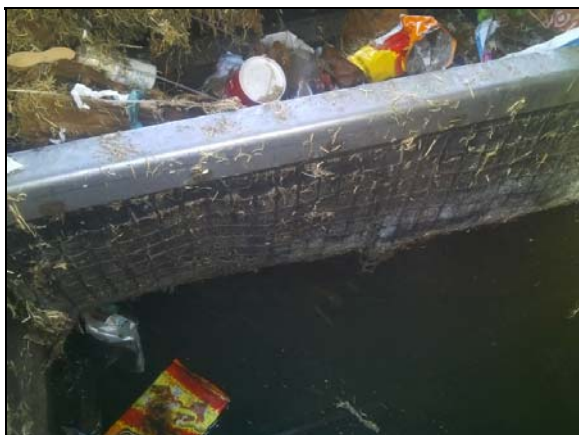
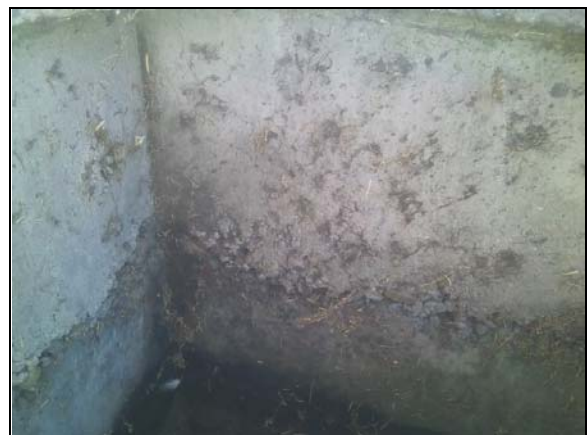
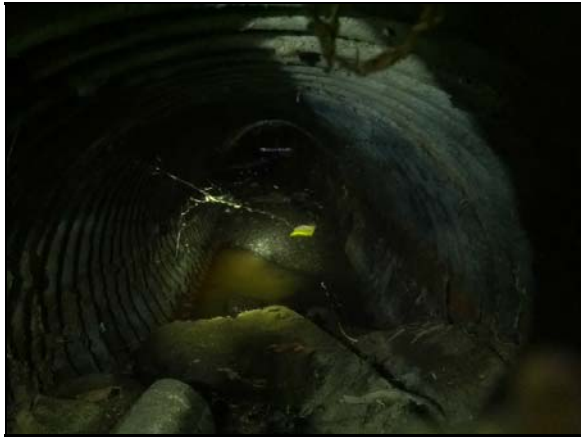
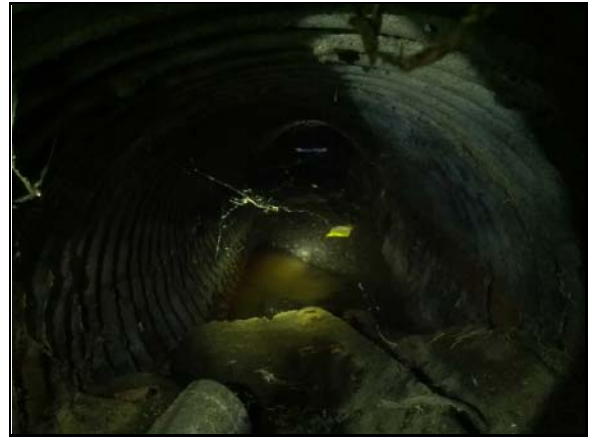
Catch Basin CB-P33-307

Susceptible to burial/overgrowth: No
Susceptible to ponding/flooding: No
Sediment/debris depth (%): 5
Type of sediment/debris: Silt/Trash
Infiltration in structure: None
Obstruction/deflection: 0
VANDA Condition Rating: Level 1 - No Damage
Prioritization Rating: Level 1 - Excellent
Prioritization Rationale: Condition
Illegal dumping evidence: No

Pipe	Dir.	Hdn g	Dia. (in.)	Mat'l	Rim-inv (ft.)	Wtr Lvl (%)	Sed. (%)	Sed. Type	Infil-tration	Obs/Dfl. (%)	VANDA Rating	Priority Rating	Priority Rationale	Notes
CB-P33-307_CB-P33-308	In	SW	24	CMP	3.3	5	5	Silt/Trash	None	0	Level 4 - Severe/Si gnificant Damage	Level 4 - Poor	Condition/Loc ation	Under roadway.
CB-P33-308_JSM-P33-504	Out	SW	24	CMP	3.3	5	5	Silt/Trash	None	0	Level 4 - Severe/Si gnificant Damage	Level 4 - Poor	Condition

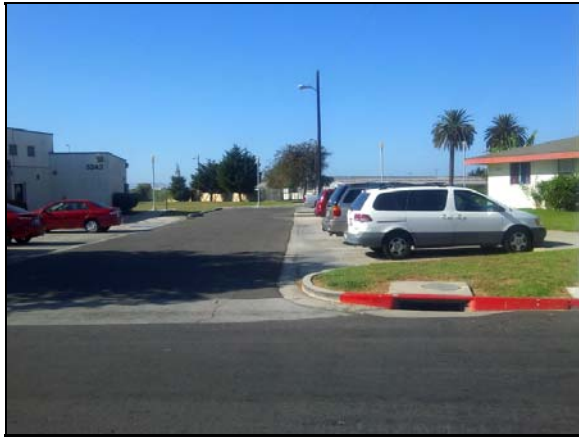
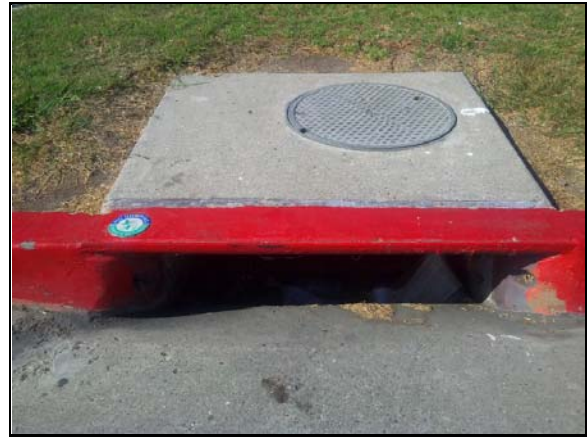
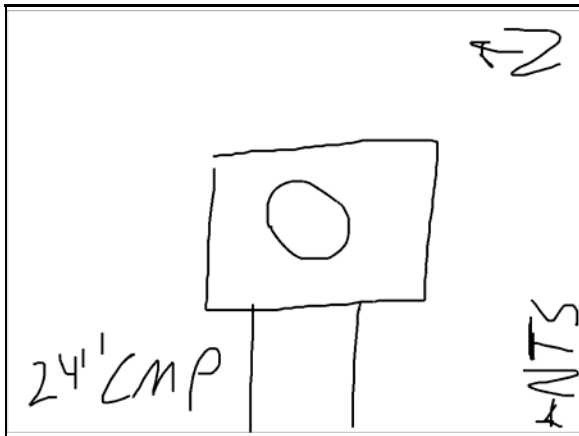
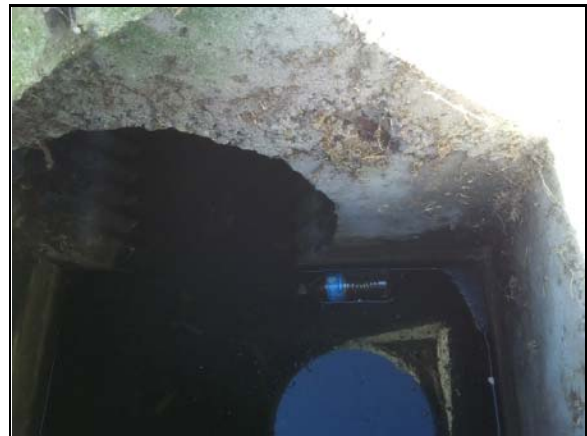
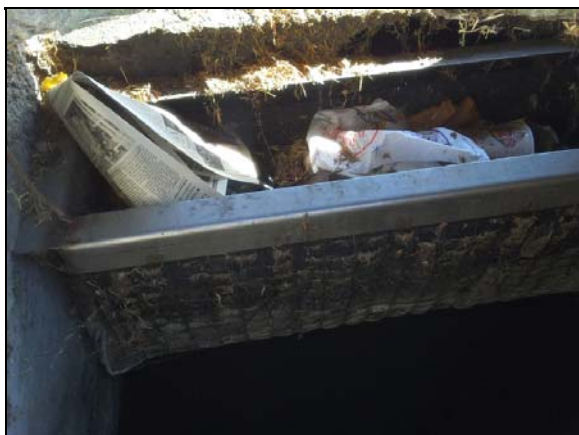
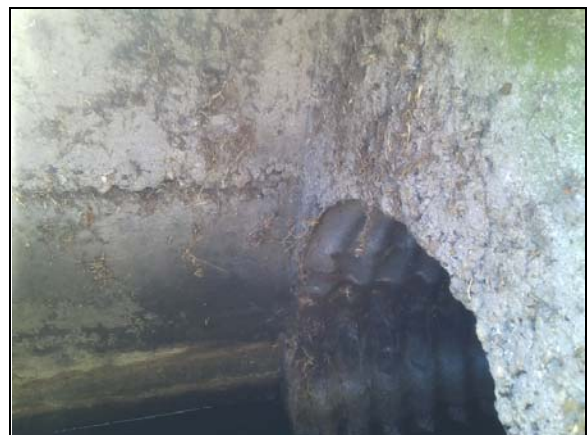
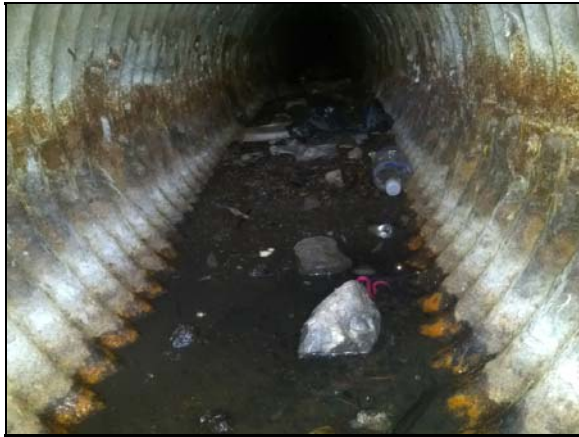
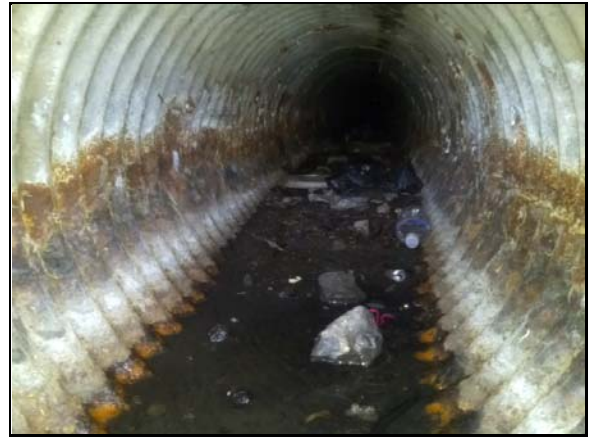
Catch Basin CB-P33-308

Susceptible to burial/overgrowth: No
Susceptible to ponding/flooding: Yes
Sediment/debris depth (%): 10
Type of sediment/debris: Silt/Trash
Infiltration in structure: None
Obstruction/deflection: 0
VANDA Condition Rating: Level 2 - Minor Damage
Prioritization Rating: Level 2 - Good
Prioritization Rationale: Condition
Illegal dumping evidence: No

Pipe	Dir.	Hdn g	Dia. (in.)	Mat'l	Rim-inv (ft.)	Wtr Lvl (%)	Sed. (%)	Sed. Type	Infiltration	Obs/Dfl. (%)	VANDA Rating	Priority Rating	Priority Rationale	Notes
CB-P33-308_CB-P33-308	Out	SW	24	CMP	3.2	10	25	Silt/Rock/Trash	None	0	Level 4 - Severe/Si gnificant Damage	Level 4 - Poor	Condition/Location	Under roadway. Moderate to significant corrosion on CMP.

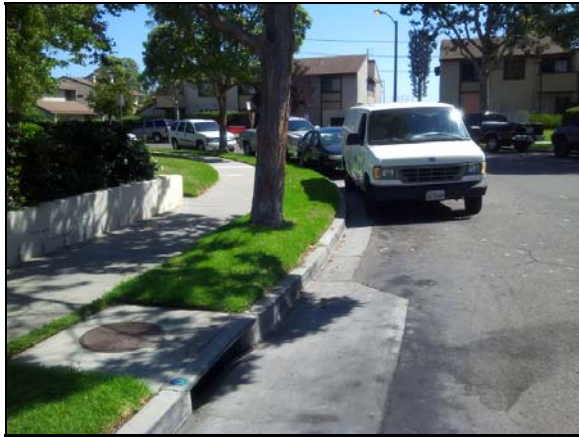
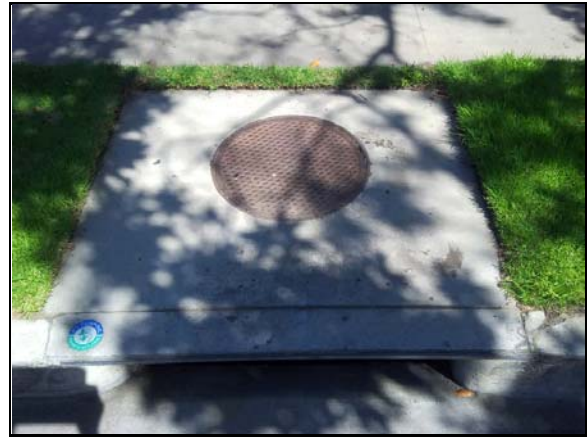
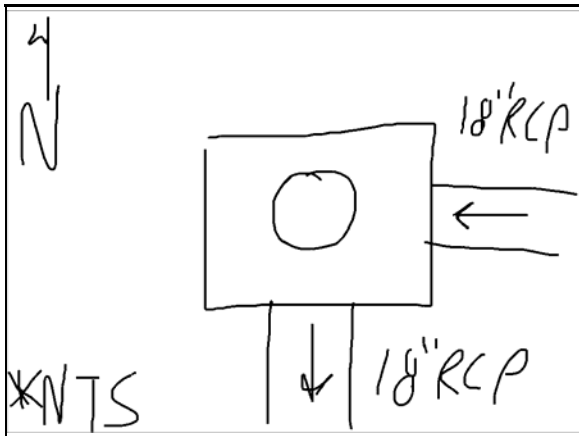
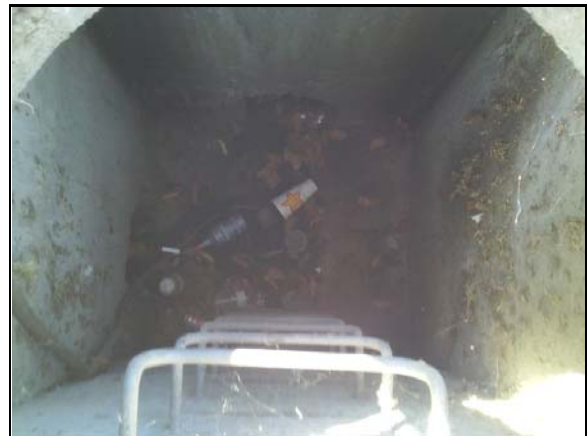
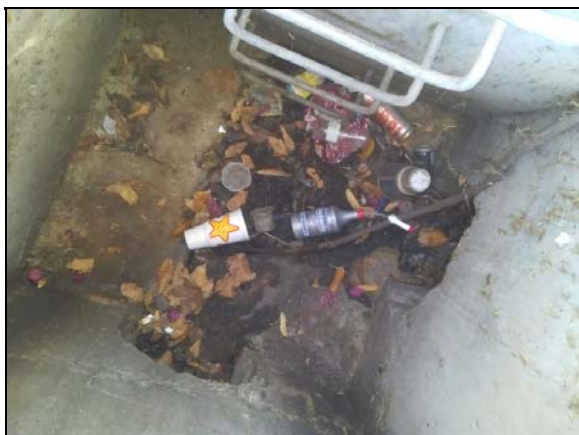
Catch Basin CB-P32-310

Susceptible to burial/overgrowth: No
Susceptible to ponding/flooding: No
Sediment/debris depth (%): 50
Type of sediment/debris: Vegetation
Infiltration in structure: None
Obstruction/deflection: 0.0
VANDA Condition Rating: Level 1 - No Damage
Prioritization Rating: Level 4 - Poor
Prioritization Rationale: Sediment/Location
Illegal dumping evidence: No

Pipe	Dir.	Hdn g	Dia. (in.)	Mat'l	Rim-inv (ft.)	Wtr Lvl (%)	Sed. (%)	Sed. Type	Infil- tration	Obs/Dfl. (%)	VANDA Rating	Priority Rating	Priority Rationale	Notes
CB-P32-310_CB-P32-311	Out	S	18	RCP	6.75	0	5	Trash/Vegetation	Unknown		Unknown	Level 3 - Fair	Condition/Location	Under roadway.
GB-P32-803_CB-P32-310	In	W	18	RCP	6.75	0	5	Trash/Vegetation	Unknown		Unknown	Level 2 - Good	Condition

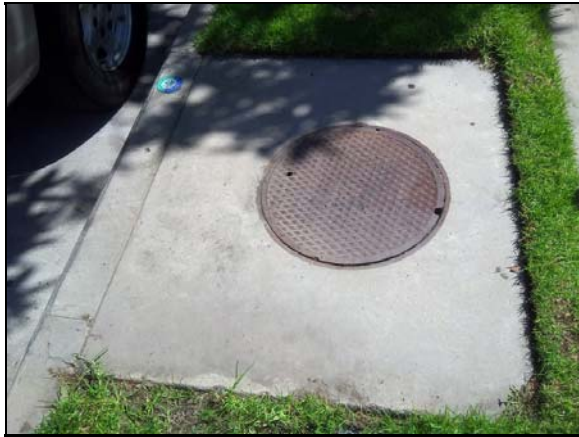
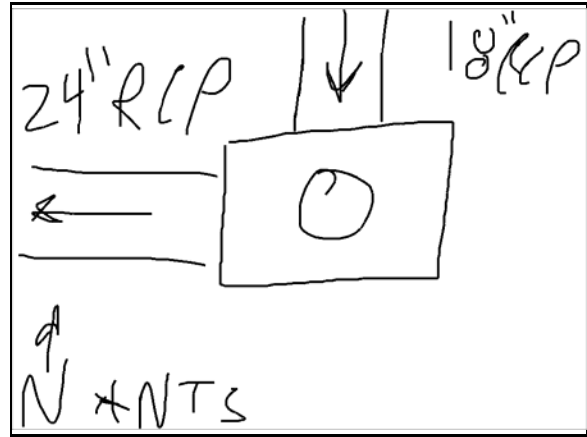
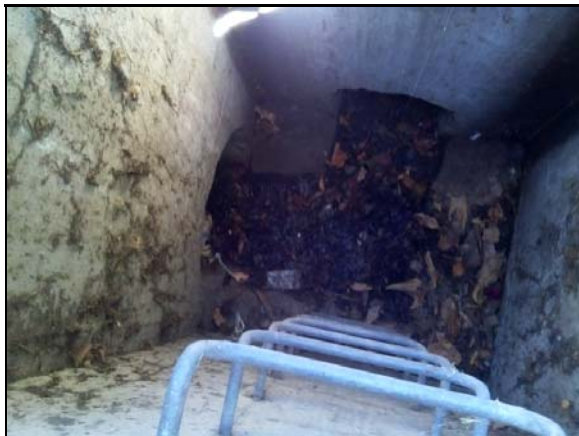
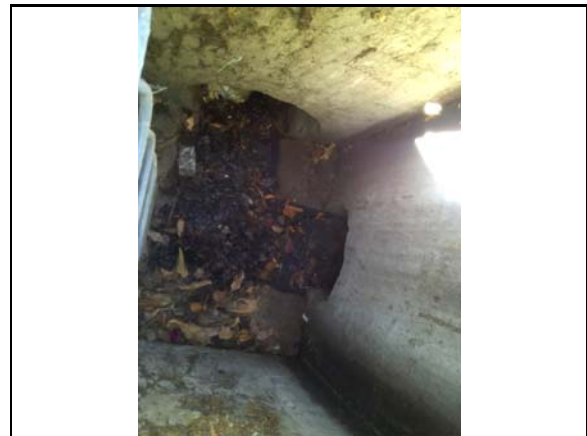
Catch Basin CB-P32-311

Susceptible to burial/overgrowth: No
Susceptible to ponding/flooding: No
Sediment/debris depth (%): 10
Type of sediment/debris: Silt/Vegetation
Infiltration in structure: None
Obstruction/deflection: 0
VANDA Condition Rating: Level 1 - No Damage
Prioritization Rating: Level 1 - Excellent
Prioritization Rationale: Condition
Illegal dumping evidence: No

Pipe	Dir.	Hdn g	Dia. (in.)	Mat'l	Rim-inv (ft.)	Wtr Lvl (%)	Sed. (%)	Sed. Type	Infil- tration	Obs/Dfl. (%)	VANDA Rating	Priority Rating	Priority Rationale	Notes
CB-P32-310_CB-P32-311	In	S	18	RCP	7.4	0	5	Trash/Vegetation	Unknown		Unknown	Level 3 - Fair	Condition/Location	Under roadway.
CB-P32-311_JS-P33-500	Out	SW	24	RCP	7.4	0	5	Trash/Vegetation	Unknown		Unknown	Level 2 - Good	Condition

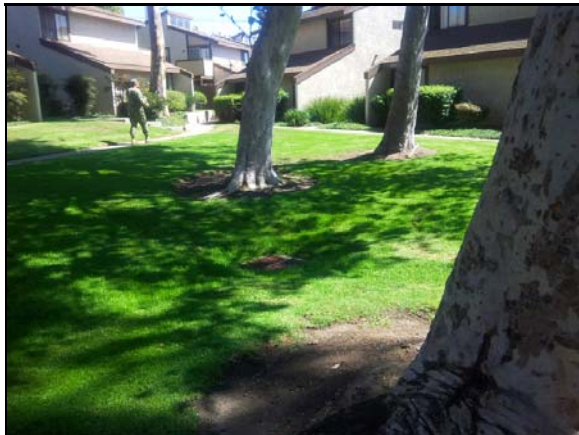
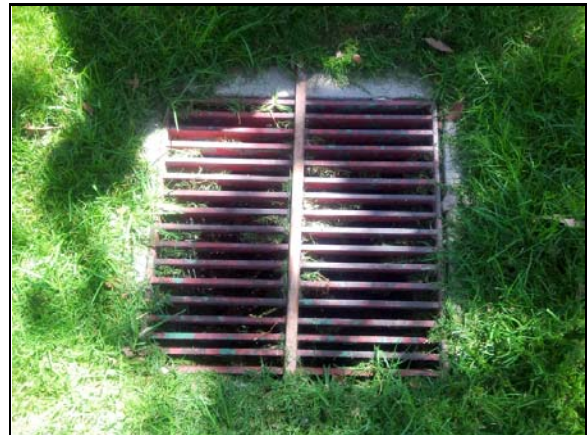
Susceptible to burial/overgrowth: No
Susceptible to ponding/flooding: No
Sediment/debris depth (%): 50
Type of sediment/debris: Vegetation
Infiltration in structure: None
Obstruction/deflection: 0
VANDA Condition Rating: Level 1 - No Damage
Prioritization Rating: Level 4 - Poor
Prioritization Rationale: Sediment/Location
Illegal dumping evidence: No

Unable to remove grate at time of assessment. Bolted down. Significant debris.

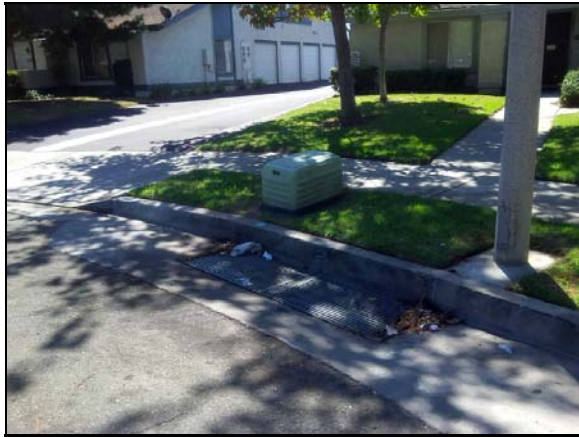
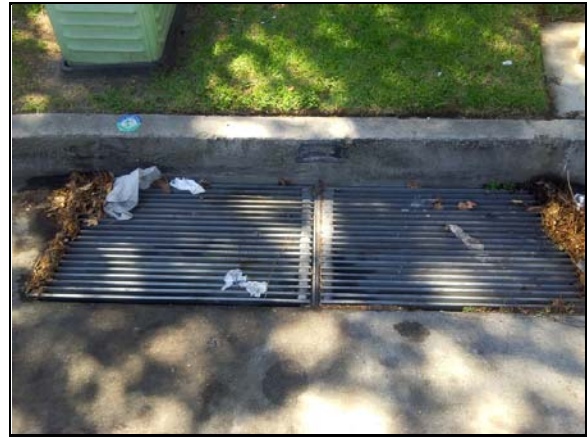
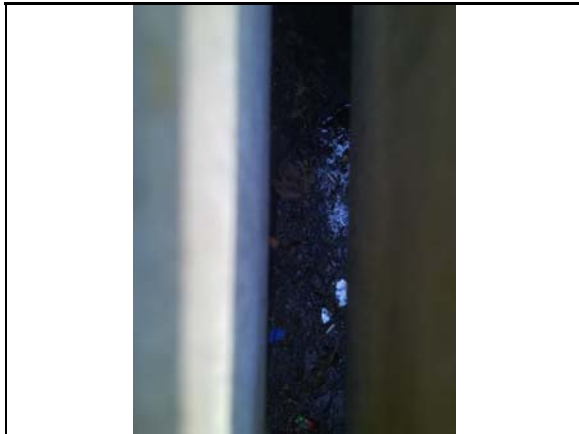
Catch Basin CB-P33-304

Susceptible to burial/overgrowth: No
Susceptible to ponding/flooding: No
Sediment/debris depth (%): 5
Type of sediment/debris: Silt/Vegetation
Infiltration in structure: None
Obstruction/deflection: 0.0
VANDA Condition Rating: Level 1 - No Damage
Prioritization Rating: Level 1 - Excellent
Prioritization Rationale: Condition
Illegal dumping evidence: No

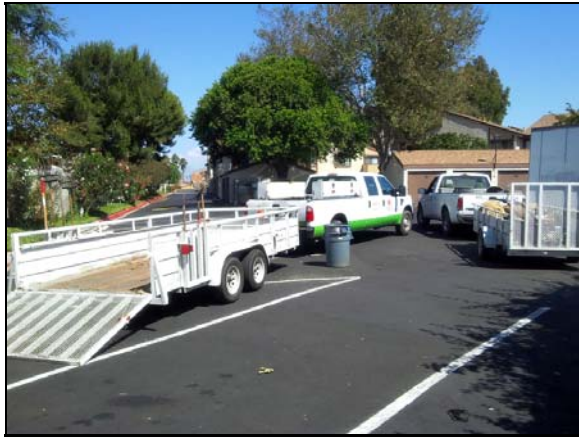
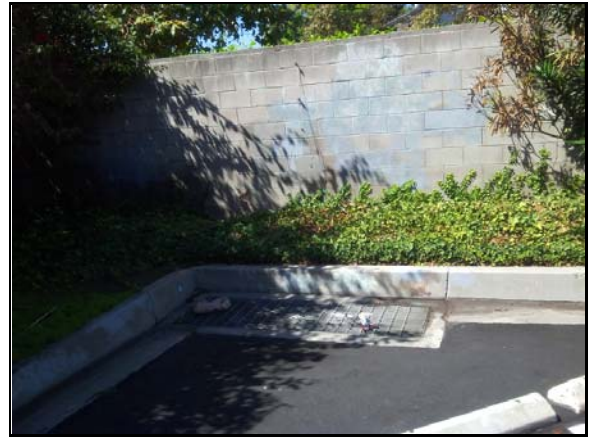
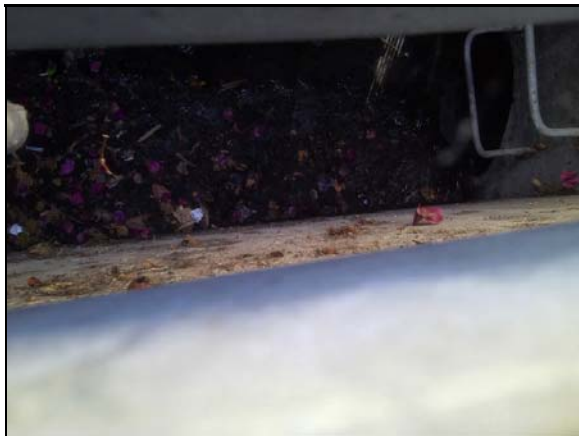
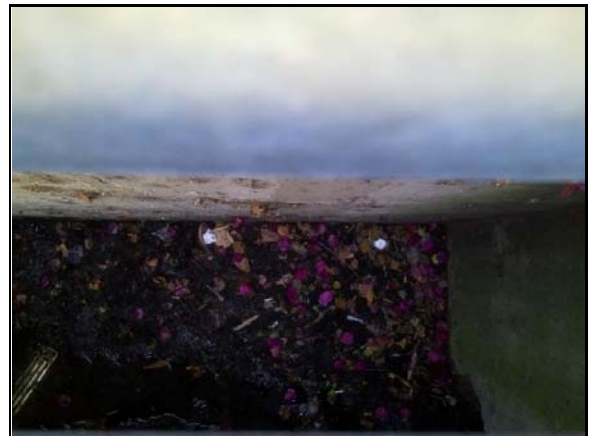
Catch Basin CB-P33-306

Susceptible to burial/overgrowth: No
Susceptible to ponding/flooding: No
Sediment/debris depth (%): 25
Type of sediment/debris: Silt/Vegetation
Infiltration in structure: None
Obstruction/deflection: 0
VANDA Condition Rating: Level 2 - Minor Damage
Prioritization Rating: Level 3 - Fair
Prioritization Rationale: Sediment/Other
Illegal dumping evidence: No

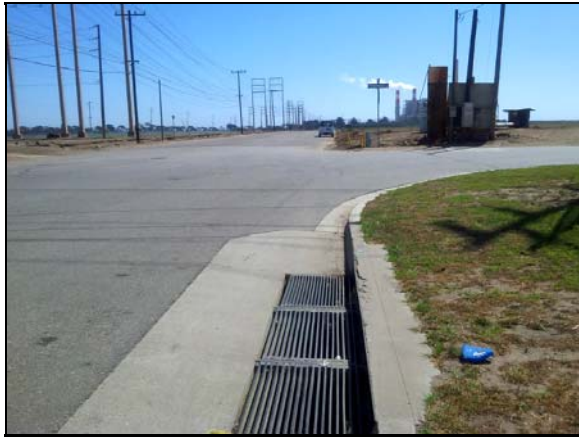
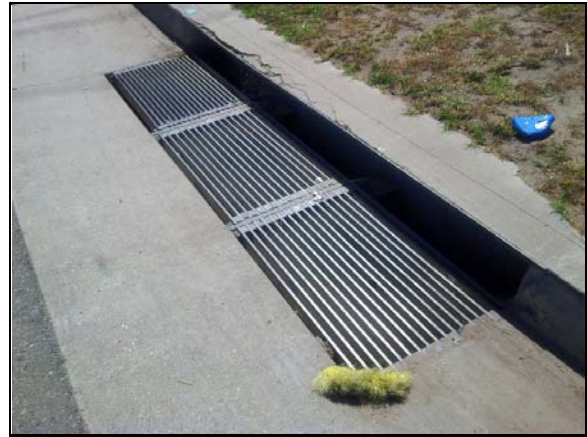
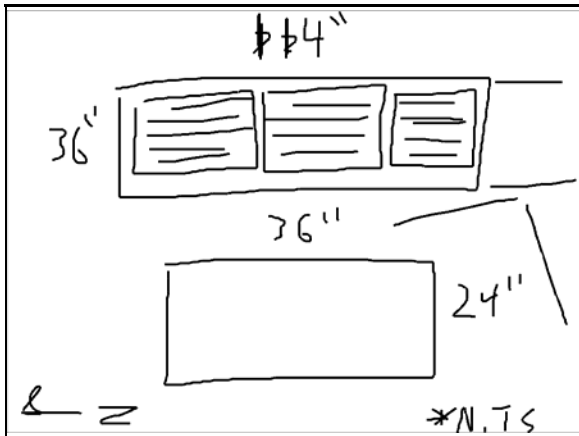
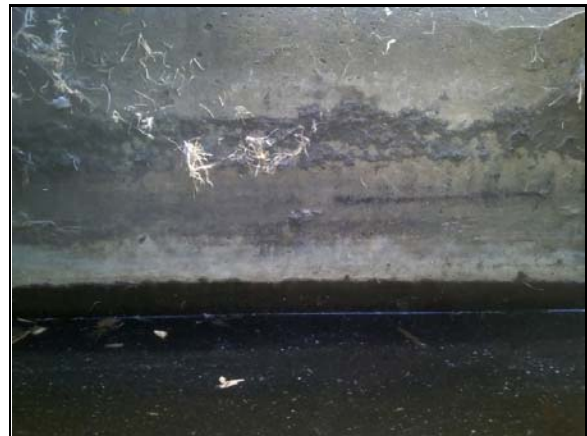
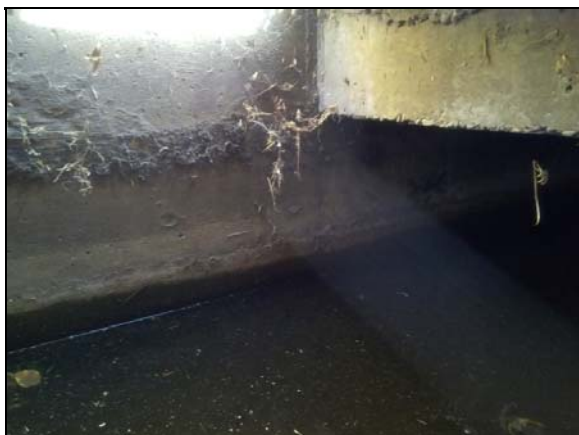
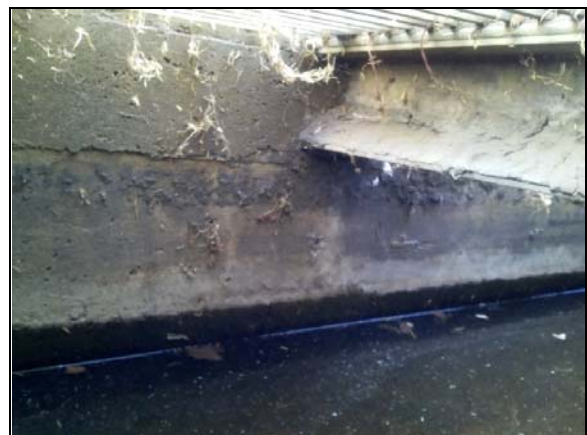
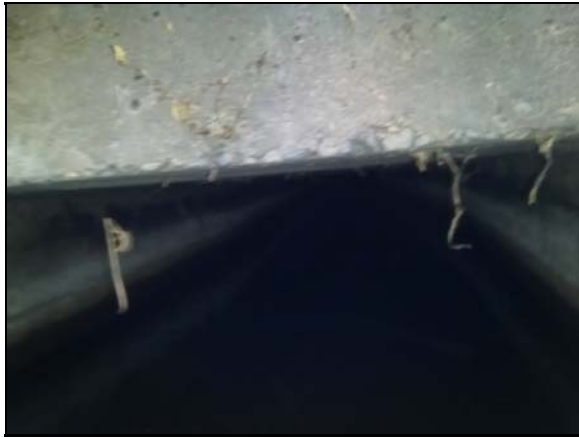
Catch Basin CB-P36-300

Susceptible to burial/overgrowth: No
Susceptible to ponding/flooding: Yes
Sediment/debris depth (%): 0
Type of sediment/debris: None
Infiltration in structure: None
Obstruction/deflection: 0.0
VANDA Condition Rating: Level 1 - No Damage
Prioritization Rating: Level 1 - Excellent
Prioritization Rationale: Condition
Illegal dumping evidence: No

Pipe	Dir.	Hdn g	Dia. (in.)	Mat'l	Rim-inv (ft.)	Wtr Lvl (%)	Sed. (%)	Sed. Type	Infil-tration	Obs/Dfl. (%)	VANDA Rating	Priority Rating	Priority Rationale	Notes
CB-P36-300_CB-P36-301	Out	S	24H x 36W	RCB	2.3	10	0	None	None	0	Level 1 - No Damage	Level 1 - Excellent	Condition	Under roadway.

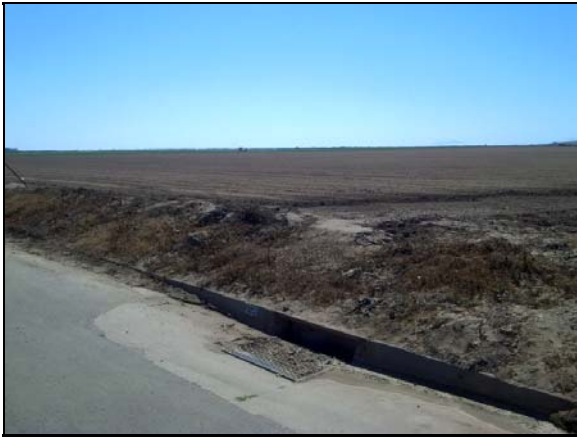
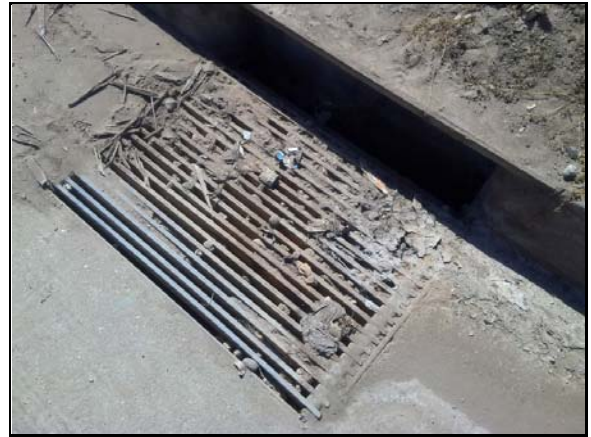
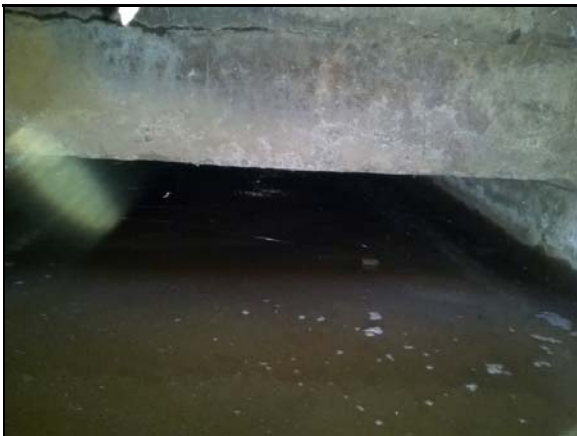
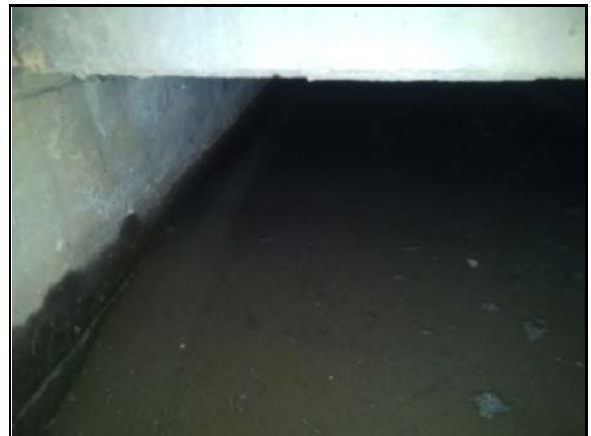
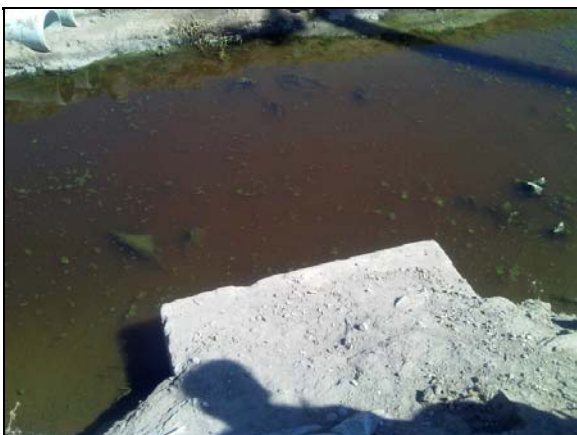
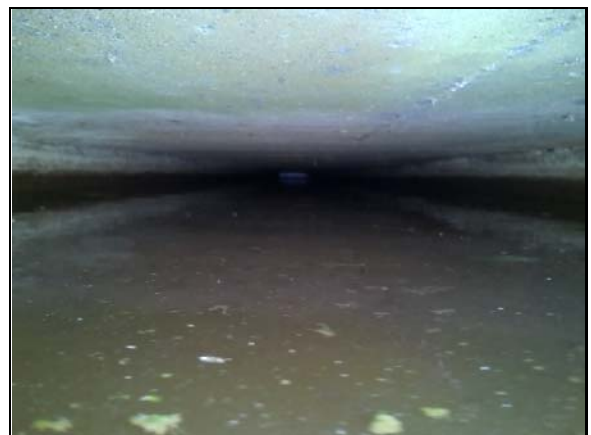
Catch Basin CB-P36-301

Susceptible to burial/overgrowth: No
Susceptible to ponding/flooding: Yes
Sediment/debris depth (%): 5
Type of sediment/debris: Silt
Infiltration in structure: None
Obstruction/deflection: 0
VANDA Condition Rating: Level 1 - No Damage
Prioritization Rating: Level 1 - Excellent
Prioritization Rationale: Condition
Illegal dumping evidence: No

Pipe	Dir.	Hdn g	Dia. (in.)	Mat'l	Rim-inv (ft.)	Wtr Lvl (%)	Sed. (%)	Sed. Type	Infiltration	Obs/Dfl. (%)	VANDA Rating	Priority Rating	Priority Rationale	Notes
CB-P36-300_CB-P36-301	In	S	24H x 36W	RCB	2.3	10	0	None	None	0	Level 1 - No Damage	Level 1 - Excellent	Condition	Under roadway.
CB-P36-301_HW-P36-800	Out	E	24H x 36W	RCB	2.3	40	0	None	None	0	Level 1 - No Damage	Level 1 - Excellent	Condition	Under roadway.
