City of Oxnard

Public Works Integrated Master Plan

**PROJECT MEMORANDUM 5.3
CONDITION ASSESSMENT**

CITY OF OXNARD STORM DRAINAGE CONDITION ASSESSMENT

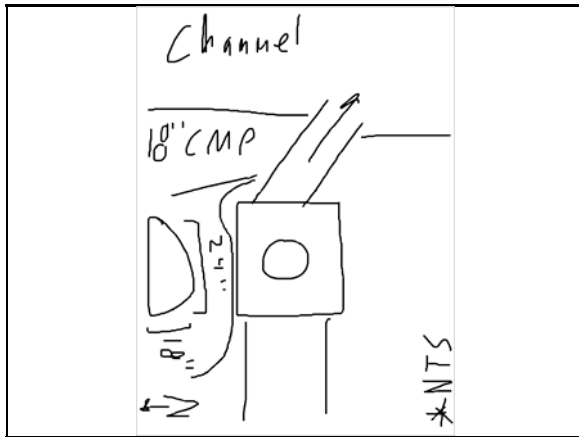
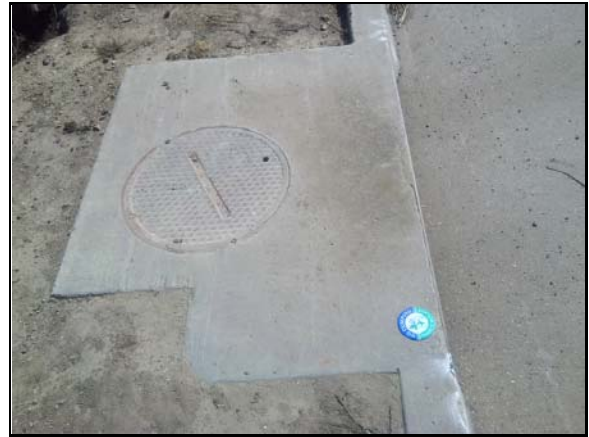
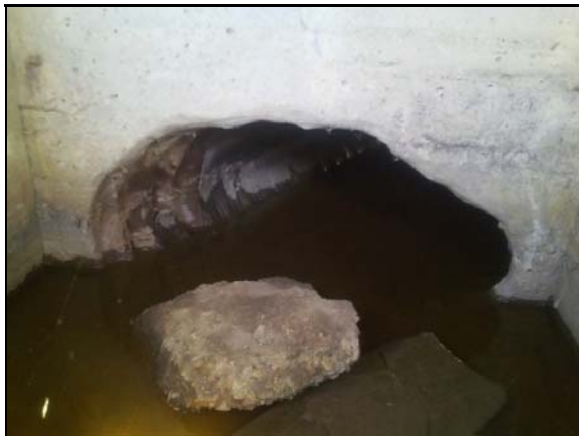
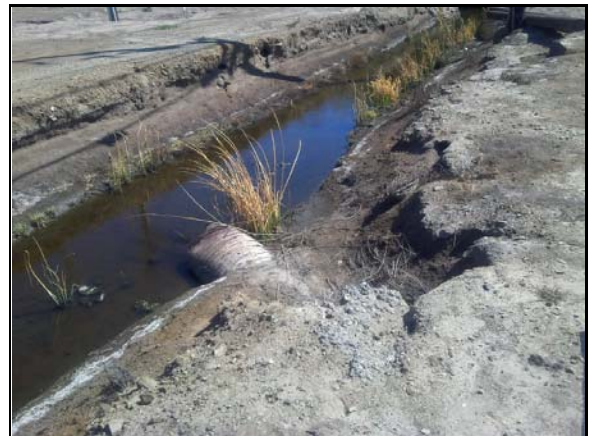
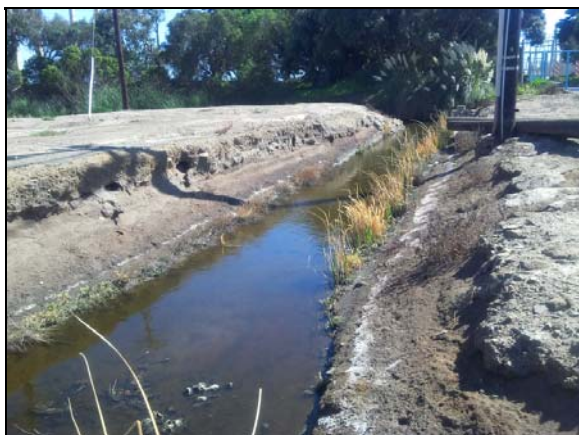
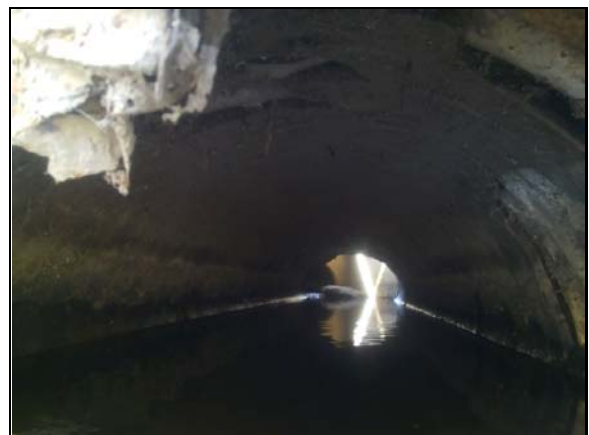
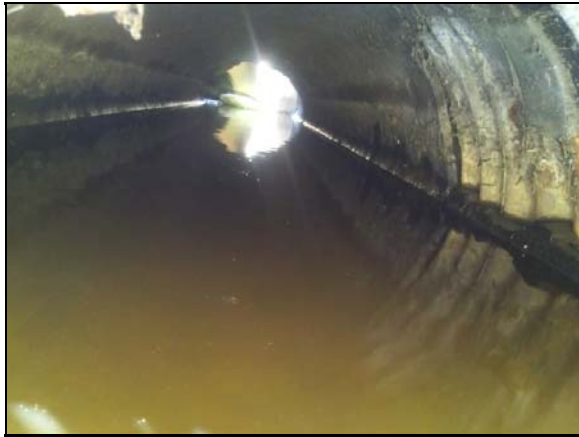
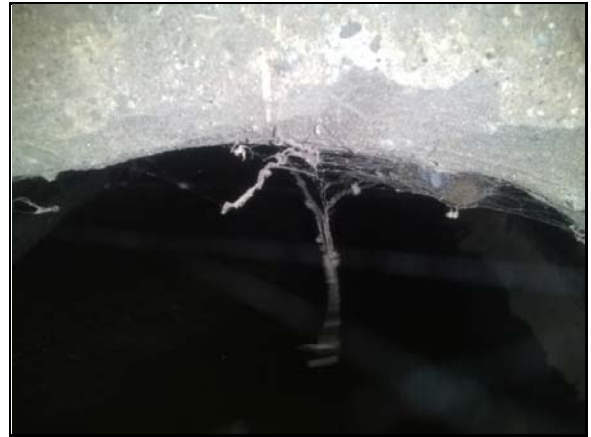
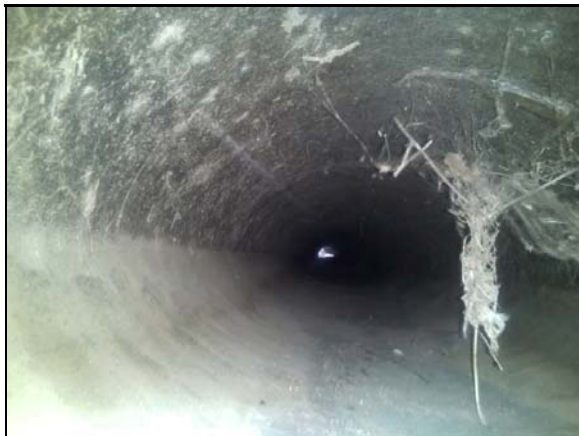
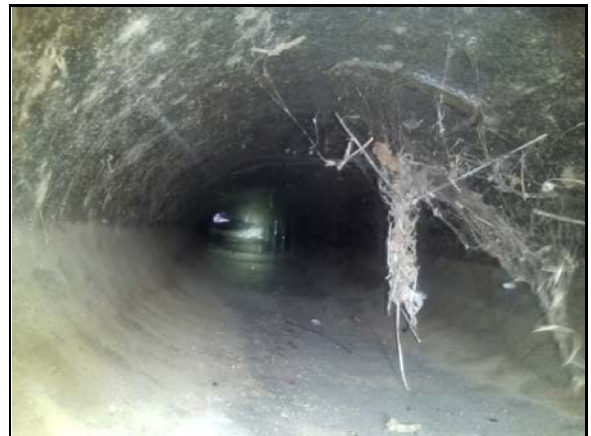
Catch Basin CB-P37-302

Pipe	Dir.	Hdn g	Dia. (in.)	Mat'l	Rim-inv (ft.)	Wtr Lvl (%)	Sed. (%)	Sed. Type	Infiltration	Obs/Dfl. (%)	VANDA Rating	Priority Rating	Priority Rationale	Notes
CB-P37-300_CB-P37-302	In		18H x 24W	CMP	2.7	0	5	Silt	None	0	Level 1 - No Damage	Level 1 - Excellent	Condition	Pipe has coal tar epoxy coating and is in good interior condition.
CB-P37-302_RR-P37-800	Out		18H x 24W	CMP	2.7	15	5	Silt	None	10	Level 2 - Minor Damage	Level 2 - Good	Condition	Effluent pipe deflected at outlet and has minor exterior corrosion. Pipe has coal tar epoxy coating and is in good interior condition. Drains to channel.

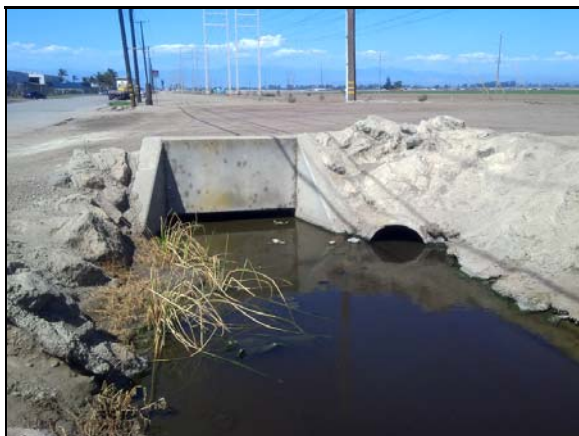
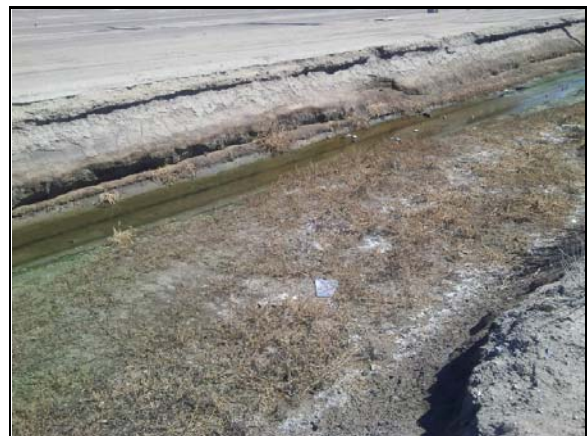
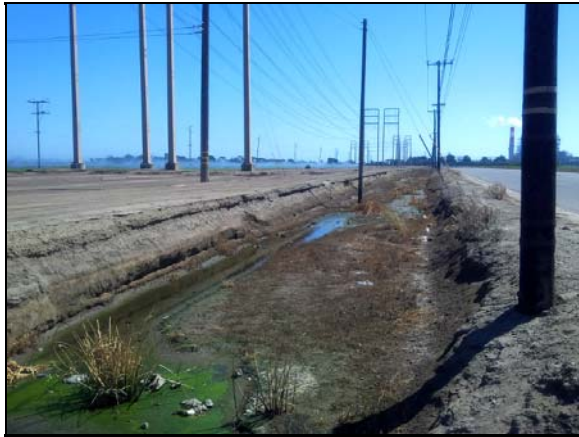
Channel IN-P36-1000_RR-P37-800

Susceptible to burial/overgrowth: No
Susceptible to ponding/flooding: Yes
Sediment/debris depth (%): 5
Type of sediment/debris: Silt/Vegetation
Infiltration in structure: None
Obstruction/deflection: 0.0
VANDA Condition Rating: Level 1 - No Damage
Prioritization Rating: Level 1 - Excellent
Prioritization Rationale: Condition
Illegal dumping evidence: No

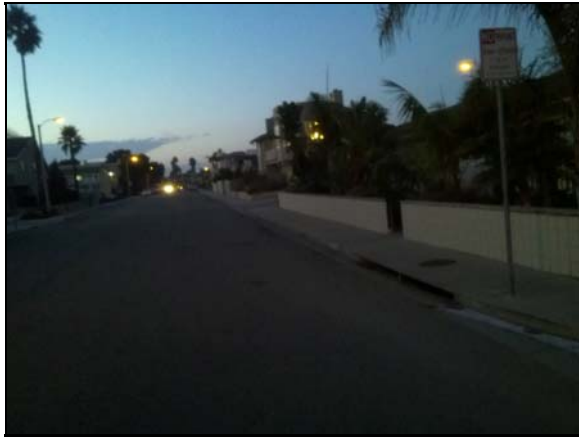
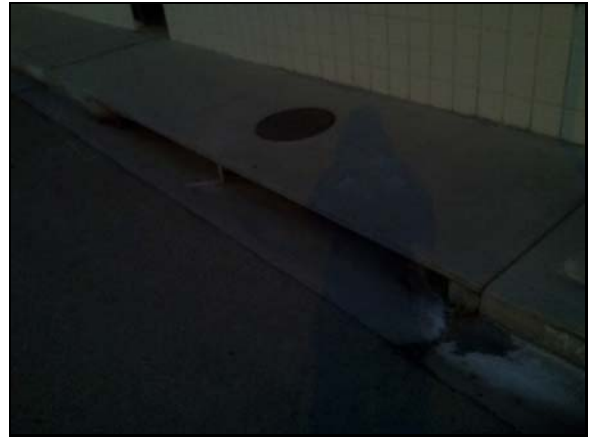
Catch Basin CB-E25-300

Susceptible to burial/overgrowth: No
Susceptible to ponding/flooding: Yes
Sediment/debris depth (%): 0
Type of sediment/debris: None
Infiltration in structure: None
Obstruction/deflection: 0.0
VANDA Condition Rating: Level 1 - No Damage
Prioritization Rating: Level 1 - Excellent
Prioritization Rationale: Condition
Illegal dumping evidence: No

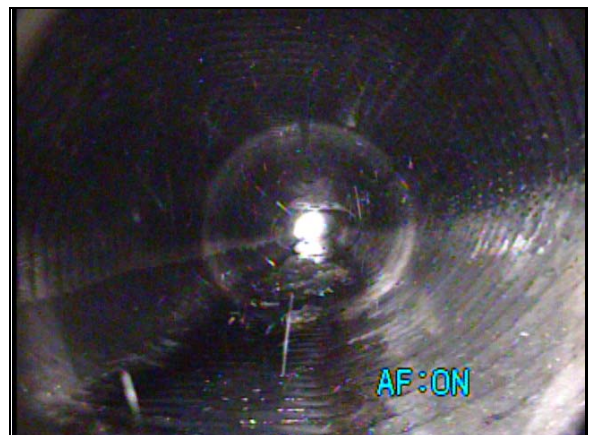
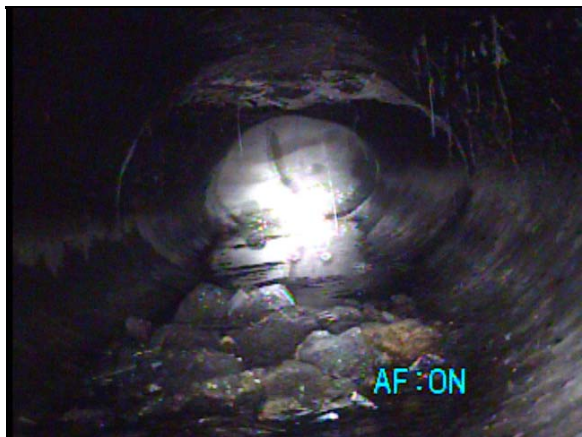
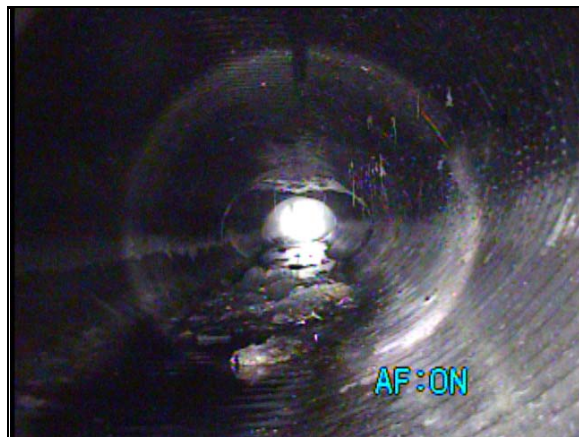
Catch Basin CB-E25-300

Pipe	Dir.	Hdn g	Dia. (in.)	Mat'l	Rim-inv (ft.)	Wtr Lvl (%)	Sed. (%)	Sed. Type	Infil-tration	Obs/Dfl. (%)	VANDA Rating	Priority Rating	Priority Rationale	Notes
CB-E25-300_CB-E25-301	Out	W	36	CMP	4.2	5	10	Silt/Rock	None	5	Level 3 - Moderate Damage	Level 4 - Poor	Condition/Location	Under roadway.

View inside outlet pipe

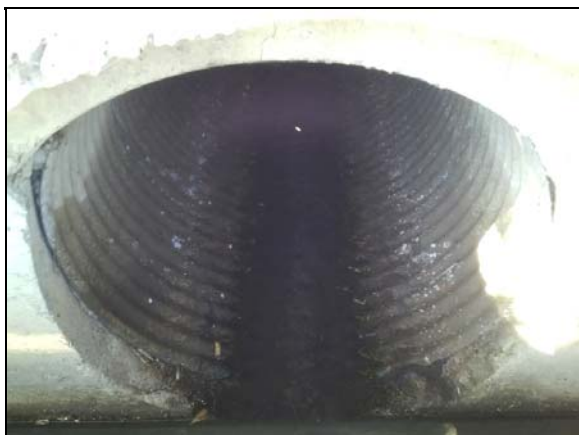
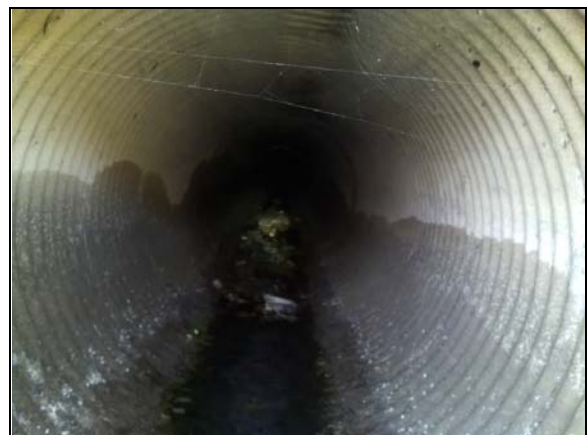
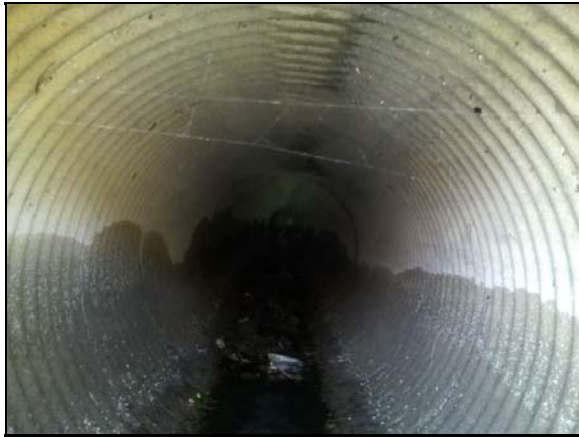
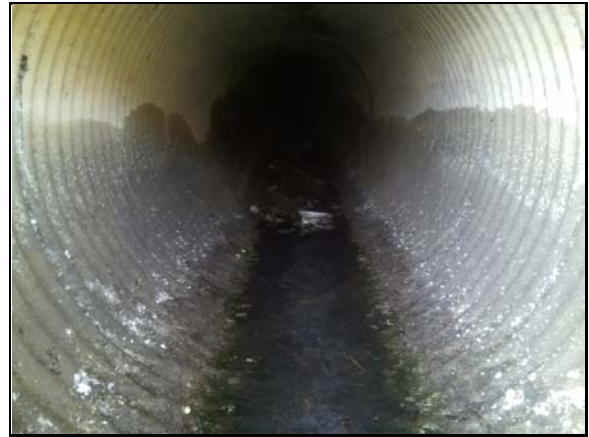
Catch Basin CB-E25-301

Pipe	Dir.	Hdn g	Dia. (in.)	Mat'l	Rim-inv (ft.)	Wtr Lvl (%)	Sed. (%)	Sed. Type	Infil- tration	Obs/Dfl. (%)	VANDA Rating	Priority Rating	Priority Rationale	Notes
CB-E25-300_CB-E25-301	In	W	36	CMP	4.7	10	10	Silt/Rock	None	0	Level 3 - Moderate Damage	Level 4 - Poor	Condition/Loc ation	Under roadway.
CB-E25-301_CB-E25-302	Out	W	48	CMP	4.7	5	5	Silt/Rock	None	0	Level 3 - Moderate Damage	Level 4 - Poor	Condition/Loc ation	Under residences.

View of outlet

View inside outlet pipe

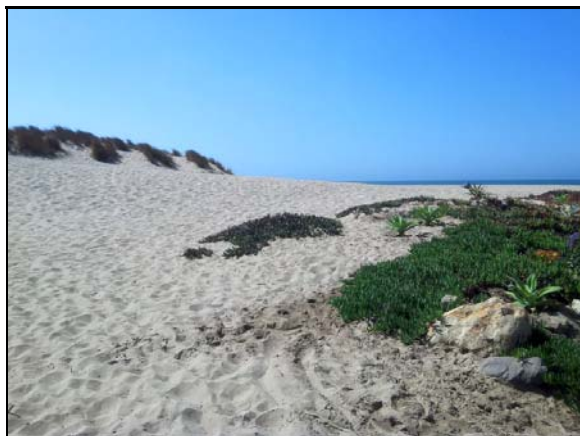
Flooding may be due to tidal influence. Area appears to slope towards ocean.

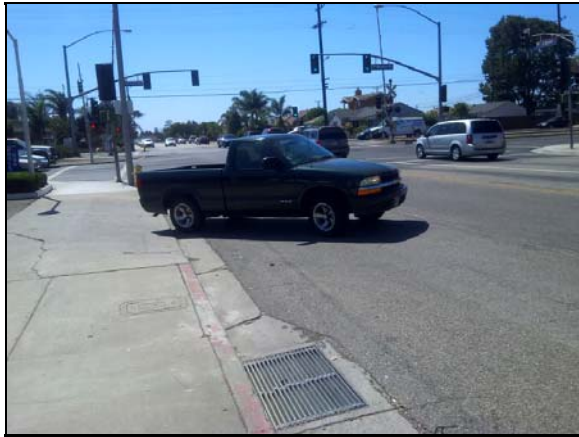
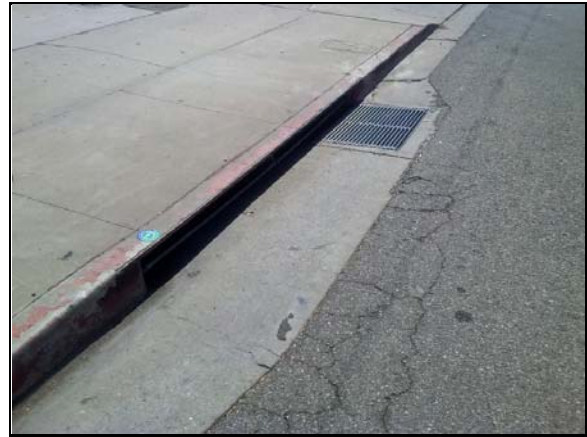
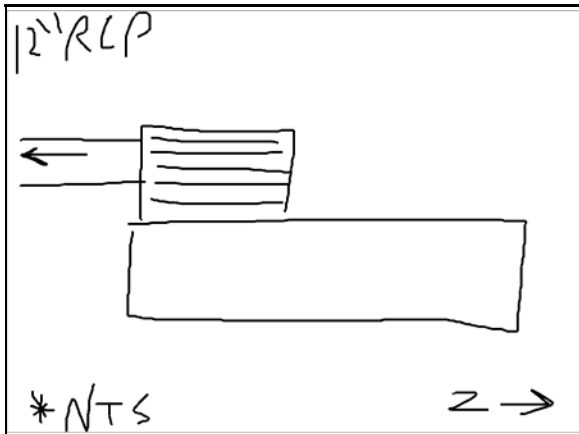
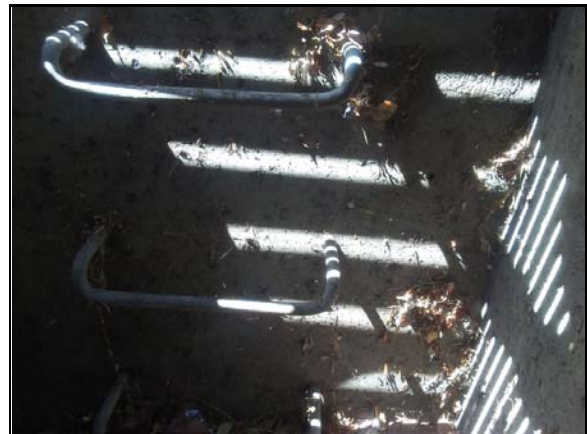
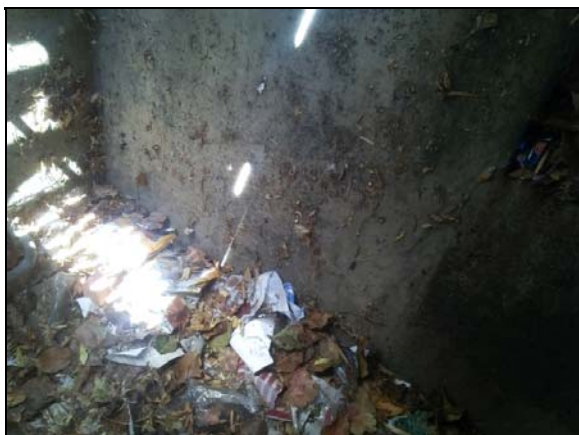
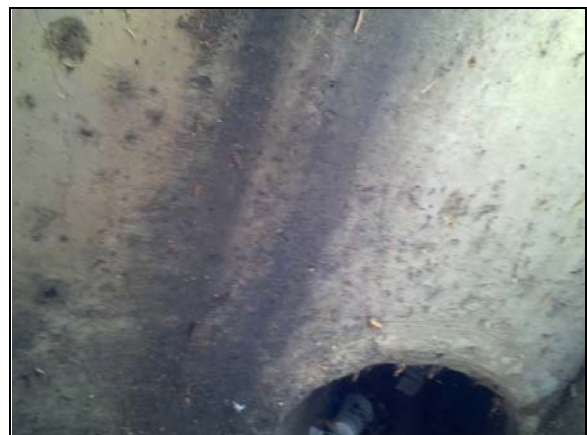
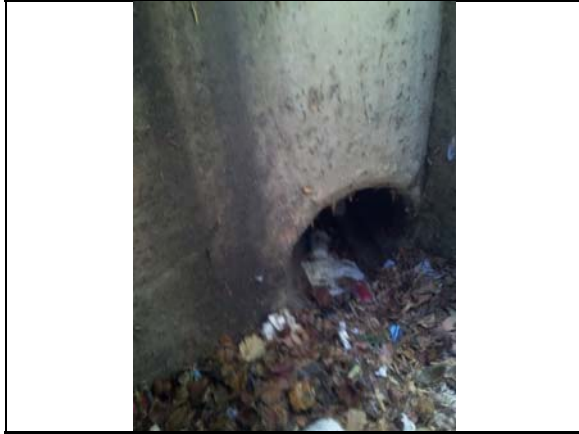
Catch Basin CB-M24-300

Susceptible to burial/overgrowth: No
Susceptible to ponding/flooding: No
Sediment/debris depth (%): 10
Type of sediment/debris: Vegetation/Trash
Infiltration in structure: None
Obstruction/deflection: 0.0
VANDA Condition Rating: Level 1 - No Damage
Prioritization Rating: Level 2 - Good
Prioritization Rationale: Condition/Other
Illegal dumping evidence: No

Pipe	Dir.	Hdn g	Dia. (in.)	Mat'l	Rim-inv (ft.)	Wtr Lvl (%)	Sed. (%)	Sed. Type	Infil-tration	Obs/Dfl. (%)	VANDA Rating	Priority Rating	Priority Rationale	Notes
CB-M24-300_CB-M24-302	Out	S	12	RCP	4.2	0	5	Trash	None	0	Level 1 - No Damage	Level 1 - Excellent	Condition

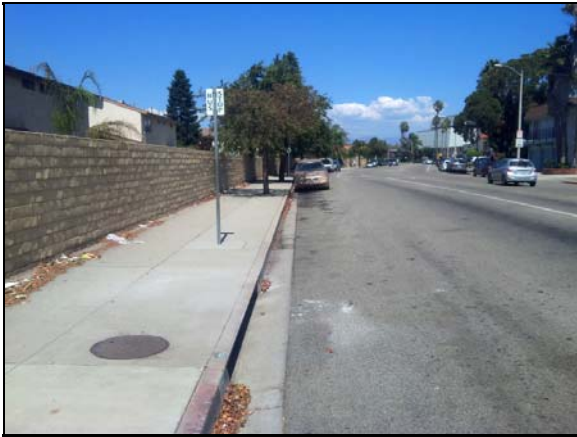
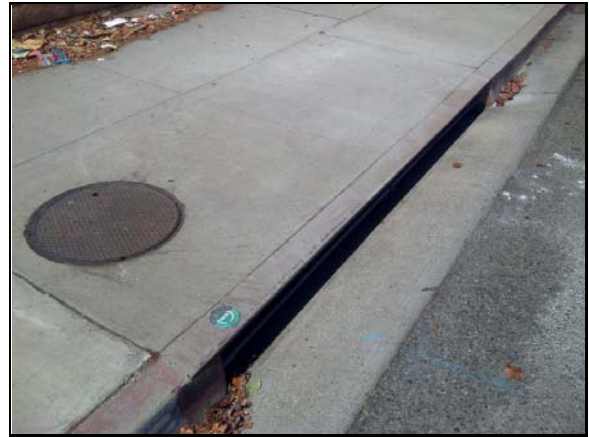
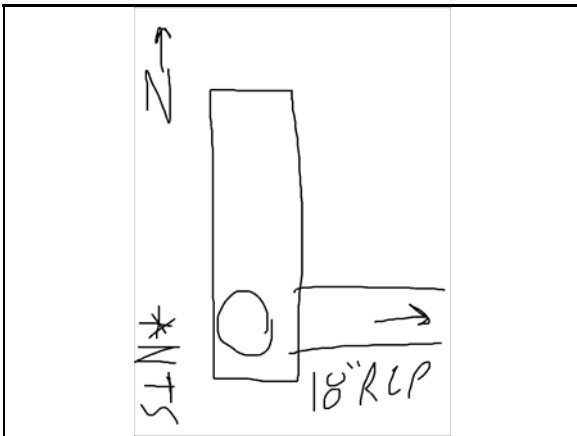
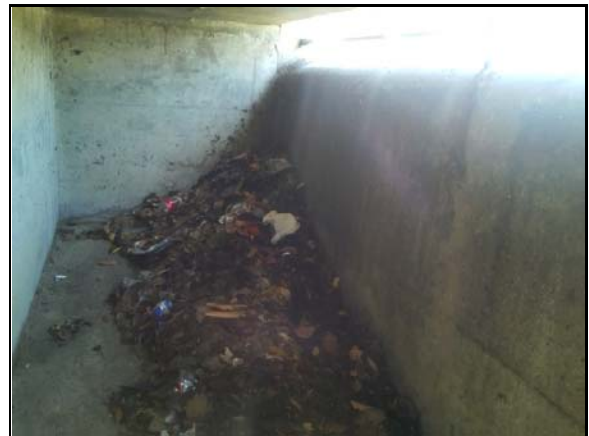
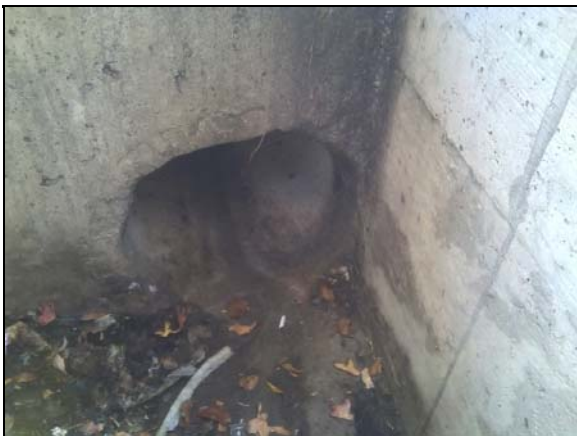
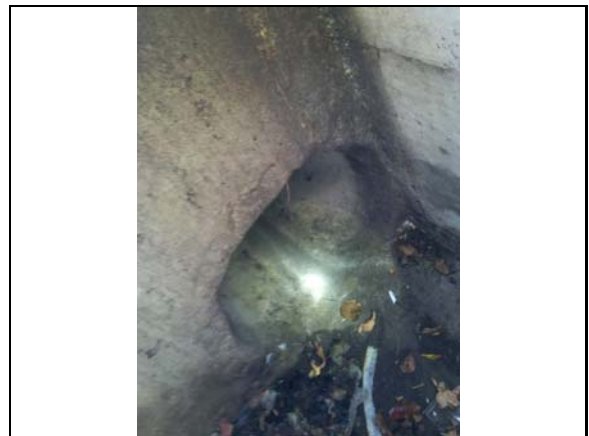
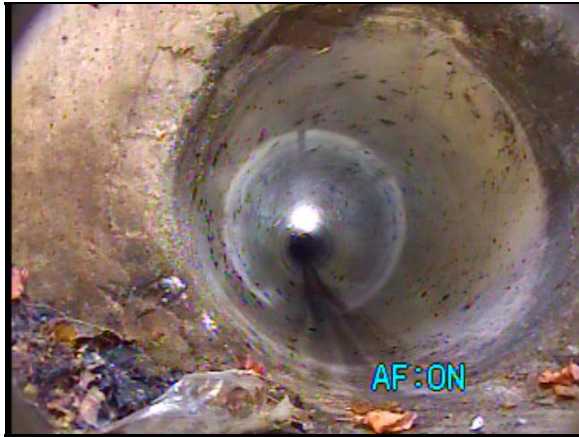
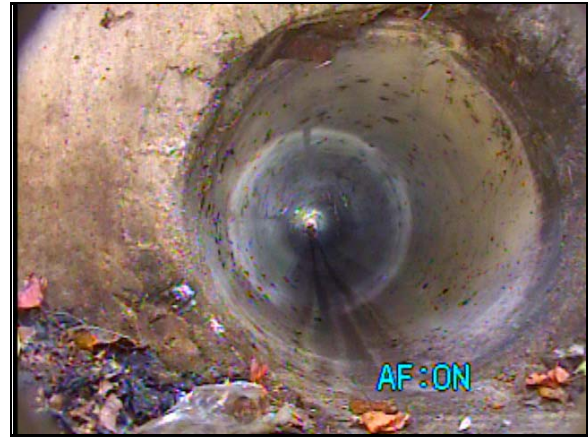
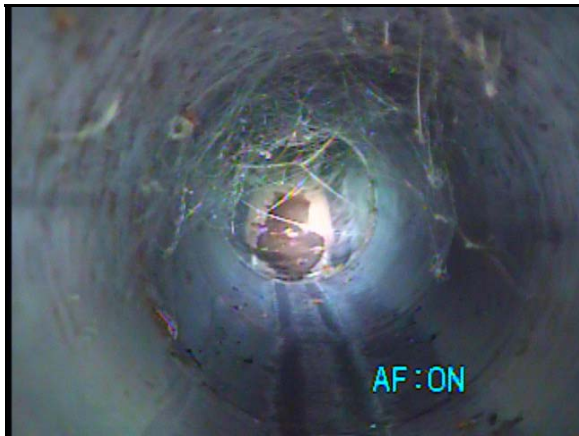
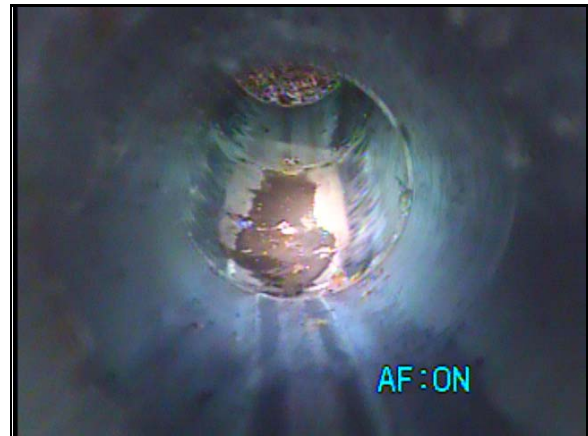
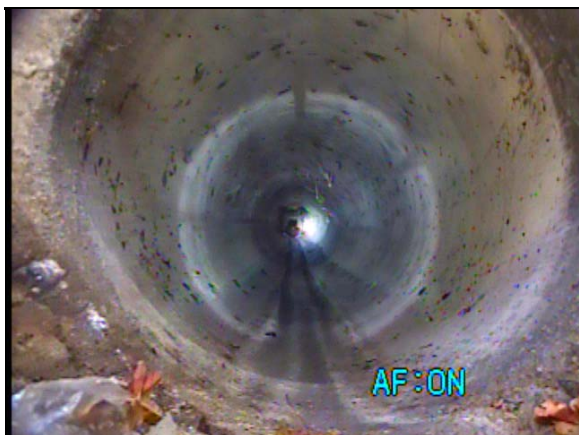
Catch Basin CB-M24-301

Susceptible to burial/overgrowth: No
Susceptible to ponding/flooding: No
Sediment/debris depth (%): 10.0
Type of sediment/debris: Vegetation/Trash
Infiltration in structure: None
Obstruction/deflection: 0
VANDA Condition Rating: Level 1 - No Damage
Prioritization Rating: Level 1 - Excellent
Prioritization Rationale: Condition
Illegal dumping evidence: No

Pipe	Dir.	Hdn g	Dia. (in.)	Mat'l	Rim-inv (ft.)	Wtr Lvl (%)	Sed. (%)	Sed. Type	Infil-tration	Obs/Dfl. (%)	VANDA Rating	Priority Rating	Priority Rationale	Notes
CB-M24-301_CB-M24-302	Out	E	18	RCP	4.2	0	0	None	None	0	Level 1 - No Damage	Level 1 - Excellent	Condition	Under roadway. Water ponding at low point.

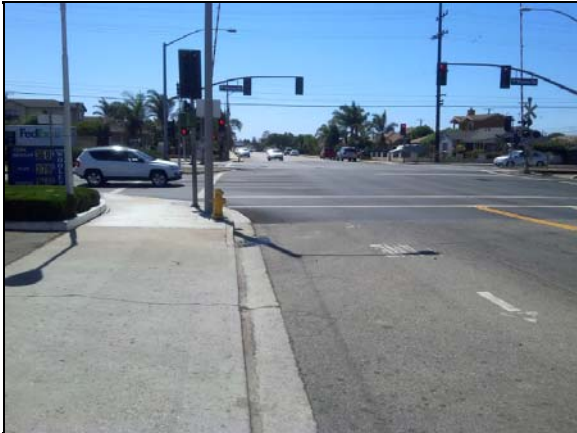
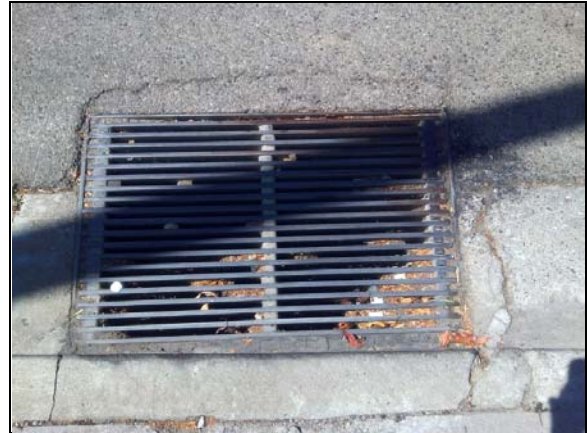
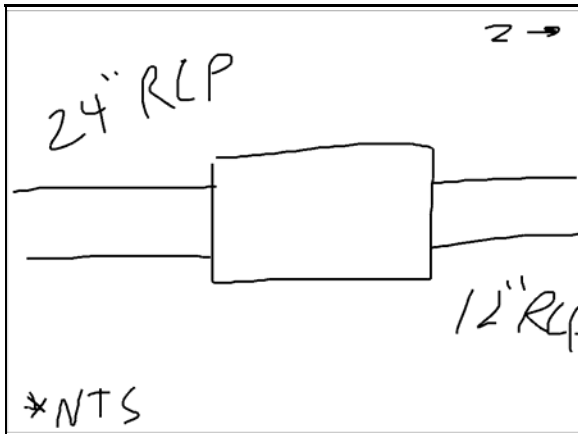
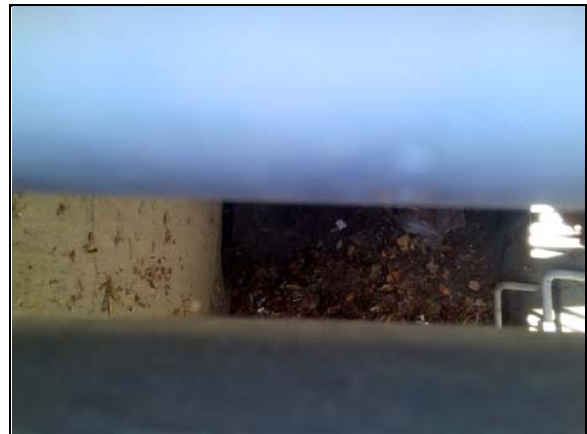
Susceptible to burial/overgrowth: No
Susceptible to ponding/flooding: No
Sediment/debris depth (%): 5
Type of sediment/debris: Silt/Vegetation
Infiltration in structure: None
Obstruction/deflection: 0.0
VANDA Condition Rating: Unknown
Prioritization Rating: Level 2 - Good
Prioritization Rationale: Condition/Location
Illegal dumping evidence: No

Pipe	Dir.	Hdn g	Dia. (in.)	Mat'l	Rim-inv (ft.)	Wtr Lvl (%)	Sed. (%)	Sed. Type	Infiltration	Obs/Dfl. (%)	VANDA Rating	Priority Rating	Priority Rationale	Notes
CB-M24-302_JS-M24-500	Out	S	Unknown	Unknown	6	0		Unknown	Unknown		Unknown	Level 3 - Fair	Condition/Location	Under roadway.

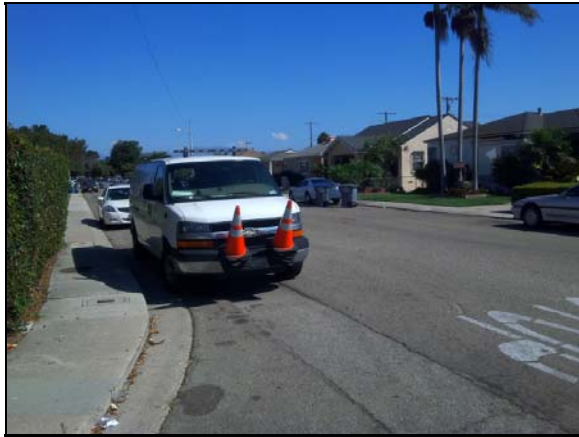
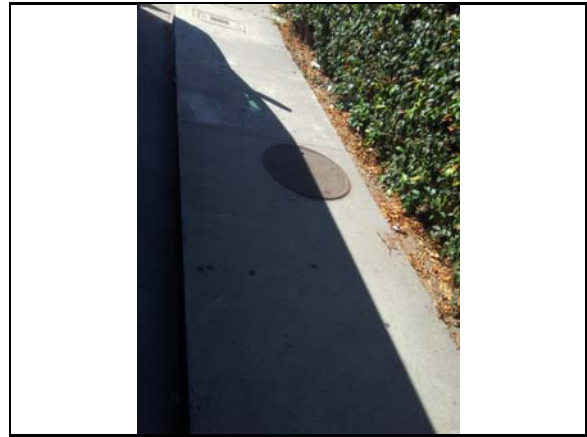
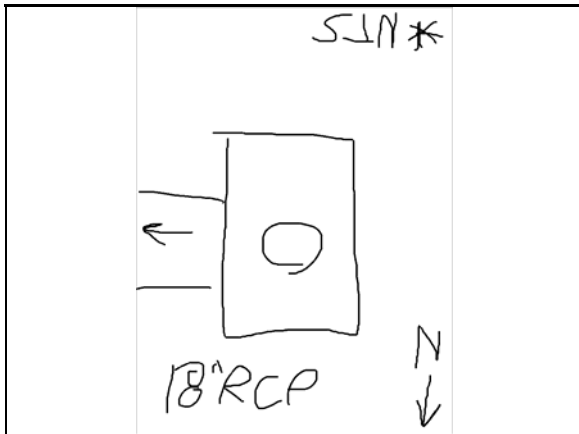
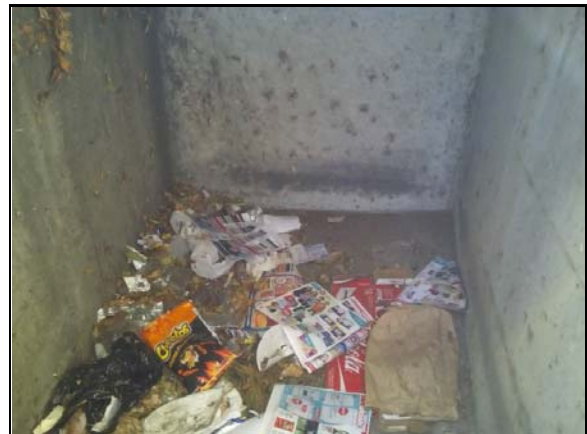
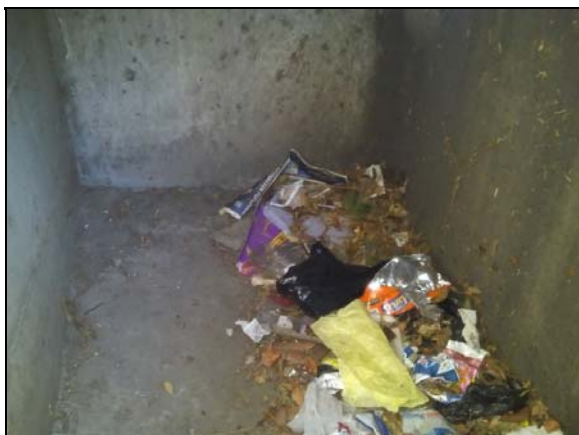
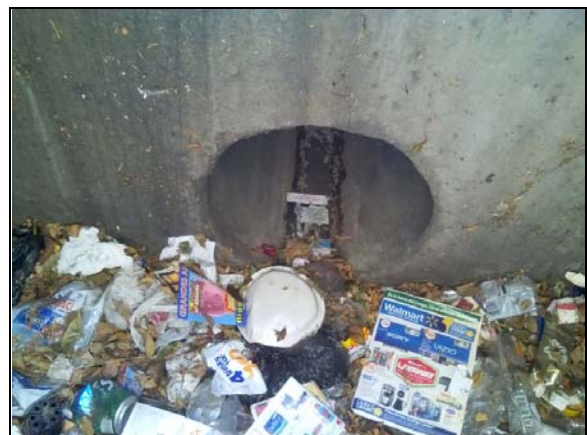
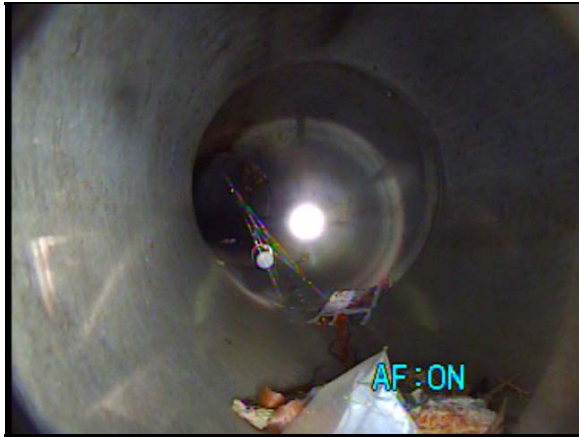
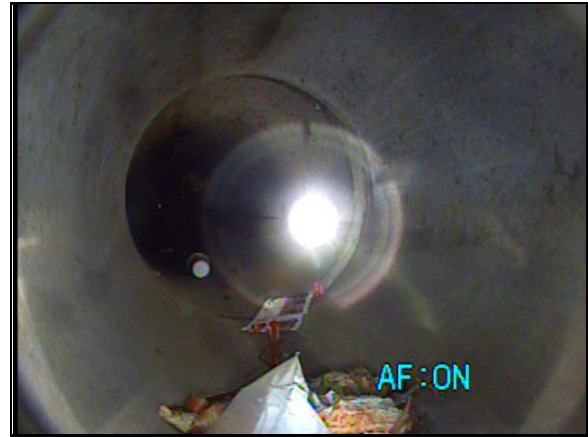
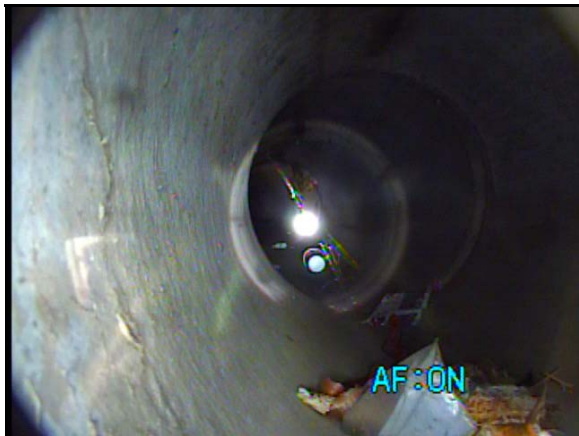
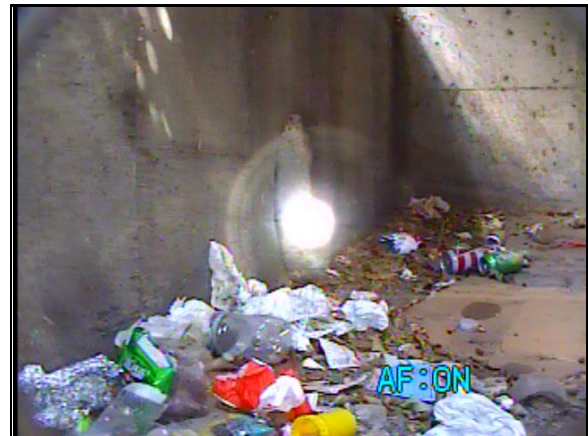
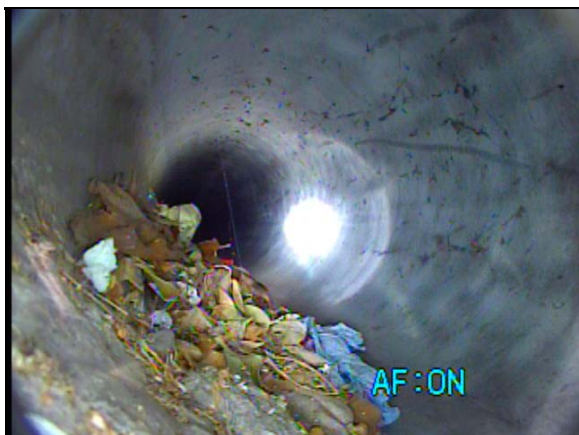
Catch Basin CB-M24-308

Susceptible to burial/overgrowth: No
Susceptible to ponding/flooding: No
Sediment/debris depth (%): 10
Type of sediment/debris: Silt/Vegetation/Trash
Infiltration in structure: None
Obstruction/deflection: 0.0
VANDA Condition Rating: Level 1 - No Damage
Prioritization Rating: Level 1 - Excellent
Prioritization Rationale: Condition
Illegal dumping evidence: No

Pipe	Dir.	Hdn g	Dia. (in.)	Mat'l	Rim-inv (ft.)	Wtr Lvl (%)	Sed. (%)	Sed. Type	Infil- tration	Obs/Dfl. (%)	VANDA Rating	Priority Rating	Priority Rationale	Notes
CB-M24-307_CB-M24-308	In	E	18	RCP	5.25	0	5	Trash	None	0	Level 1 - No Damage	Level 1 - Excellent	Condition	Under roadway.
CB-M24-308_CB-M24-316	Out	S	18	RCP	5.25	0	5	Trash	None	0	Level 1 - No Damage	Level 1 - Excellent	Condition

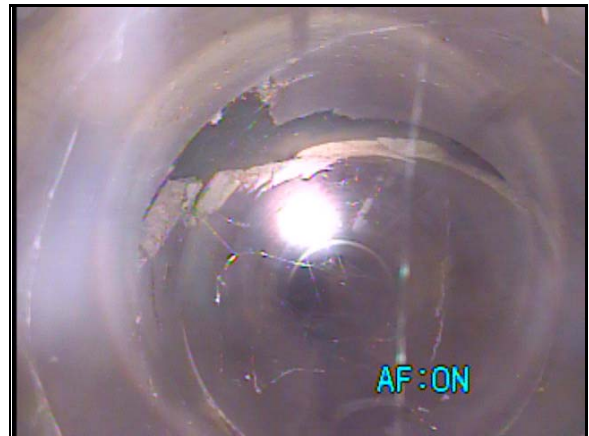
Catch Basin CB-M24-313

Pipe	Dir.	Hdn g	Dia. (in.)	Mat'l	Rim-inv (ft.)	Wtr Lvl (%)	Sed. (%)	Sed. Type	Infil- tration	Obs/Dfl. (%)	VANDA Rating	Priority Rating	Priority Rationale	Notes
CB-M24-313_JS-M24-502	Out	S	18	RCP	2.8	0	0	None	None	0	Level 4 - Severe/Si gnificant Damage	Level 5 - Immediate Attention	Condition/Loc ation	Under roadway. Hole in pipe

Hole in pipe.

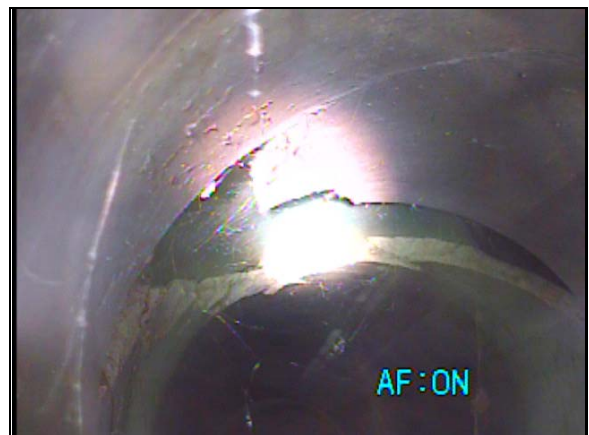
Catch Basin CB-M24-313

Hole in pipe.

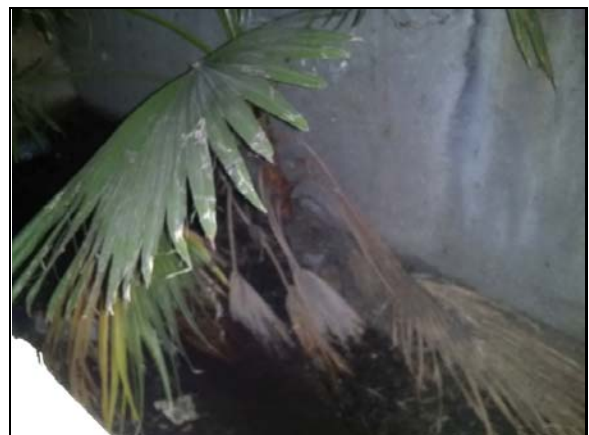
Tree growing inside catch basin

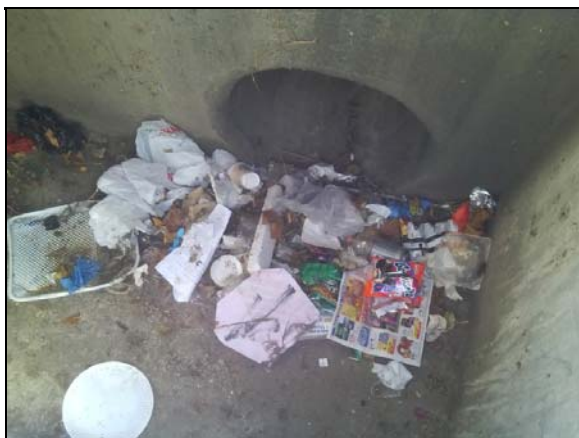
Pipe	Dir.	Hdn g	Dia. (in.)	Mat'l	Rim-inv (ft.)	Wtr Lvl (%)	Sed. (%)	Sed. Type	Infil-tration	Obs/Dfl. (%)	VANDA Rating	Priority Rating	Priority Rationale	Notes
CB-N24-302_MH-N24-100	Out	E	24	RCP	6	0	0	None	None	0	Level 1 - No Damage	Level 1 - Excellent	Condition	Under roadway.

View of outlet

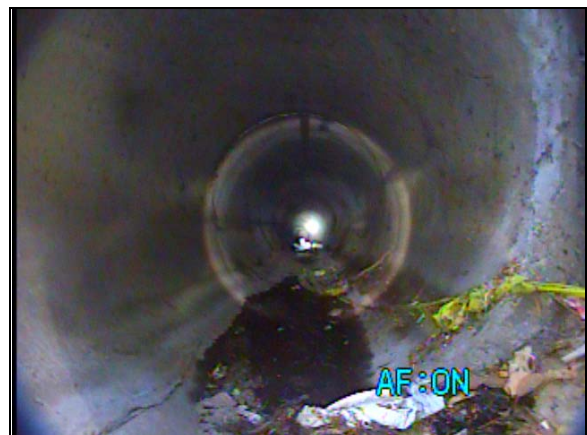
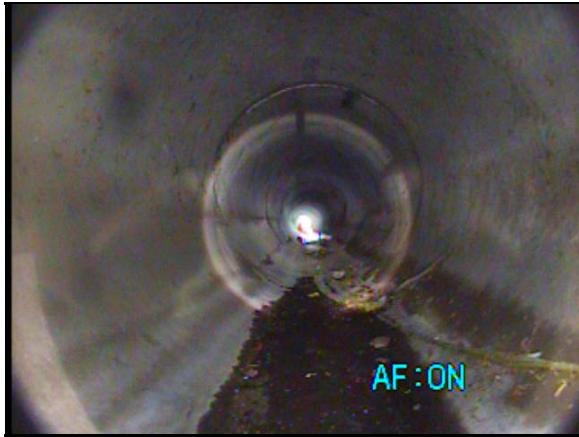
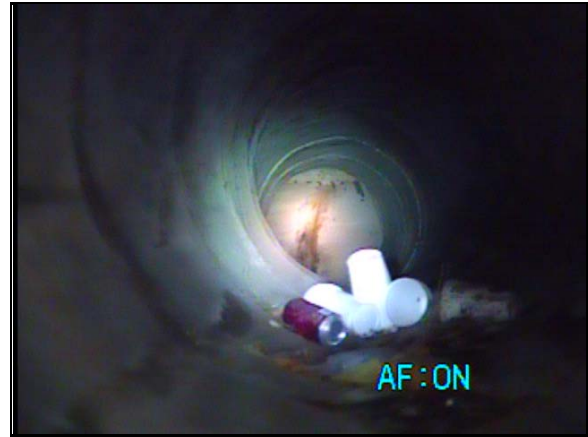
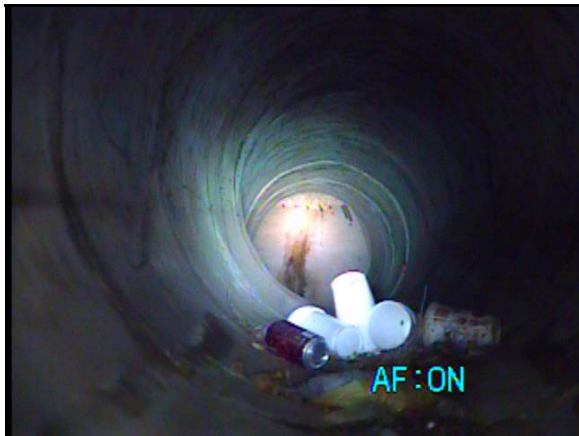
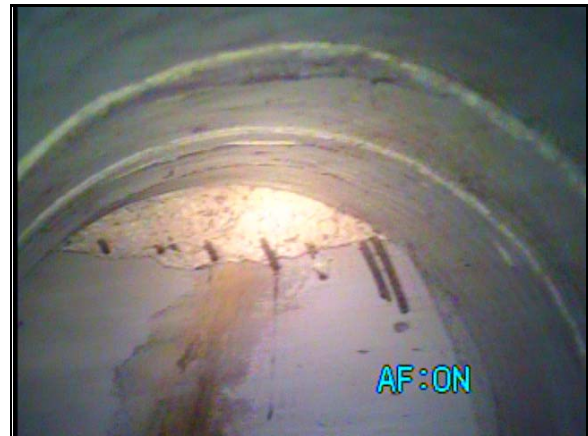
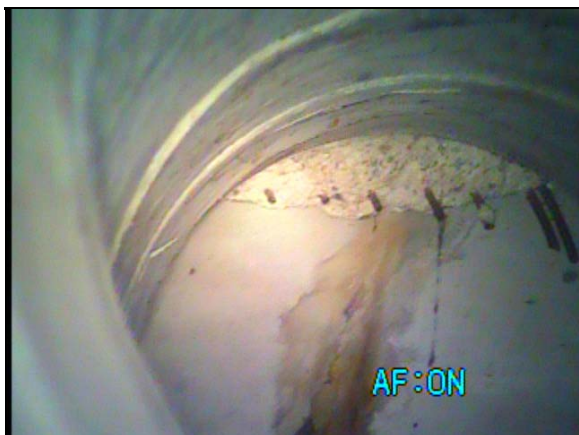
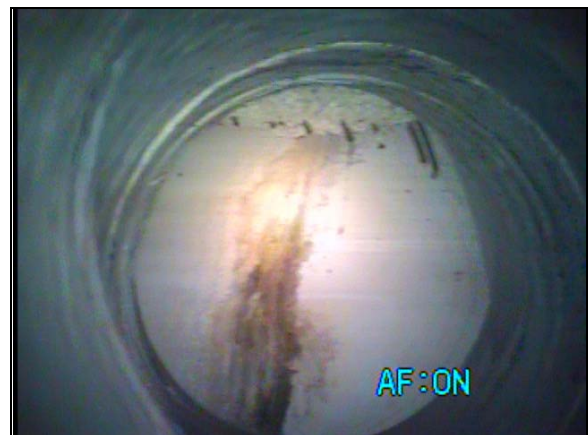
Pipe	Dir.	Hdn g	Dia. (in.)	Mat'l	Rim-inv (ft.)	Wtr Lvl (%)	Sed. (%)	Sed. Type	Infil- tration	Obs/Dfl. (%)	VANDA Rating	Priority Rating	Priority Rationale	Notes
CB-N24-303_MH-N24-103	Out	S	36	RCP	6.75	5	5	Trash	None	0	Level 2 - Minor Damage	Level 2 - Good	Condition	Appears to be staining and exposed reinforcing steel at end of pipe. Under roadway.
PL-N24-1200_PL-N24-1201	In	E	24	RCP	6.75	0	10	Trash	None	35	Level 2 - Minor Damage	Level 2 - Good	Condition/Sediment	Pipe is obstructed by plywood or concrete. Under roadway.

View inside outlet pipe

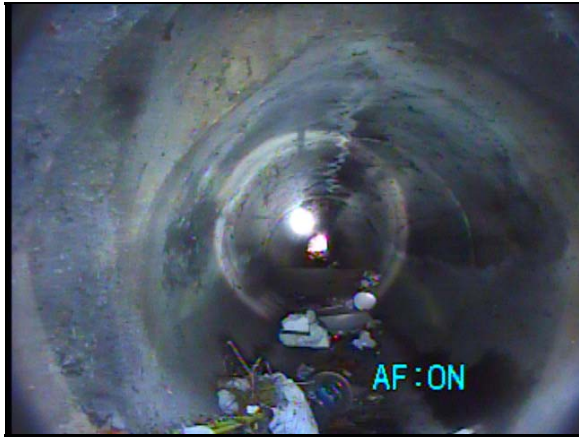
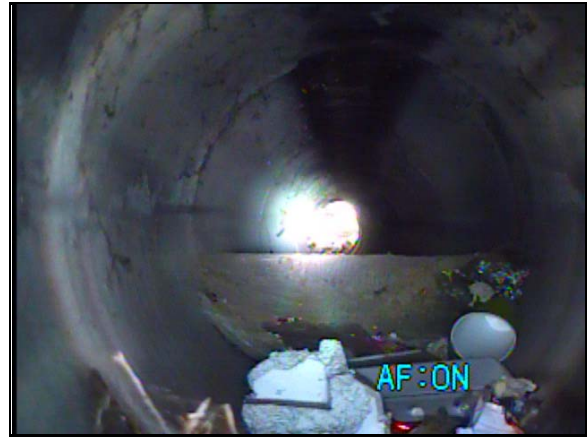
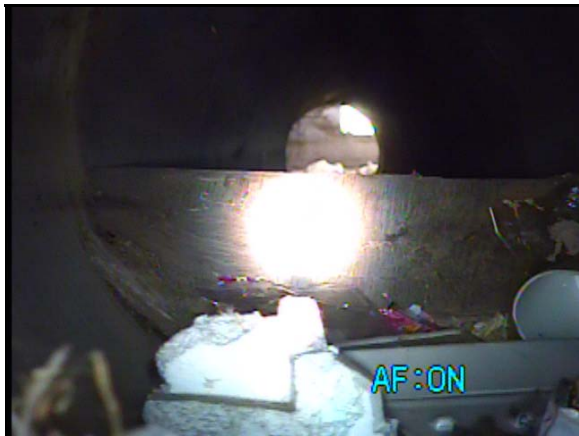
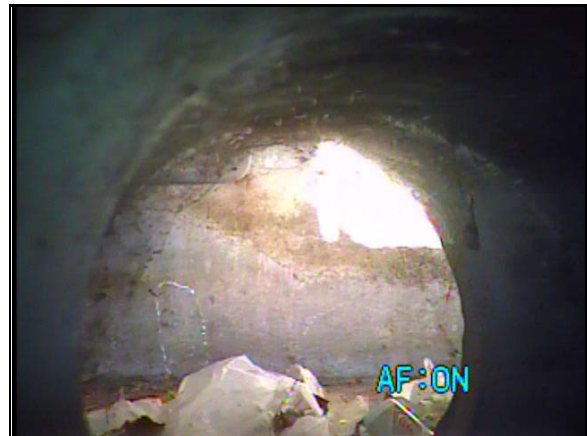
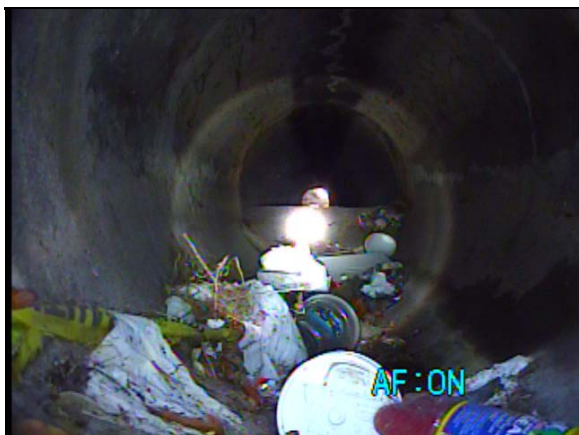
View inside inlet pipe

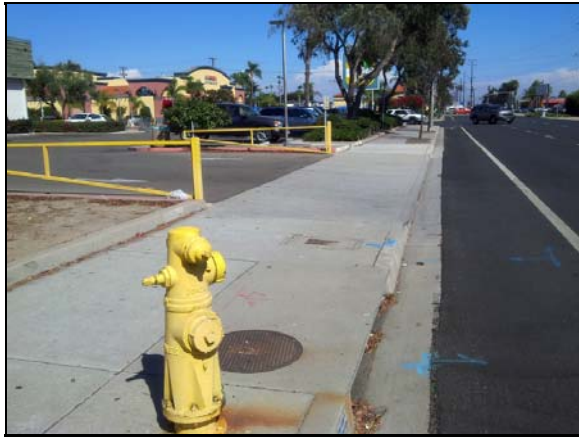
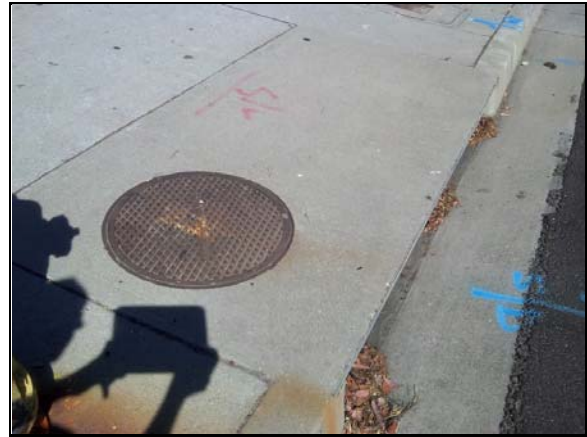
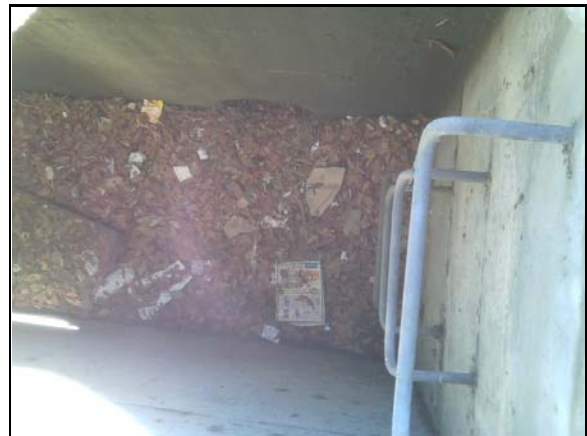
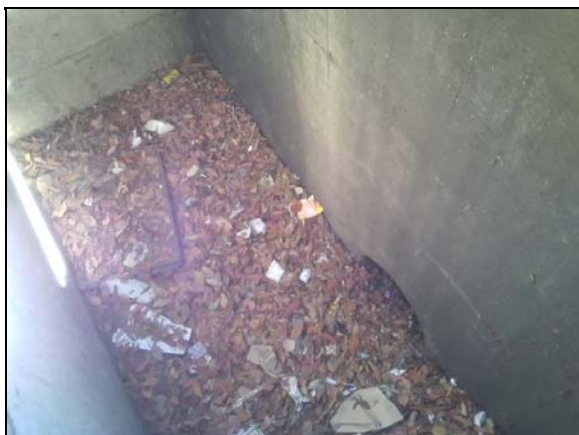
Catch Basin CB-N24-309

Susceptible to burial/overgrowth: No
Susceptible to ponding/flooding: No
Sediment/debris depth (%): 5
Type of sediment/debris: Silt/Vegetation/Trash
Infiltration in structure: None
Obstruction/deflection: 0.0
VANDA Condition Rating: Level 1 - No Damage
Prioritization Rating: Level 1 - Excellent
Prioritization Rationale: Condition
Illegal dumping evidence: No
