City of Oxnard

Public Works Integrated Master Plan

**PROJECT MEMORANDUM 5.3
CONDITION ASSESSMENT**

CITY OF OXNARD STORM DRAINAGE CONDITION ASSESSMENT

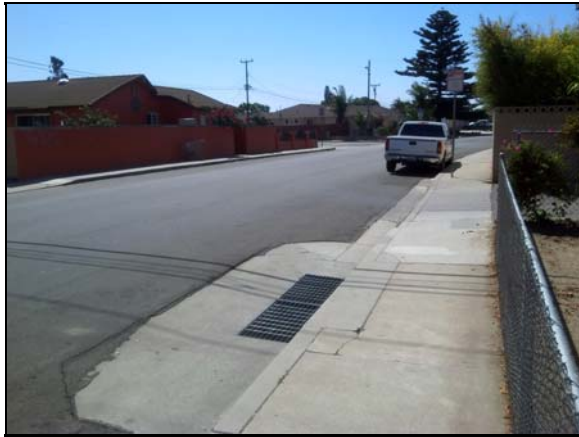
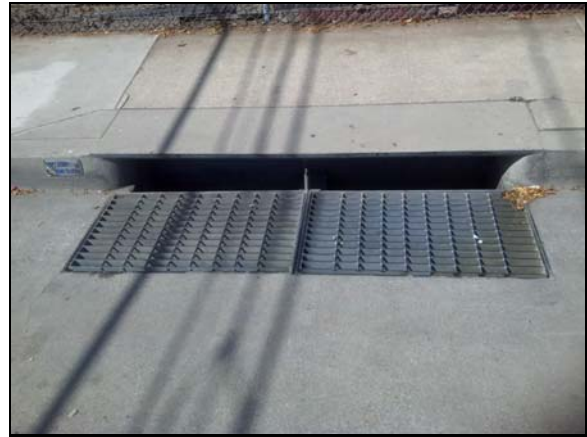
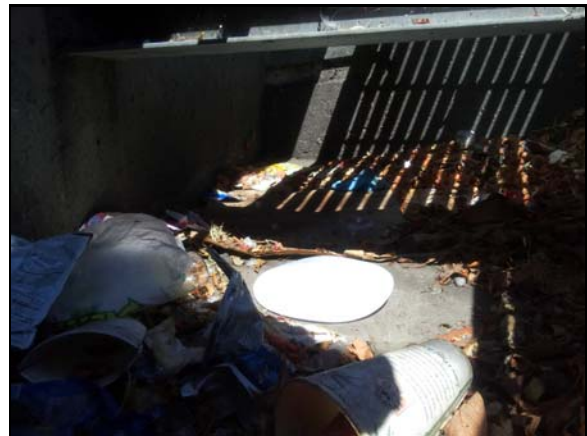
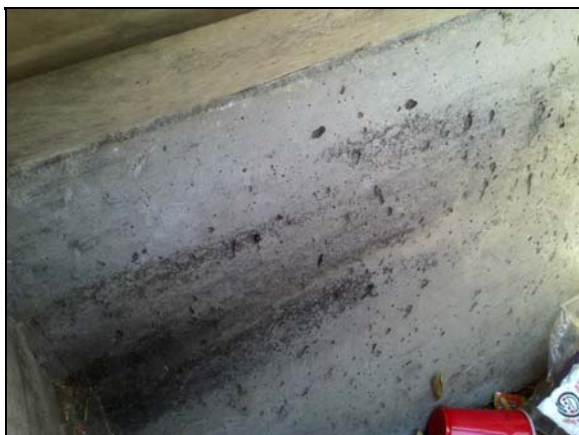
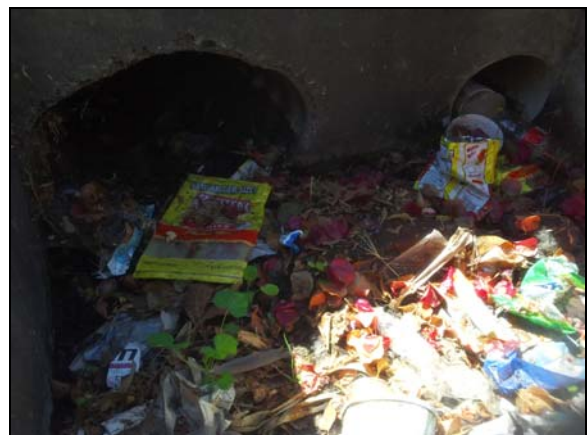
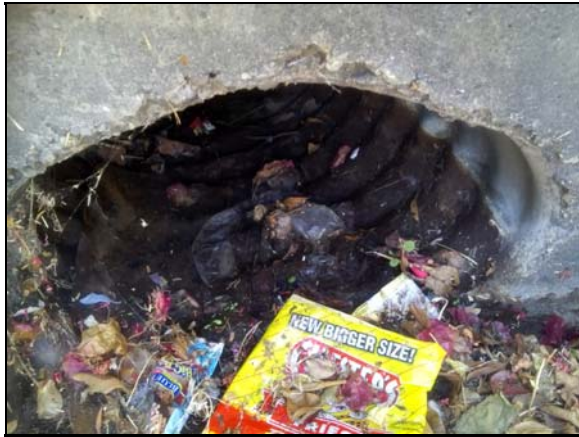
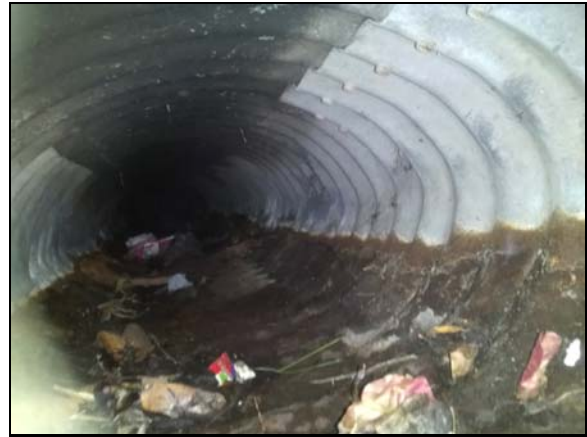
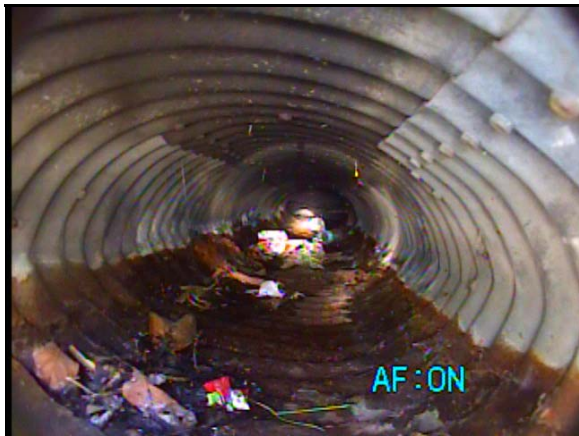
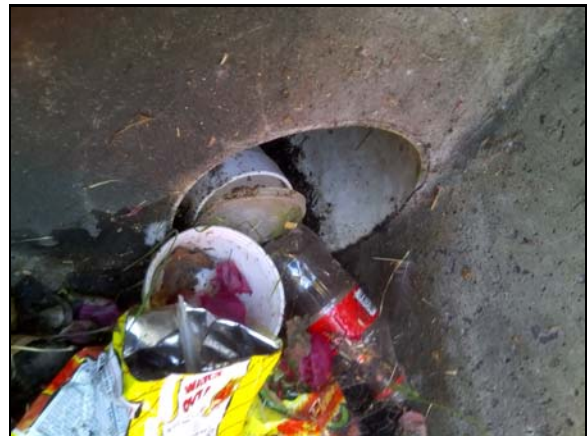
Catch Basin CB-P29-300

Susceptible to burial/overgrowth: No
Susceptible to ponding/flooding: No
Sediment/debris depth (%): 10
Type of sediment/debris: Vegetation/Trash
Infiltration in structure: None
Obstruction/deflection: 0.0
VANDA Condition Rating: Level 1 - No Damage
Prioritization Rating: Level 1 - Excellent
Prioritization Rationale: Condition
Illegal dumping evidence: No

Pipe	Dir.	Hdn g	Dia. (in.)	Mat'l	Rim-inv (ft.)	Wtr Lvl (%)	Sed. (%)	Sed. Type	Infiltration	Obs/Dfl. (%)	VANDA Rating	Priority Rating	Priority Rationale	Notes
CB-P29-300_JS-P29-500	Out	SE	12	CMP	2.3	0	5	Trash/Vegetation	None	0	Level 3 - Moderate Damage	Level 4 - Poor	Condition/Location	Under roadway.
S Inlet	In	N	8	RCP	2.2	0	0	None	None	0	Level 1 - No Damage	Level 1 - Excellent	Condition

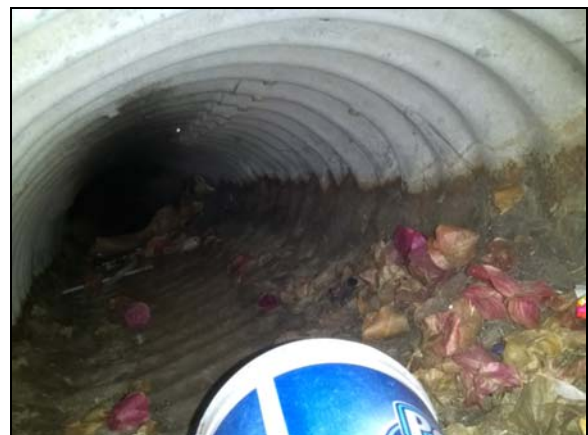
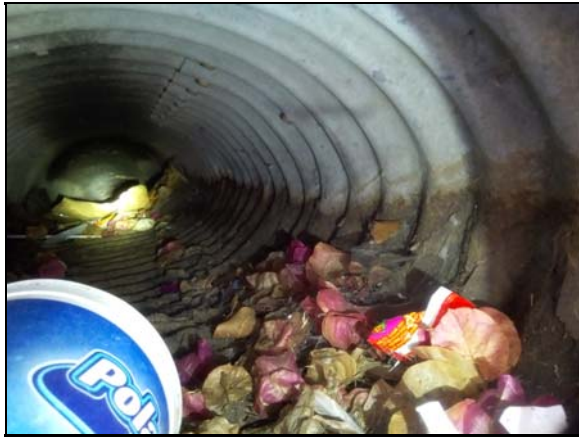
Catch Basin CB-P29-301

Pipe	Dir.	Hdn g	Dia. (in.)	Mat'l	Rim-inv (ft.)	Wtr Lvl (%)	Sed. (%)	Sed. Type	Infil-tration	Obs/Dfl. (%)	VANDA Rating	Priority Rating	Priority Rationale	Notes
CB-P29-301_JS-P29-501	Out	S	11H x 21W	CMP	2.2	0	5	Trash/Vegetation	None	0	Level 3 - Moderate Damage	Level 3 - Fair	Condition

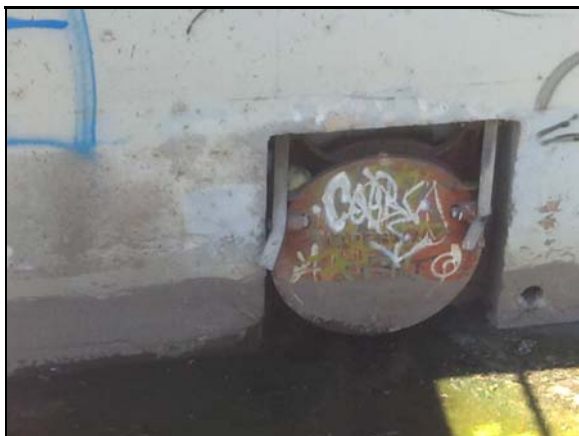
Location View

Unable to access to evaluate.

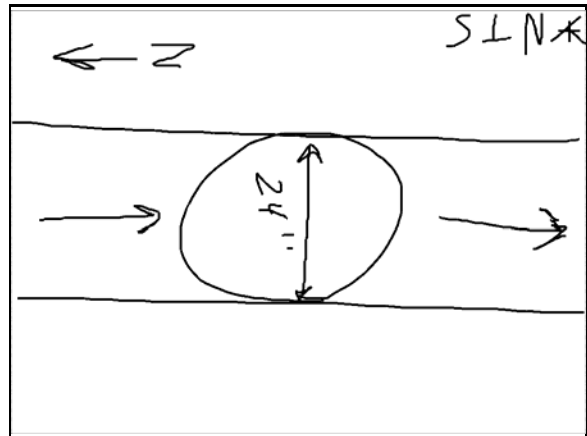
Sketch. North arrow is actually pointing West.

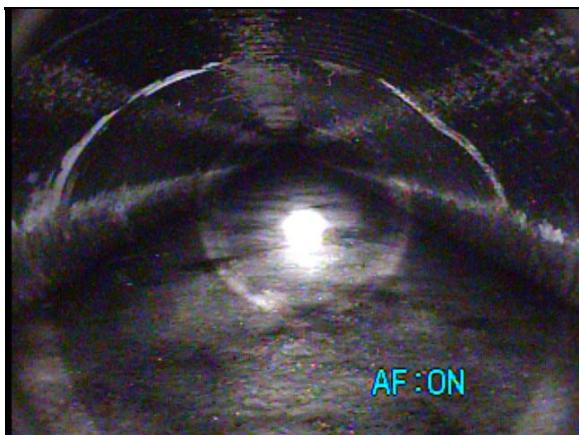
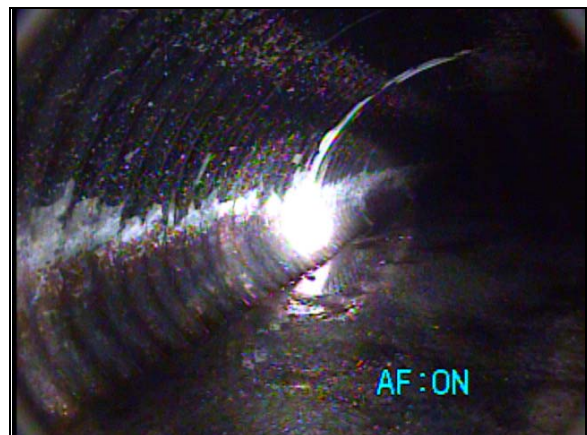
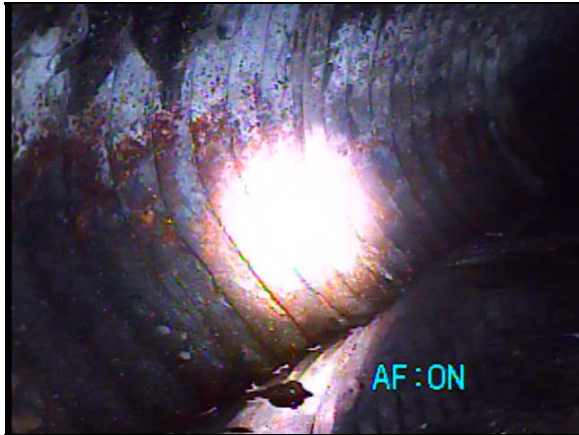
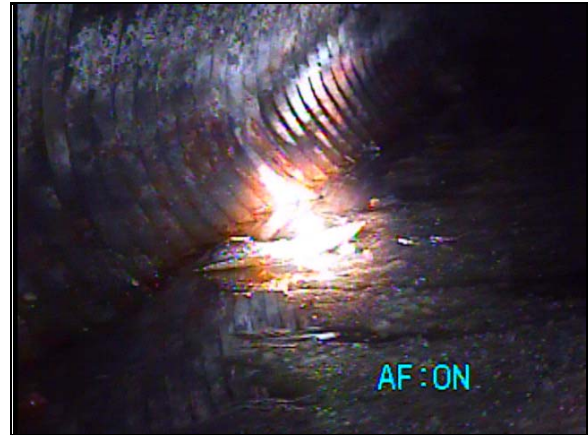
Manhole MH-S30-109

Pipe	Dir.	Hdn g	Dia. (in.)	Mat'l	Rim-inv (ft.)	Wtr Lvl (%)	Sed. (%)	Sed. Type	Infil-tration	Obs/Dfl. (%)	VANDA Rating	Priority Rating	Priority Rationale	Notes
MH-S30-109_MH-S30-108	In	E	30H x 48W	CMP	11.5	0	15	Silt/Gravel	None	0	Level 3 - Moderate Damage	Level 4 - Poor	Condition/Location	Arched CMP with moderate corrosion at areas where coal tar coating is missing. Under roadway.
MH-S30-110_MH-S30-109	Out	E	30H x 48W	CMP	11.5	0	15	Silt/Gravel	None	0	Level 3 - Moderate Damage	Level 4 - Poor	Condition/Location	Arched CMP with moderate corrosion at areas where coal tar coating is missing. Under roadway.

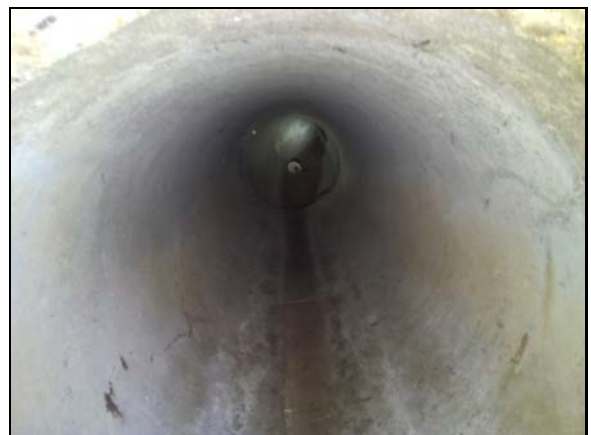
View inside pipe from inlet

Pipe	Dir.	Hdn g	Dia. (in.)	Mat'l	Rim-inv (ft.)	Wtr Lvl (%)	Sed. (%)	Sed. Type	Infil-tration	Obs/Dfl. (%)	VANDA Rating	Priority Rating	Priority Rationale	Notes
CB-K25-303_JS-K25-501	Out	W	18	RCP	2.8	0	0	None	None	0	Level 1 - No Damage	Level 1 - Excellent	Condition	Under roadway. Minor cracking in pipe near inlet.

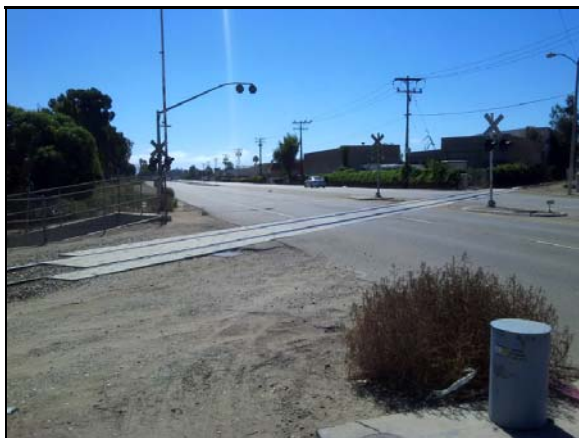
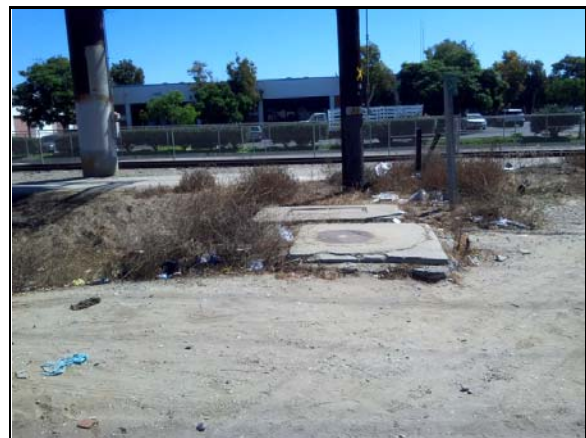
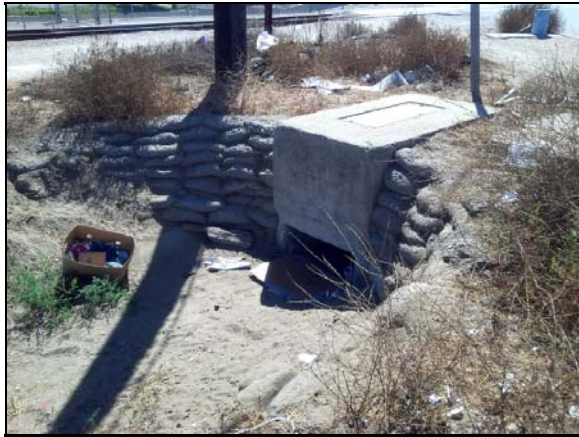
Culvert MIS-P25-812_JS-P25-509

Unable to evaluate due to person inhabiting structure. Under roadway.

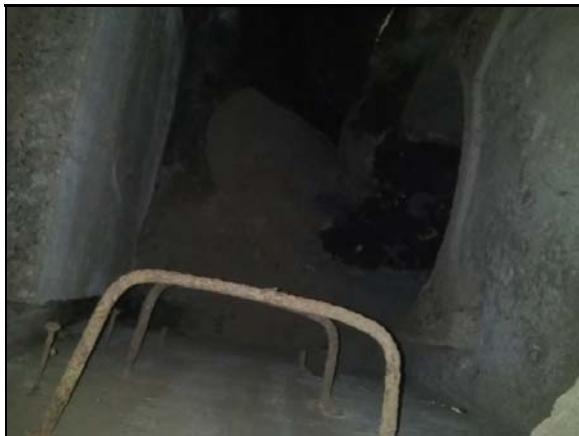
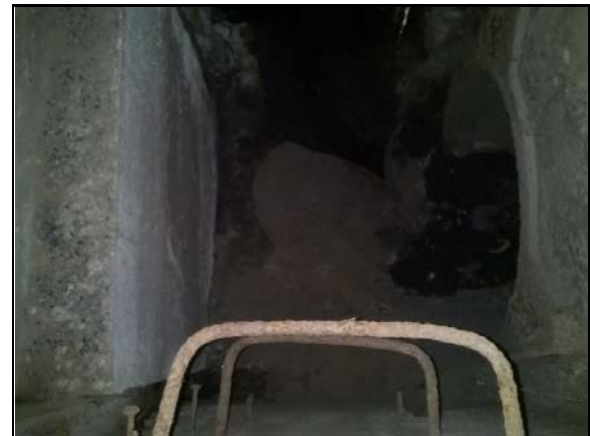
Broken flap gate at bottom of manhole.

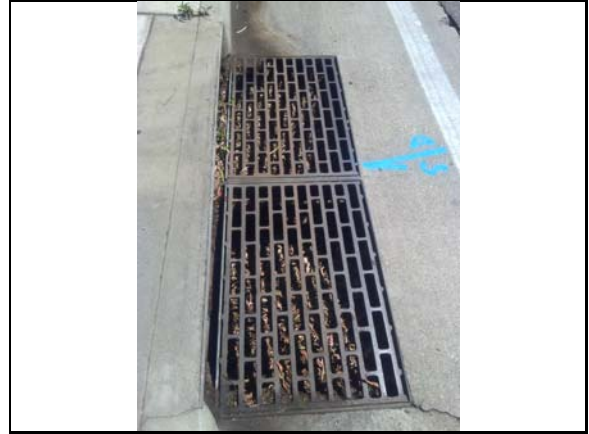
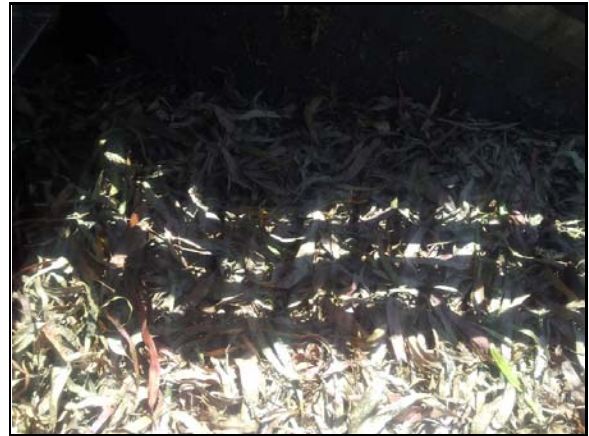
Susceptible to burial/overgrowth: No
Susceptible to ponding/flooding: No
Sediment/debris depth (%): 85
Type of sediment/debris: Vegetation
Infiltration in structure: None
Obstruction/deflection: 0.0
VANDA Condition Rating: Level 1 - No Damage
Prioritization Rating: Level 5 - Immediate Attention
Prioritization Rationale: Sediment/Location
Illegal dumping evidence: No

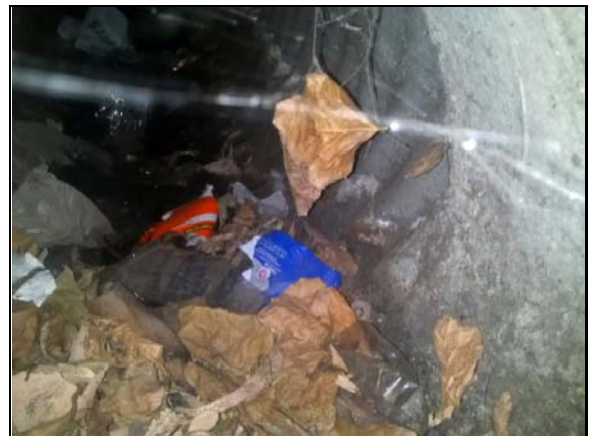
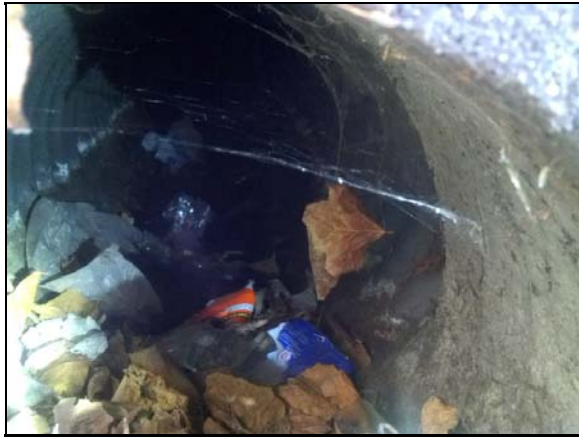
View inside outlet pipe

Pipe	Dir.	Hdn g	Dia. (in.)	Mat'l	Rim-inv (ft.)	Wtr Lvl (%)	Sed. (%)	Sed. Type	Infiltration	Obs/Dfl. (%)	VANDA Rating	Priority Rating	Priority Rationale	Notes
Outlet	Out	SW	12	CMP	2	0	20	Trash/Silt	None	0	Level 2 - Minor Damage	Level 3 - Fair	Condition/Location/Sediment	Under roadway. Loss of galvanization at invert.

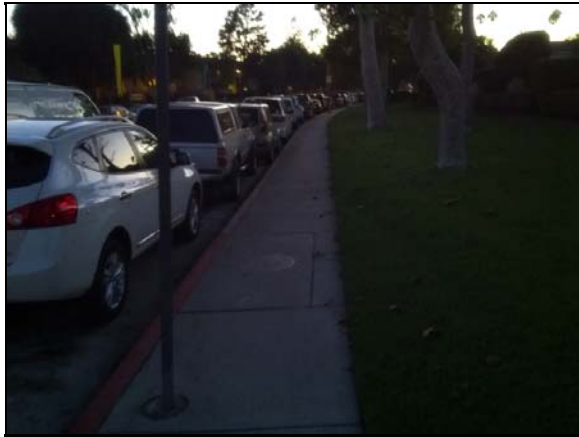
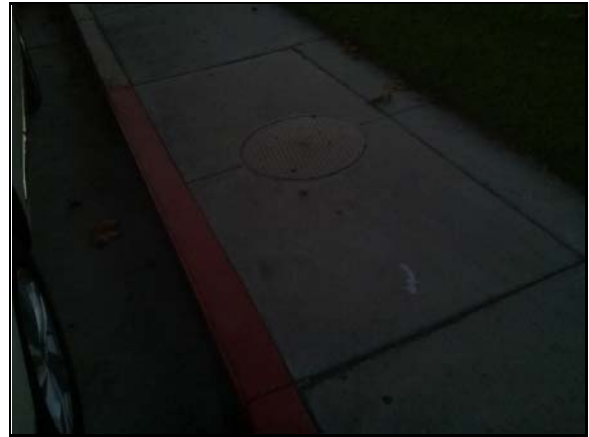
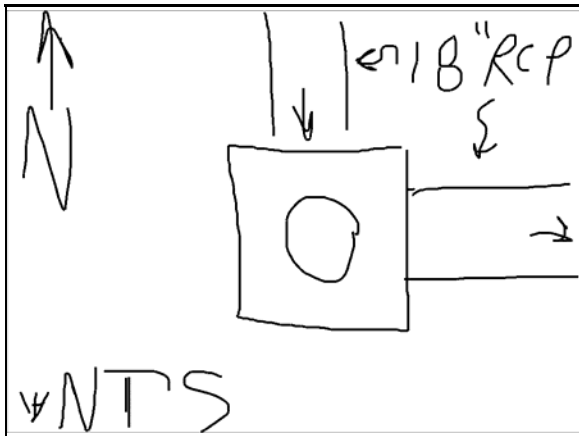
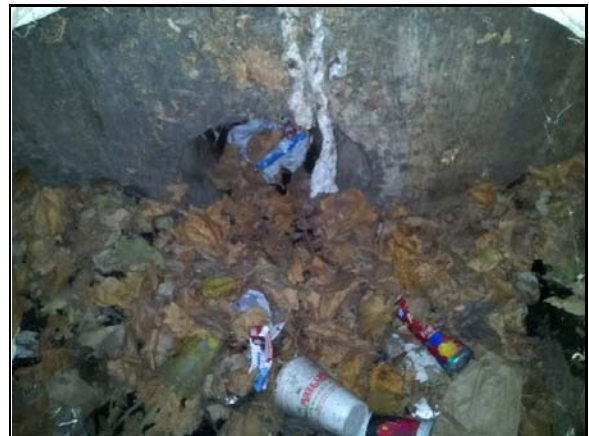
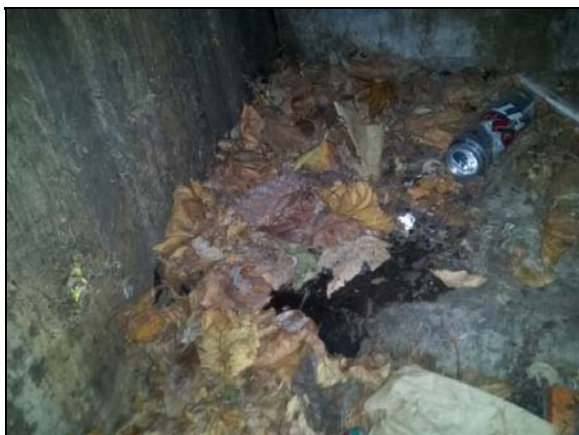
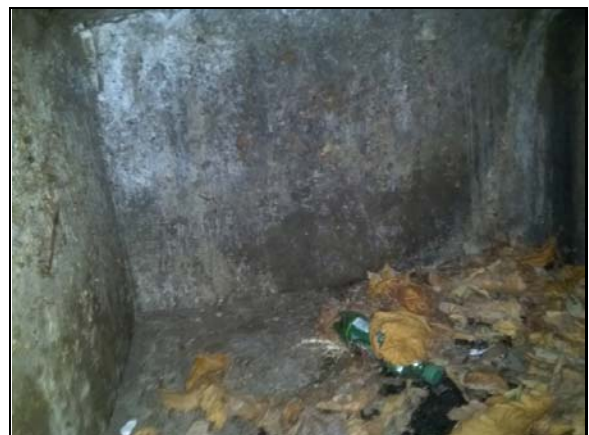
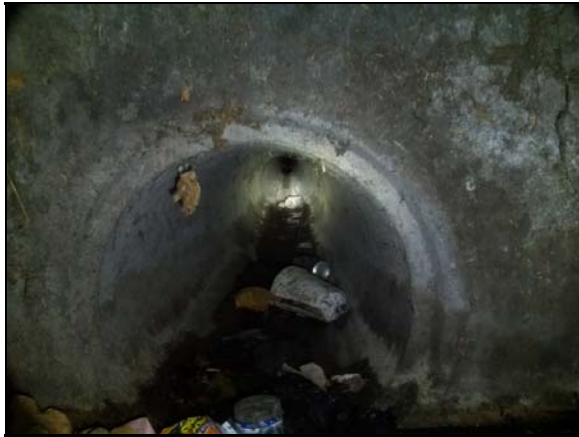
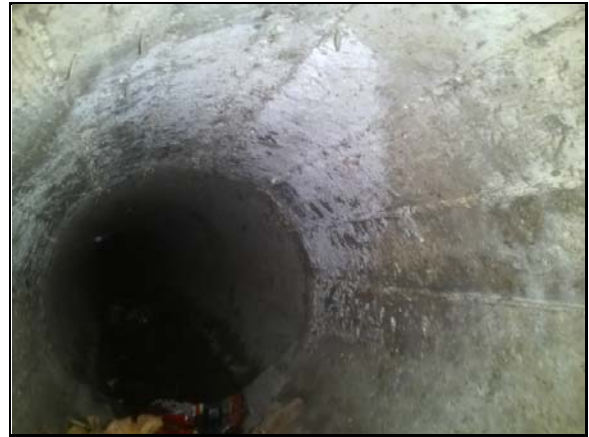
Catch Basin CB-N14-301

Susceptible to burial/overgrowth: No
Susceptible to ponding/flooding: No
Sediment/debris depth (%): 10
Type of sediment/debris: Silt/Vegetation/Trash
Infiltration in structure: None
Obstruction/deflection: 0.0
VANDA Condition Rating: Level 1 - No Damage
Prioritization Rating: Level 1 - Excellent
Prioritization Rationale: Condition
Illegal dumping evidence: No

Pipe	Dir.	Hdn g	Dia. (in.)	Mat'l	Rim-inv (ft.)	Wtr Lvl (%)	Sed. (%)	Sed. Type	Infil-tration	Obs/Dfl. (%)	VANDA Rating	Priority Rating	Priority Rationale	Notes
CB-N14-301_CB-N14-303	Out	S	18	RCP	4.3	0	5	Silt/Trash	None	0	Level 1 - No Damage	Level 1 - Excellent	Condition	Under roadway.

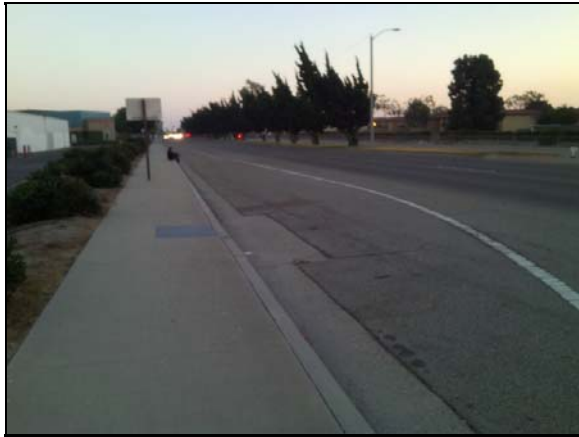
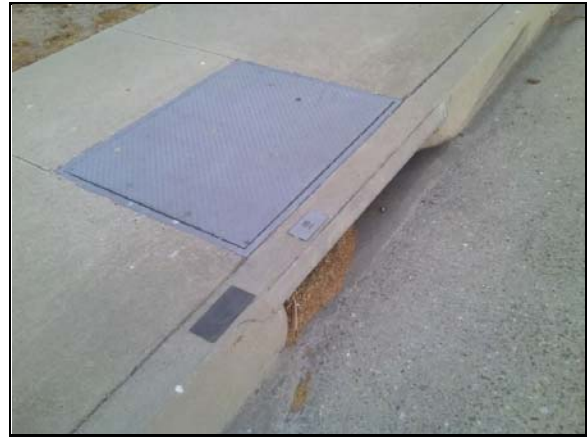
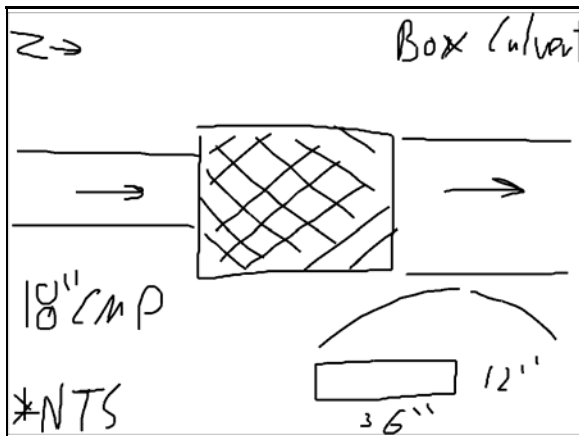
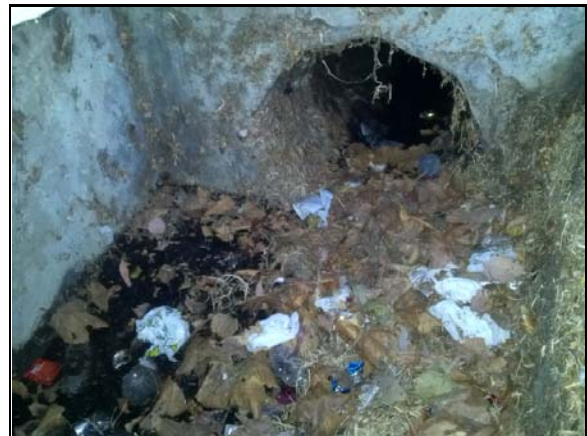
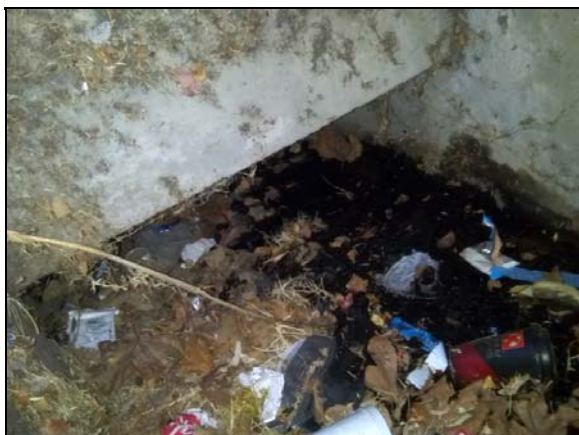
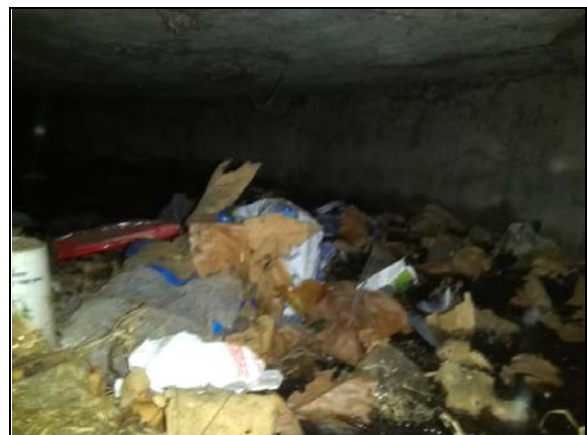
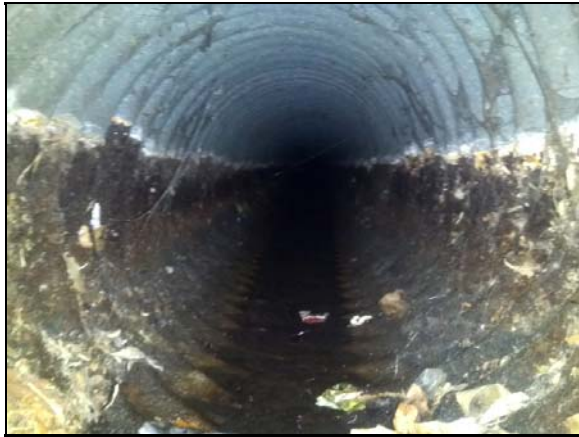
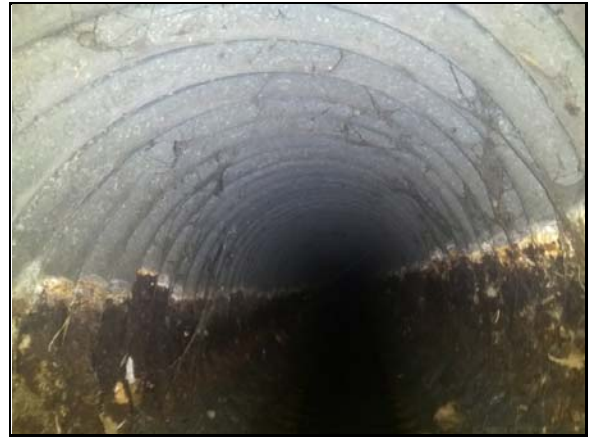
Catch Basin CB-N14-302

Susceptible to burial/overgrowth: No
Susceptible to ponding/flooding: No
Sediment/debris depth (%): 10
Type of sediment/debris: Silt/Trash/Vegetation
Infiltration in structure: None
Obstruction/deflection: 0.0
VANDA Condition Rating: Level 1 - No Damage
Prioritization Rating: Level 1 - Excellent
Prioritization Rationale: Condition
Illegal dumping evidence: No

Pipe	Dir.	Hdn g	Dia. (in.)	Mat'l	Rim-inv (ft.)	Wtr Lvl (%)	Sed. (%)	Sed. Type	Infil-tration	Obs/Dfl. (%)	VANDA Rating	Priority Rating	Priority Rationale	Notes
CB-N14-302_CR-N14-804	In	S	12H x 36W	RCB	2.5	0	15	Silt/Vegetation/Trash	None	0	Level 1 - No Damage	Level 1 - Excellent	Condition	Under roadway.
CR-N14-804_CB-N14-302	Out	S	18	CMP	2.5	0	0	None	None	0	Level 3 - Moderate Damage	Level 3 - Fair	Condition	Under sidewalk.

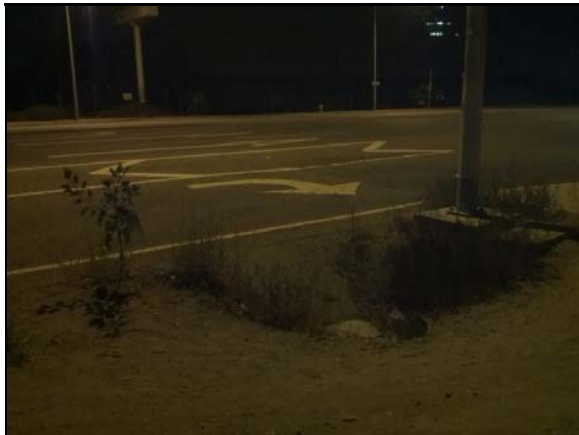
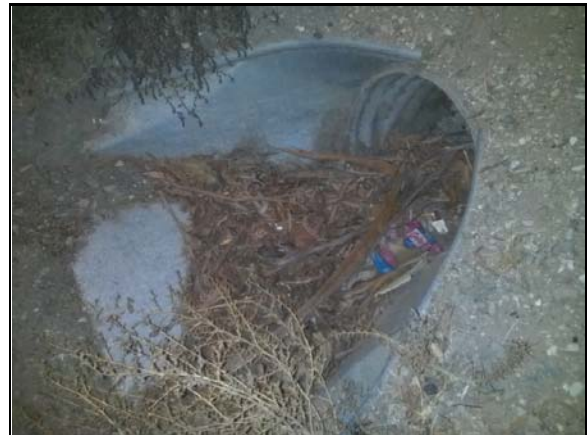
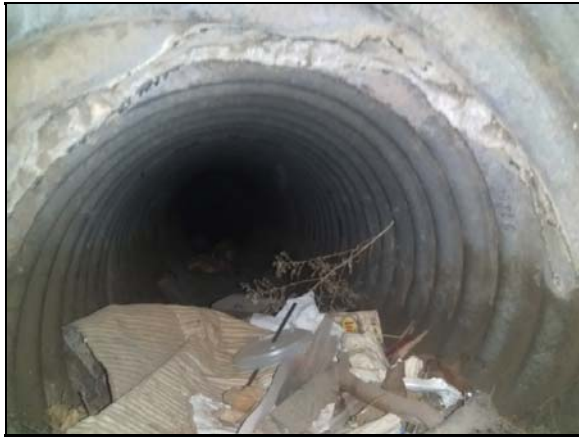
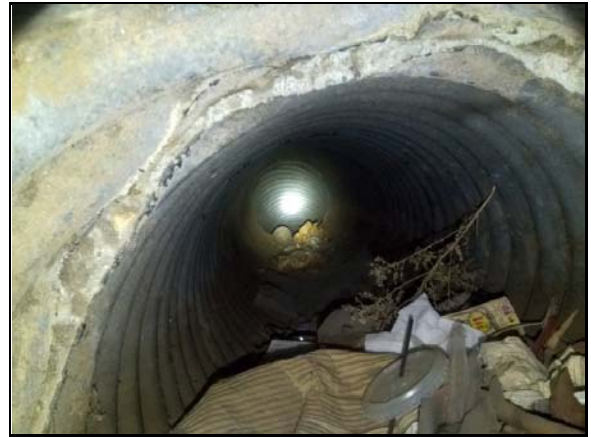
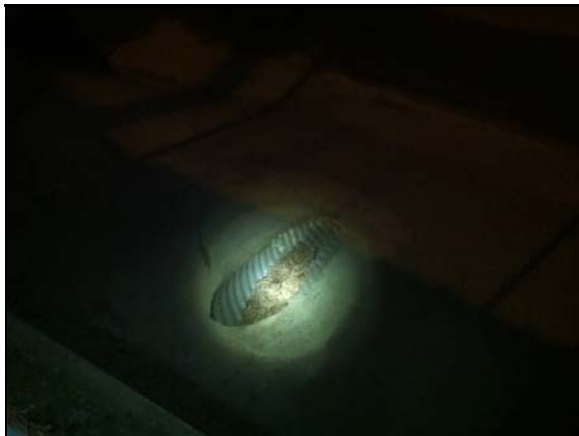
Culvert CB-N14-300

Susceptible to burial/overgrowth: No
 Susceptible to ponding/flooding: No
 Sediment/debris depth (%): 5
 Type of sediment/debris: Vegetation/Trash
 Infiltration in structure: None
 Obstruction/deflection: 0.0
 VANDA Condition Rating: Level 1 - No Damage
 Prioritization Rating: Level 1 - Excellent
 Prioritization Rationale: Condition
 Illegal dumping evidence: No

Inlet at grade. Drains into channel. Loss

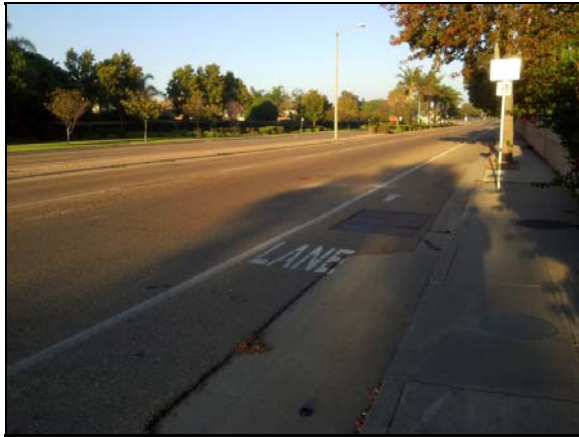
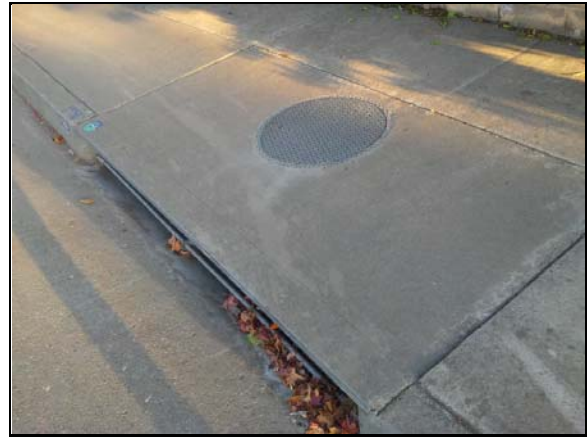
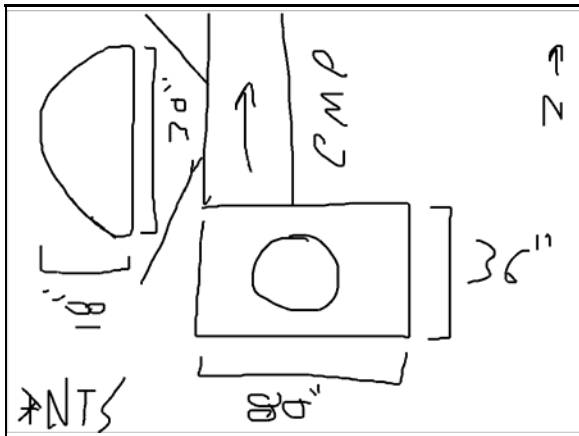
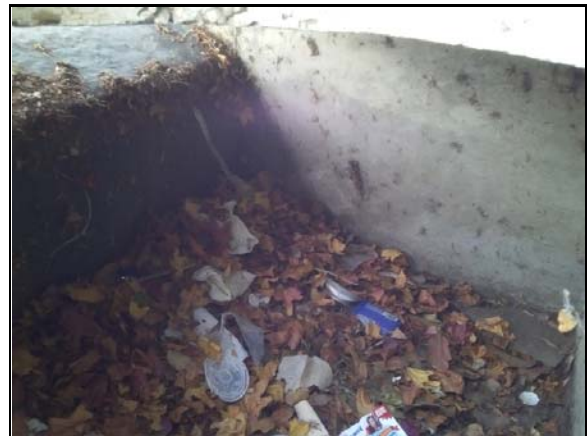
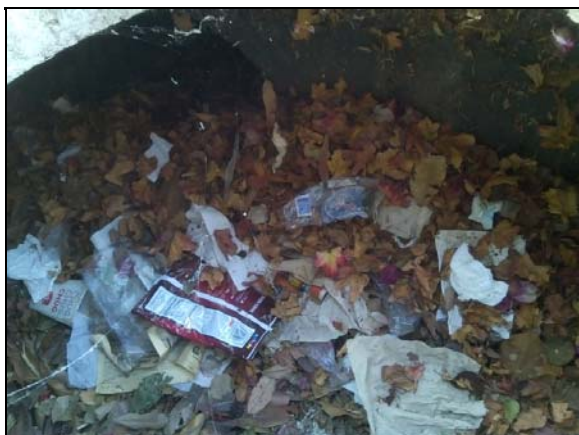
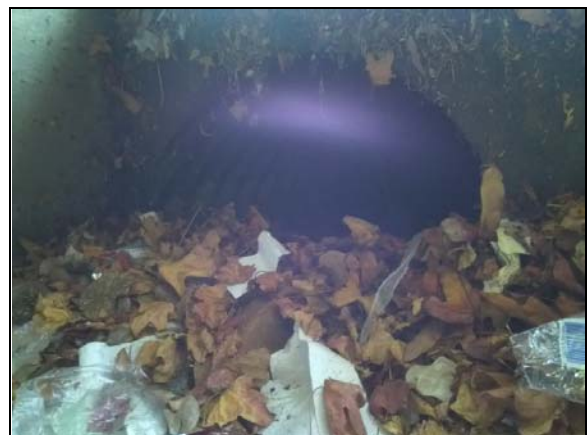
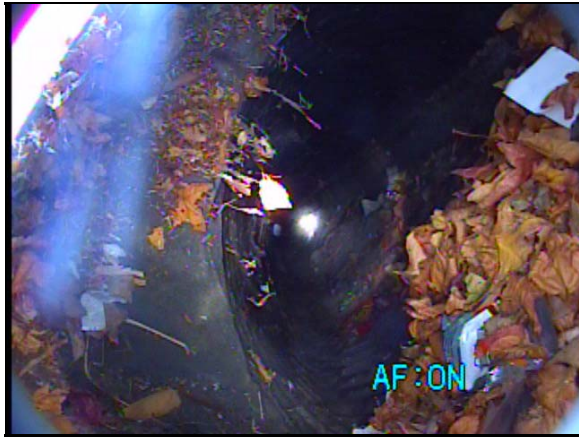
Catch Basin CB-M14-325

Susceptible to burial/overgrowth: No
Susceptible to ponding/flooding: No
Sediment/debris depth (%): 20
Type of sediment/debris: Vegetation/Trash
Infiltration in structure: None
Obstruction/deflection: 0.0
VANDA Condition Rating: Level 1 - No Damage
Prioritization Rating: Level 2 - Good
Prioritization Rationale: Sediment
Illegal dumping evidence: No

Pipe	Dir.	Hdn g	Dia. (in.)	Mat'l	Rim-inv (ft.)	Wtr Lvl (%)	Sed. (%)	Sed. Type	Infil- tration	Obs/Dfl. (%)	VANDA Rating	Priority Rating	Priority Rationale	Notes
CB-M14-325_JS-M14-509	Out	N	18H x 30W	CMP	3	0	10	Silt/Trash/Veg etation	None	0	Level 1 - No Damage	Level 2 - Good	Condition	Coal tar epoxy coating appears to be in good condition.

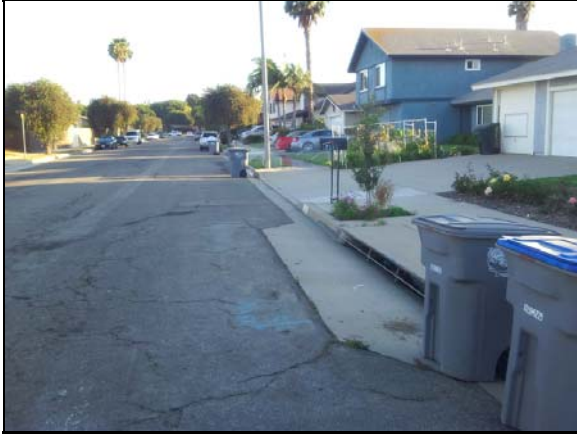
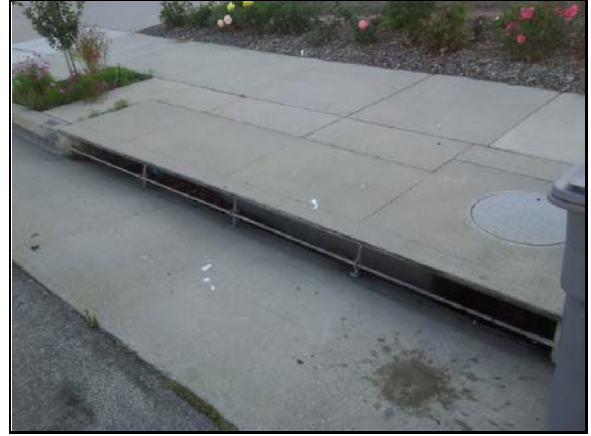
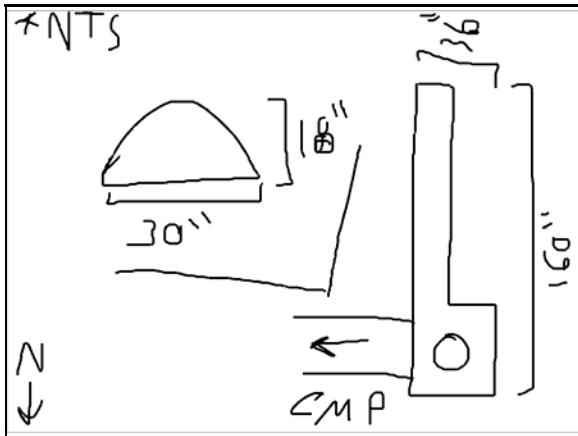
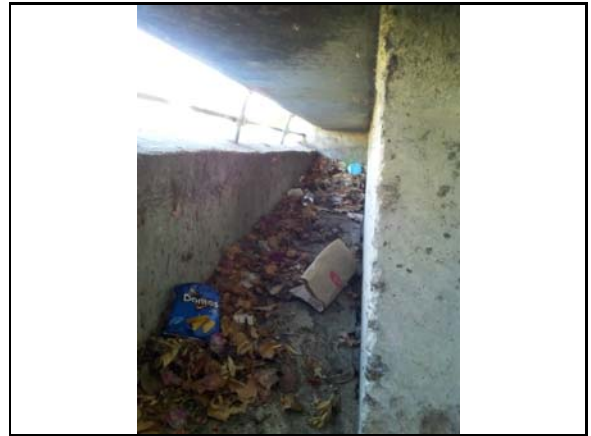
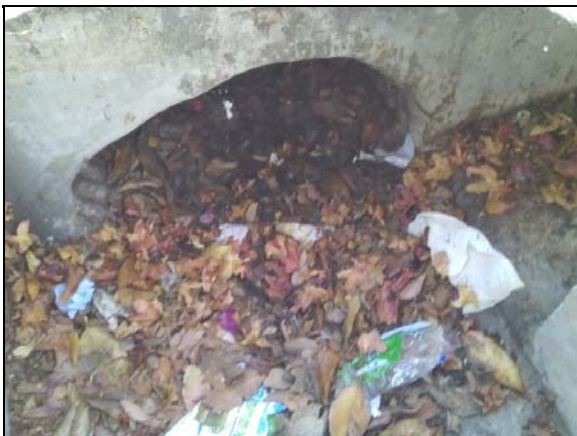
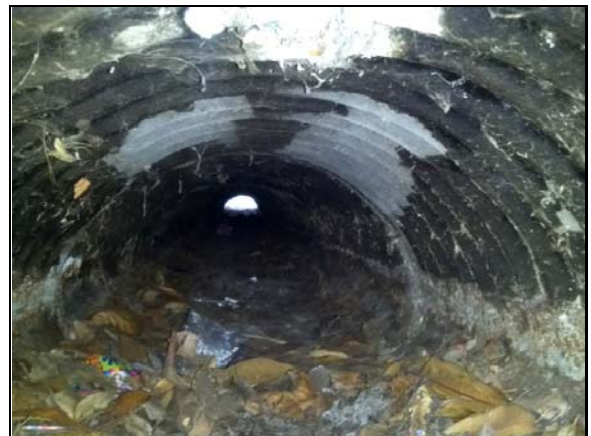
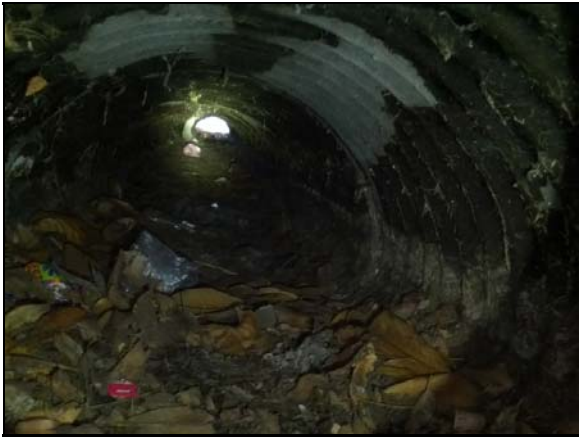
Catch Basin CB-M14-327

Susceptible to burial/overgrowth: No
Susceptible to ponding/flooding: No
Sediment/debris depth (%): 10
Type of sediment/debris: Silt/Vegetation/Trash
Infiltration in structure: None
Obstruction/deflection: 0.0
VANDA Condition Rating: Level 1 - No Damage
Prioritization Rating: Level 1 - Excellent
Prioritization Rationale: Condition
Illegal dumping evidence: No

Pipe	Dir.	Hdn g	Dia. (in.)	Mat'l	Rim-inv (ft.)	Wtr Lvl (%)	Sed. (%)	Sed. Type	Infil-tration	Obs/Dfl. (%)	VANDA Rating	Priority Rating	Priority Rationale	Notes
CB-M14-327_MH-M14-108	Out	E	18H x 30W	CMP	3.1	0	10	Silt/Trash/Vegetation	None	0	Level 2 - Minor Damage	Level 2 - Good	Condition	Coal tar epoxy coating missing at various places. Minor surface corrosion.

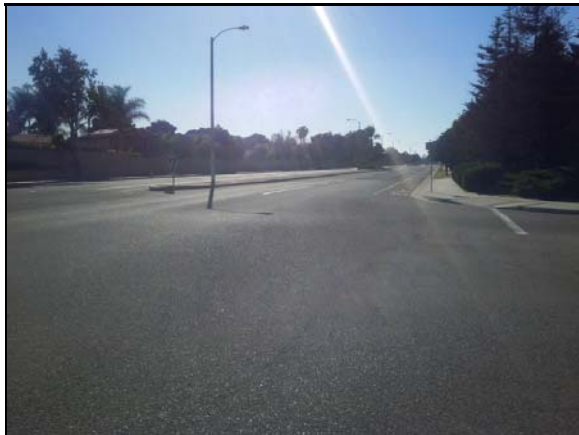
Location View

Unable to locate open channel. Possibly does not exist or is mislabeled in GIS.

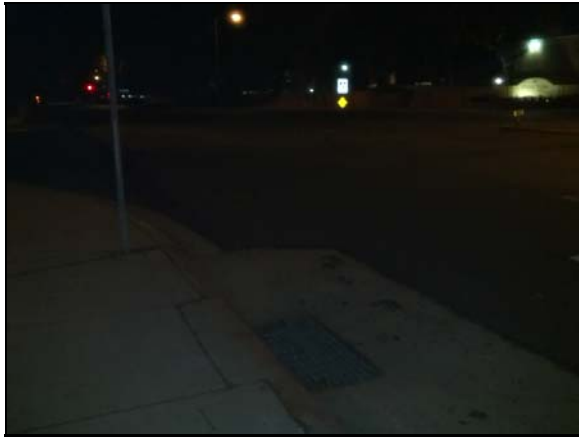
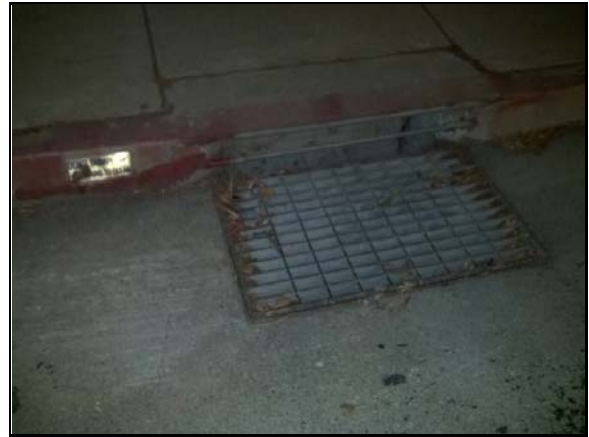
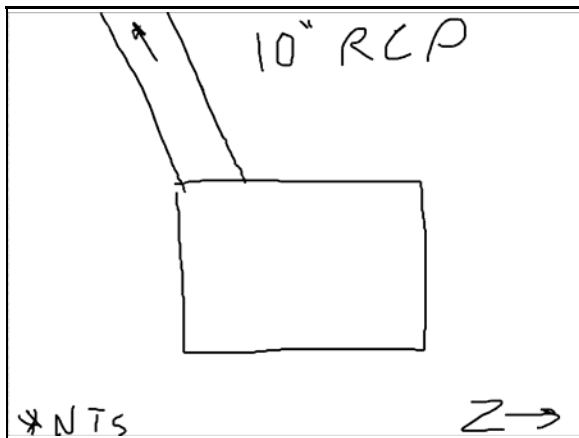
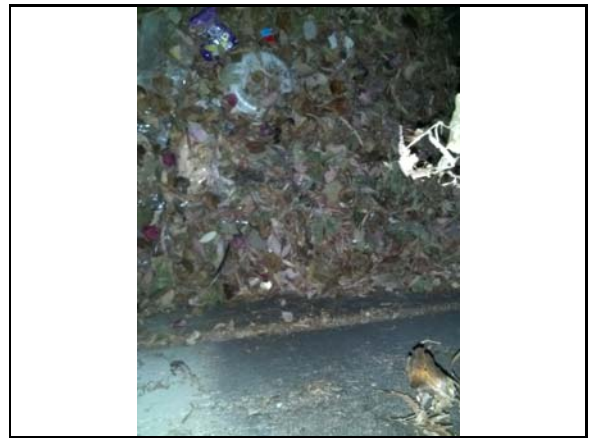
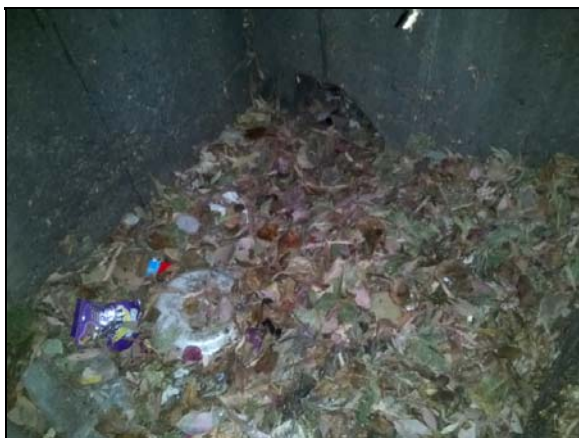
Catch Basin CB-Q31-300

Susceptible to burial/overgrowth: No
Susceptible to ponding/flooding: No
Sediment/debris depth (%): 15
Type of sediment/debris: Vegetation/Trash
Infiltration in structure: None
Obstruction/deflection: 0.0
VANDA Condition Rating: Level 1 - No Damage
Prioritization Rating: Level 2 - Good
Prioritization Rationale: Sediment
Illegal dumping evidence: No

Pipe	Dir.	Hdn g	Dia. (in.)	Mat'l	Rim-inv (ft.)	Wtr Lvl (%)	Sed. (%)	Sed. Type	Infil-tration	Obs/Dfl. (%)	VANDA Rating	Priority Rating	Priority Rationale	Notes
CB-Q31-300_JS-Q31-500	Out	W	10	RCP	4	0	25	Vegetation	None	0	Unknown	Level 3 - Fair	Condition/Sediment	Under roadway.

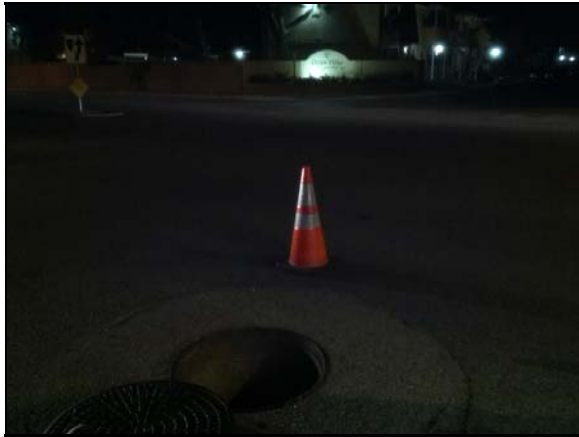
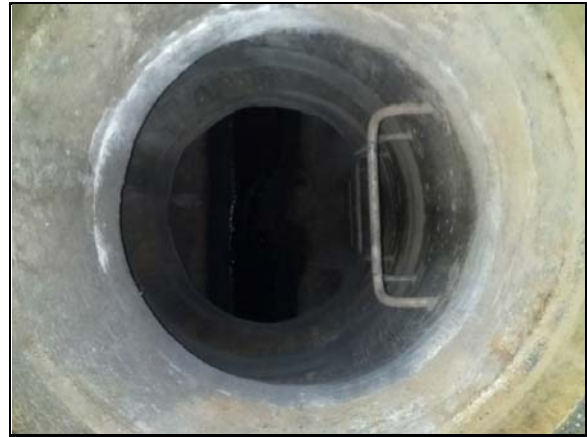
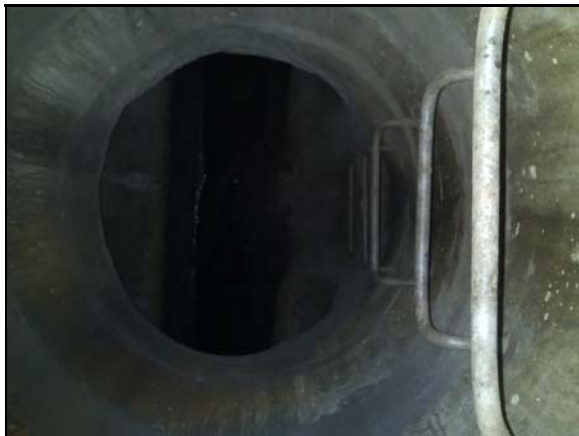
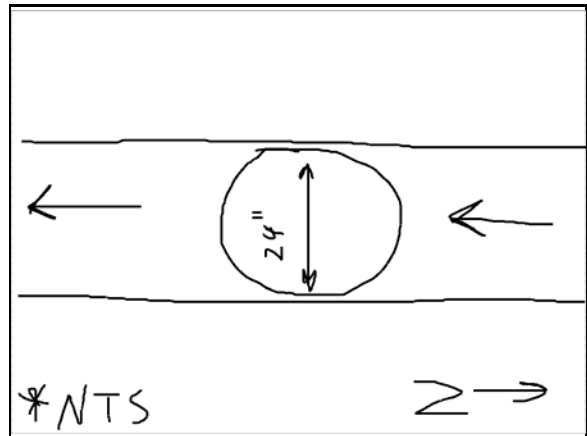
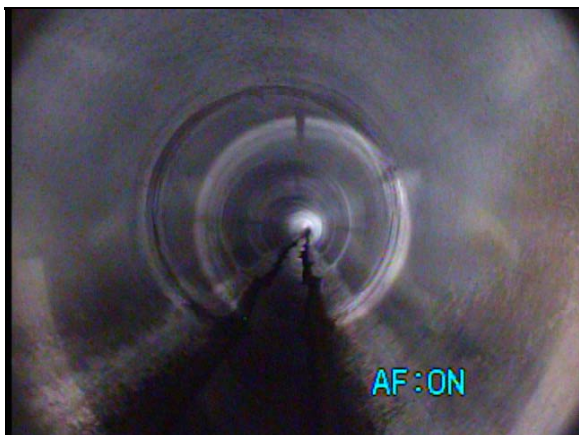
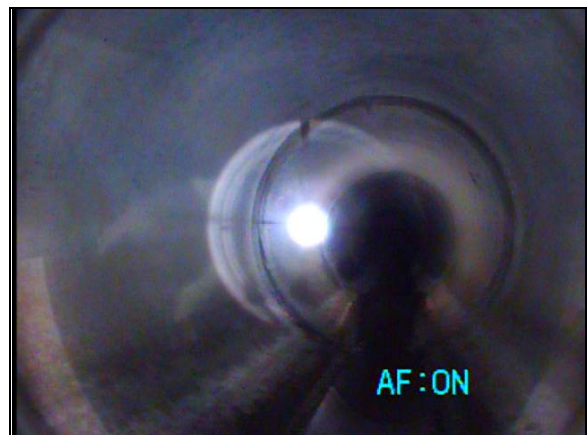
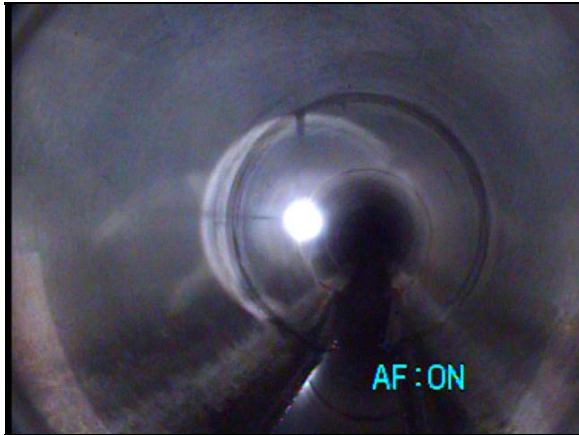
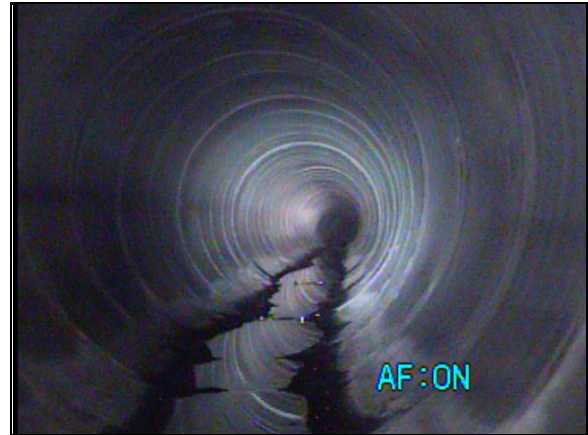
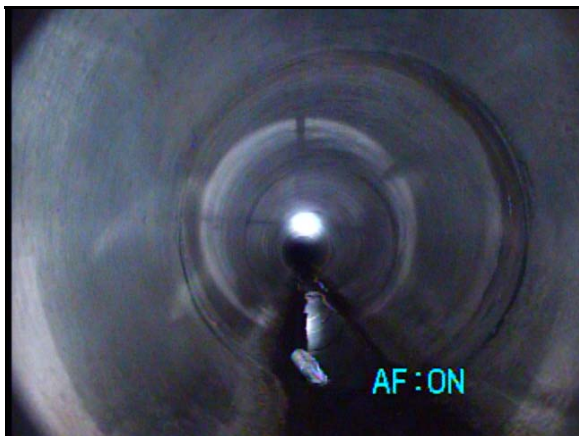
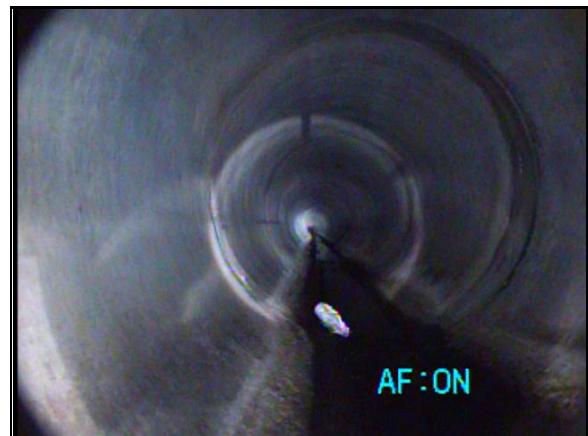
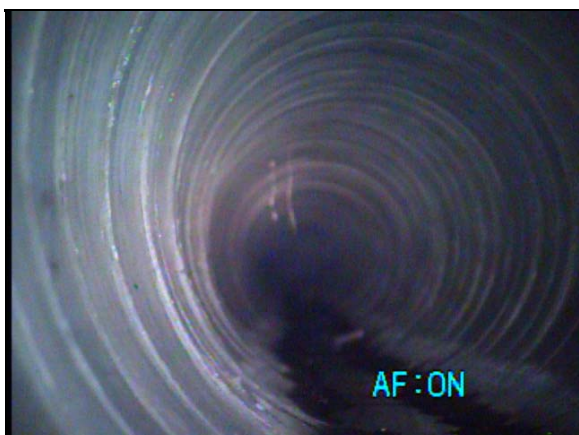
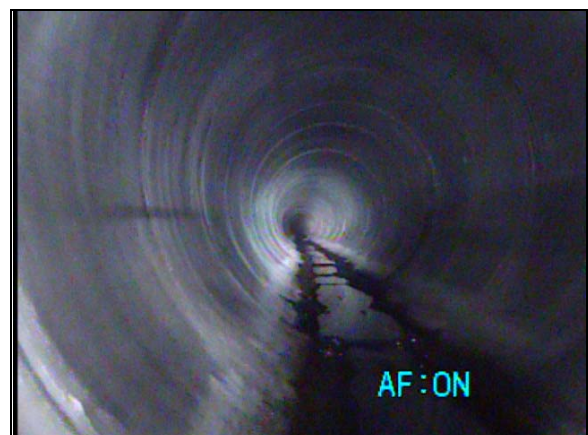
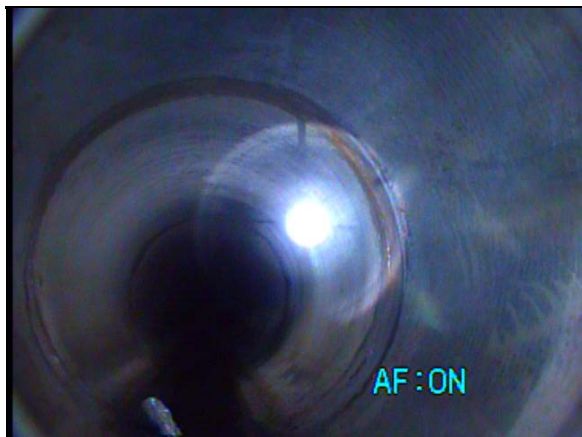
Manhole MH-Q31-102

Susceptible to burial/overgrowth: No
Susceptible to ponding/flooding: No
Sediment/debris depth (%): 0
Type of sediment/debris: None
Infiltration in structure: Stain
Obstruction/deflection: 0.0
VANDA Condition Rating: Level 1 - No Damage
Prioritization Rating: Level 2 - Good
Prioritization Rationale: Condition
Illegal dumping evidence: No

Pipe	Dir.	Hdn g	Dia. (in.)	Mat'l	Rim-inv (ft.)	Wtr Lvl (%)	Sed. (%)	Sed. Type	Infil-tration	Obs/Dfl. (%)	VANDA Rating	Priority Rating	Priority Rationale	Notes
JS-Q31-500_MH-Q31-102	In	S	48	RCP	10.5	5	0	None	Stain	0	Level 1 - No Damage	Level 2 - Good	Condition/Location	Under roadway.
MH-Q31-102_MH-Q31-104	Out	S	48	RCP	10.5	5	0	None	Stain	0	Level 1 - No Damage	Level 2 - Good	Condition/Location	Under roadway.
