City of Oxnard

Public Works Integrated Master Plan

**PROJECT MEMORANDUM 5.3
CONDITION ASSESSMENT**

CITY OF OXNARD STORM DRAINAGE CONDITION ASSESSMENT

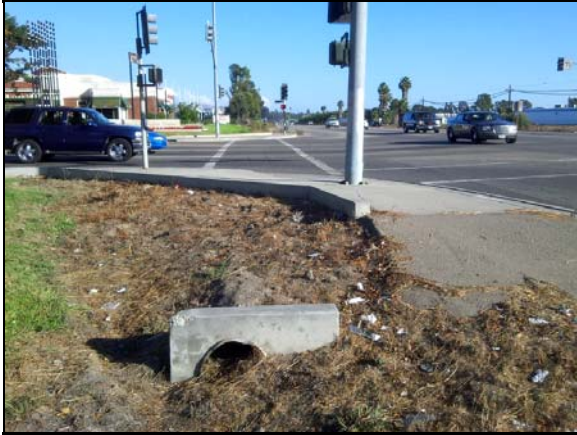
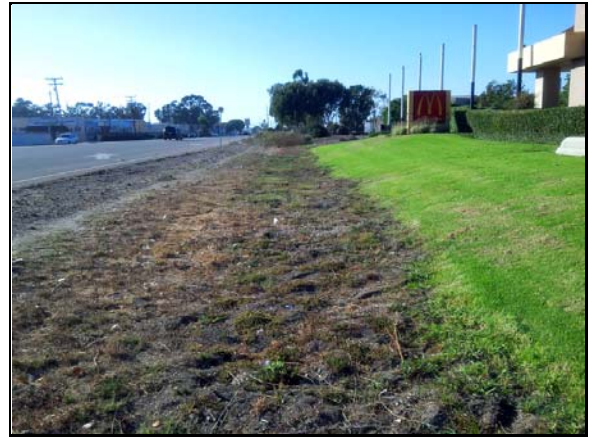
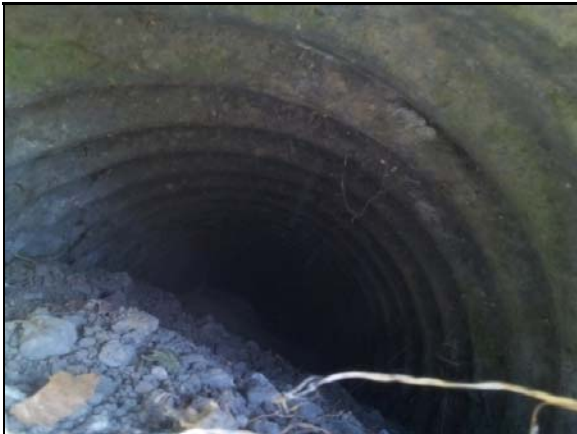
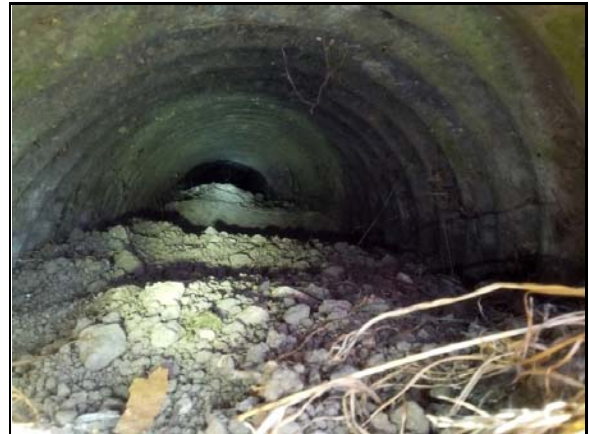
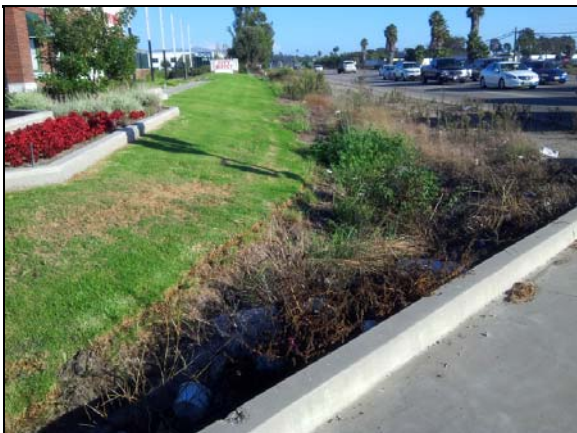
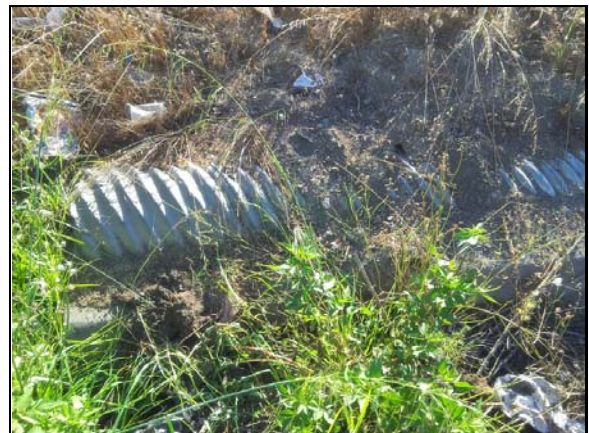
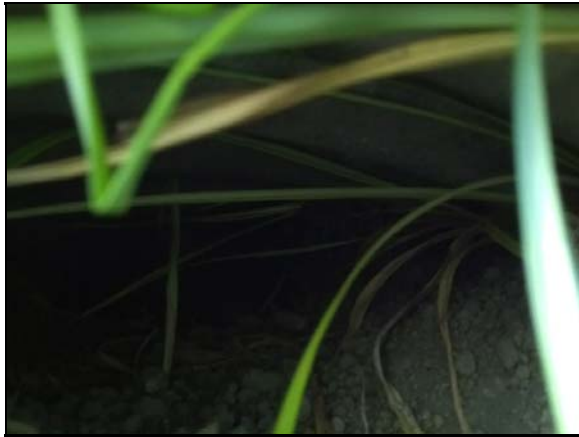
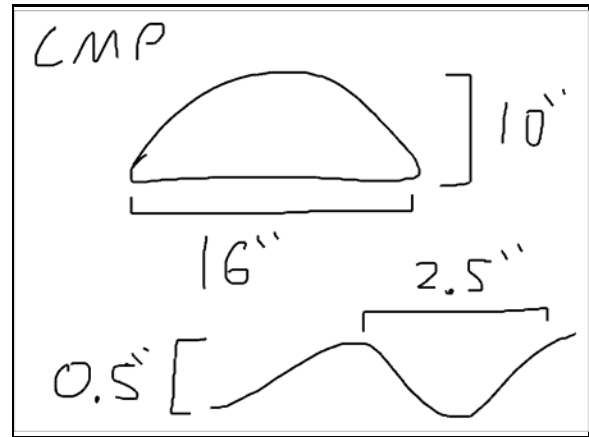
Culvert HW-P26-801_HW-P26-802

Susceptible to burial/overgrowth: Yes
Susceptible to ponding/flooding: Yes
Sediment/debris depth (%): 100.0
Type of sediment/debris: Silt/Gravel
Infiltration in structure: None
Obstruction/deflection: 0.0
VANDA Condition Rating: Level 2 - Minor Damage
Prioritization Rating: Level 5 - Immediate Attention
Prioritization Rationale: Condition/Location/Sediment
Illegal dumping evidence: No

Pipe is completely blocked at outlet and blocked at least 50% at inlet. Appears to be no exterior corrosion and minor interior corrosion.

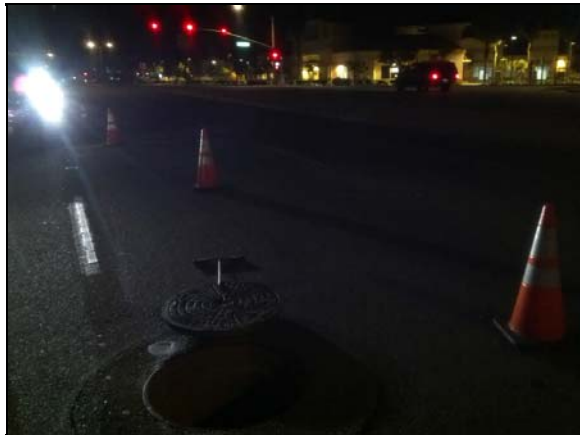
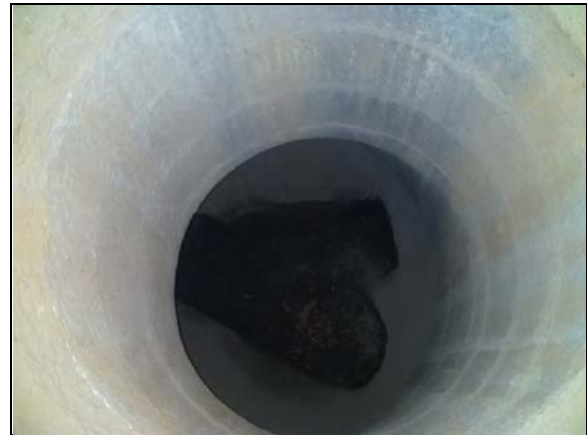
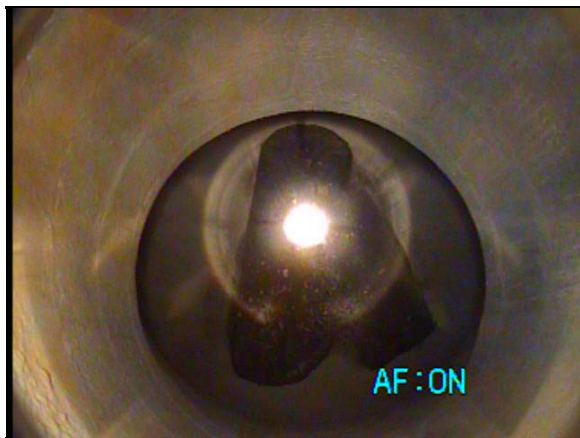
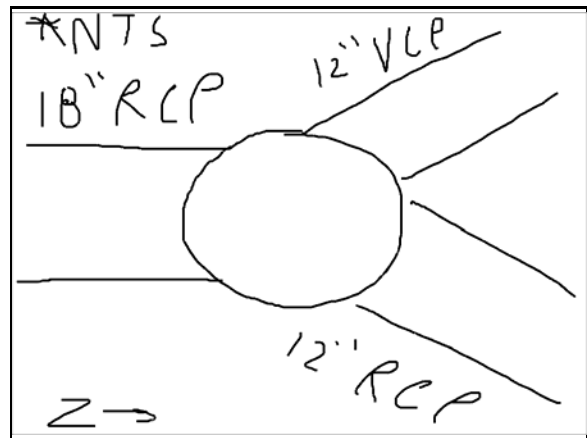
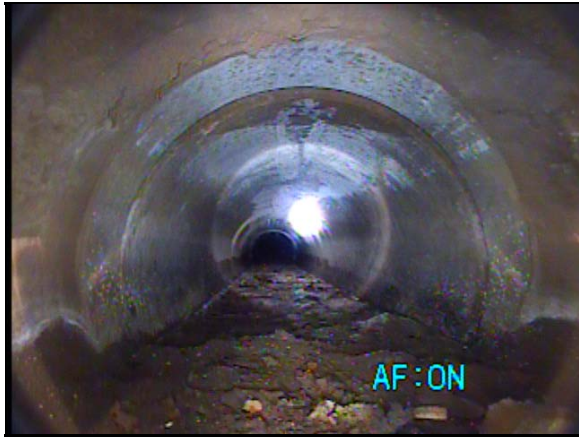
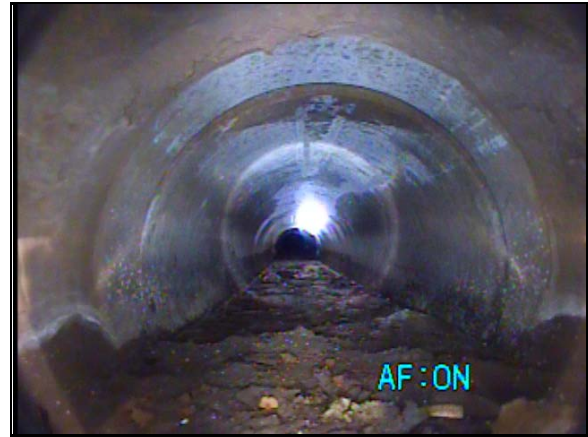
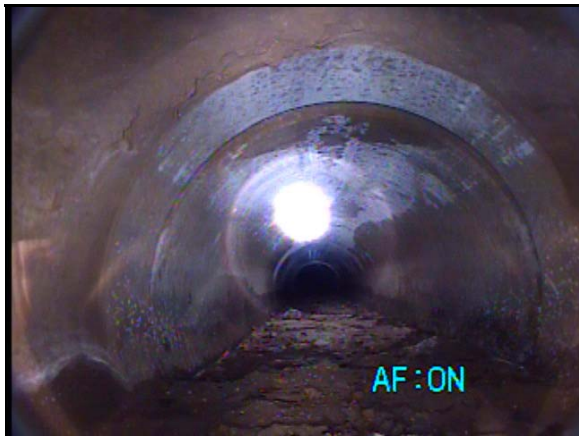
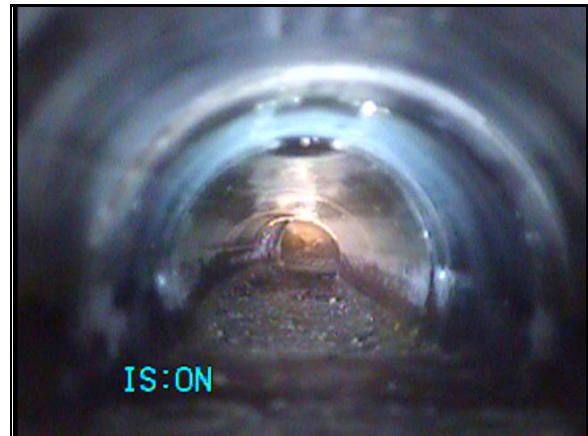
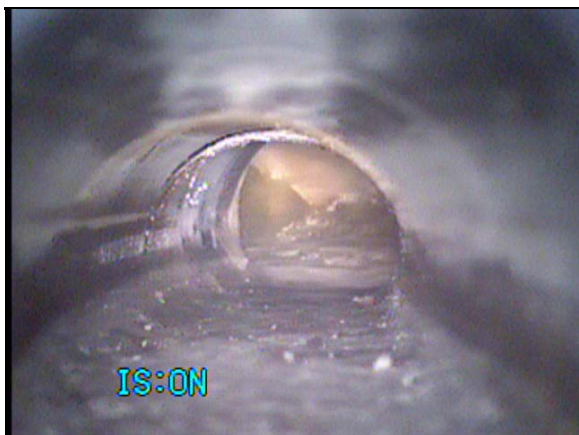
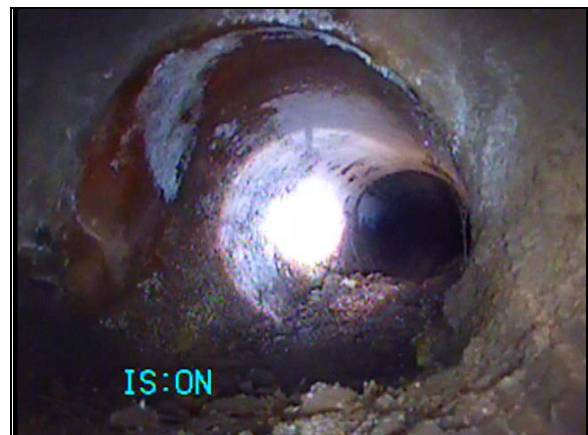
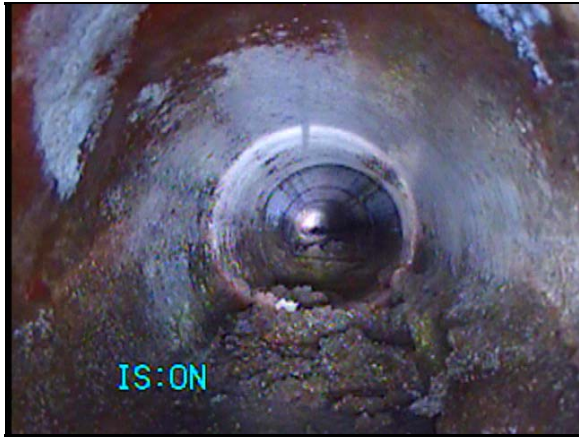
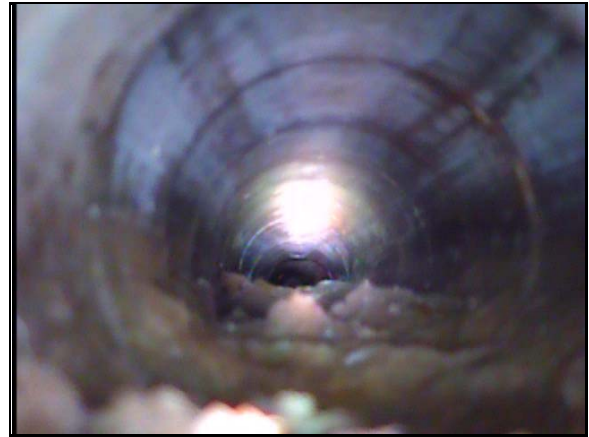
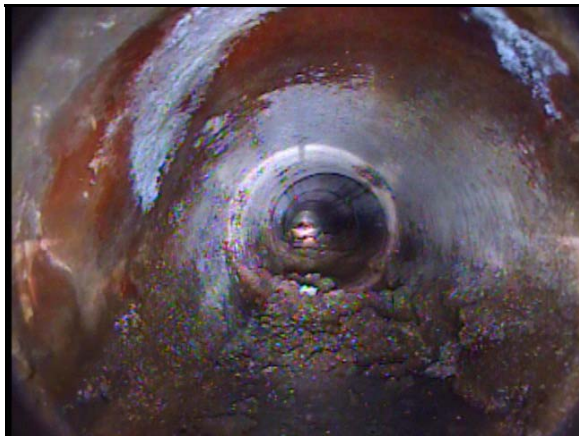
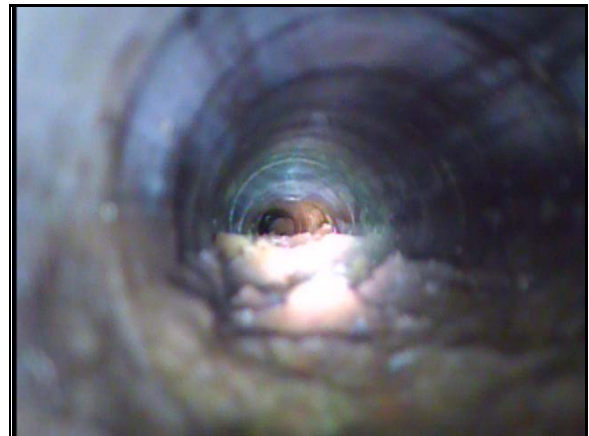
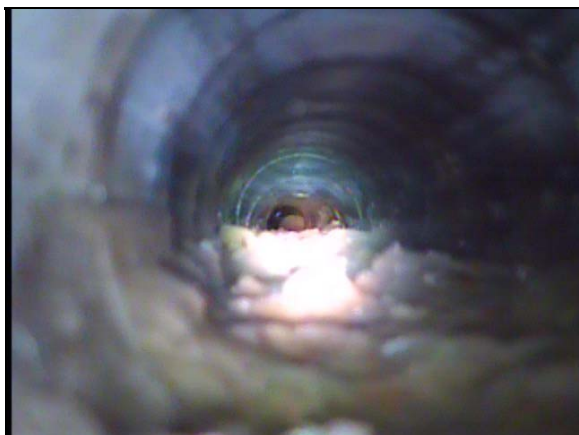
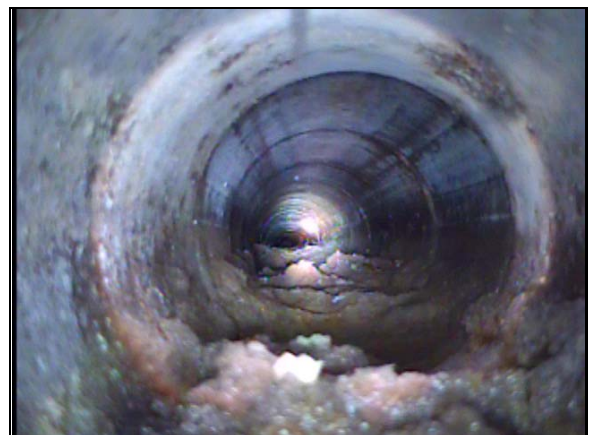
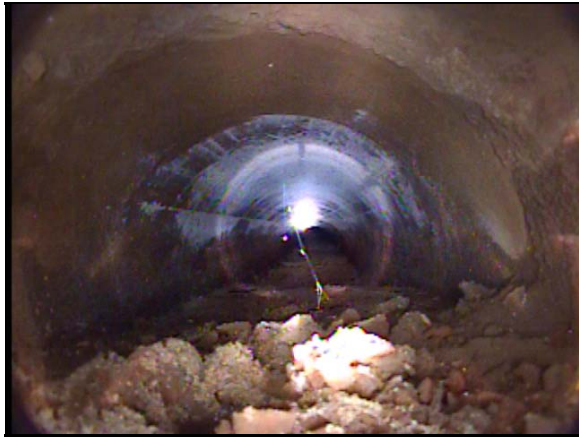
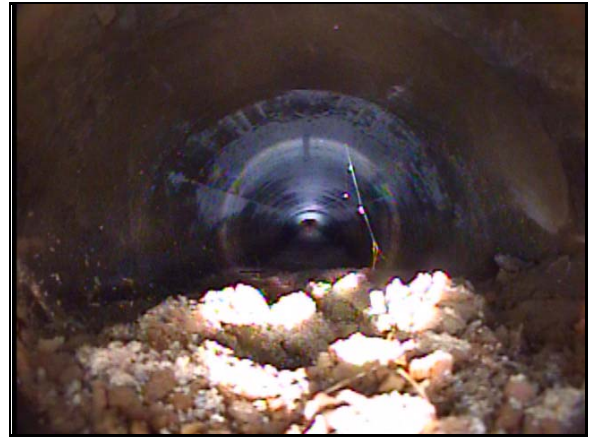
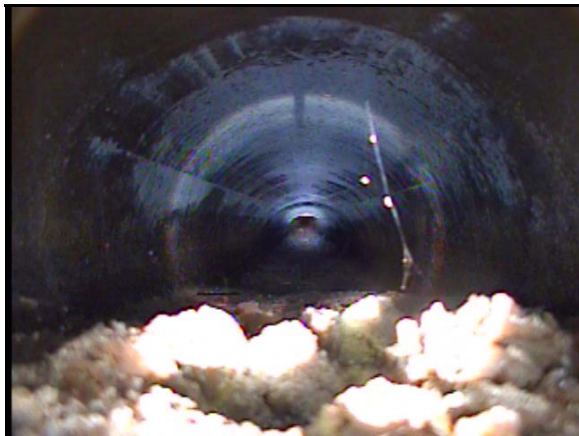
Culvert MH-Q27-103

Pipe	Dir.	Hdn g	Dia. (in.)	Mat'l	Rim-inv (ft.)	Wtr Lvl (%)	Sed. (%)	Sed. Type	Infiltration	Obs/Dfl. (%)	VANDA Rating	Priority Rating	Priority Rationale	Notes
PL-Q27-1200_MH-Q27-103	Out	S	18	RCP	6.7	0	25	Silt	None	0	Level 1 - No Damage	Level 3 - Fair	Sediment	Under roadway.

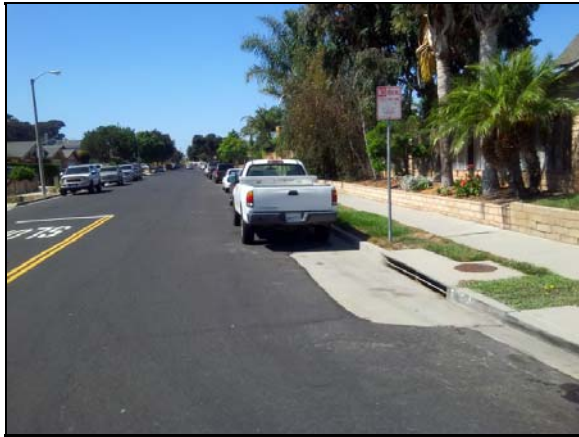
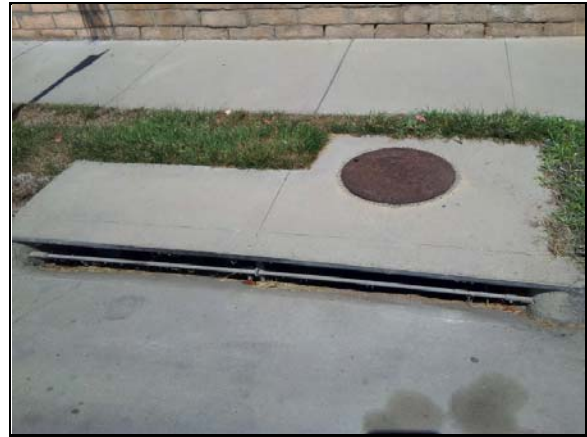
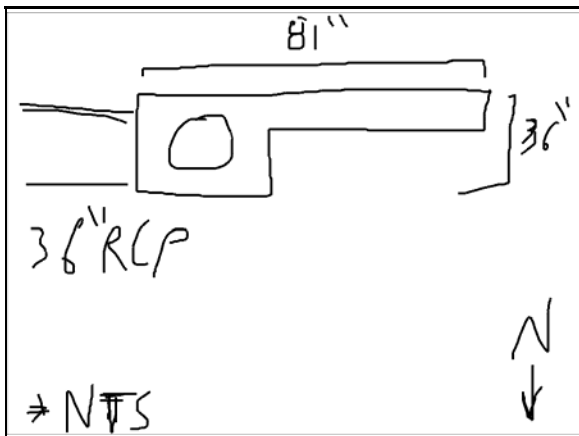
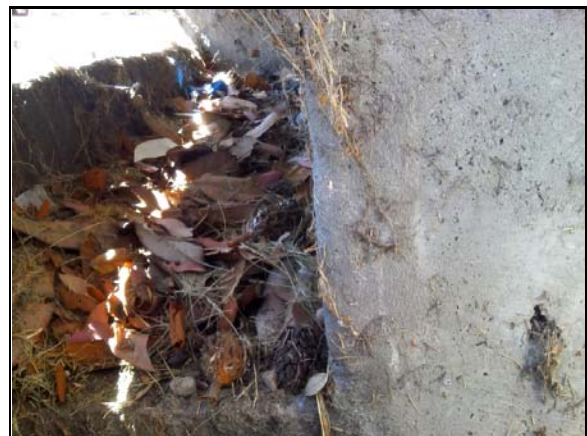
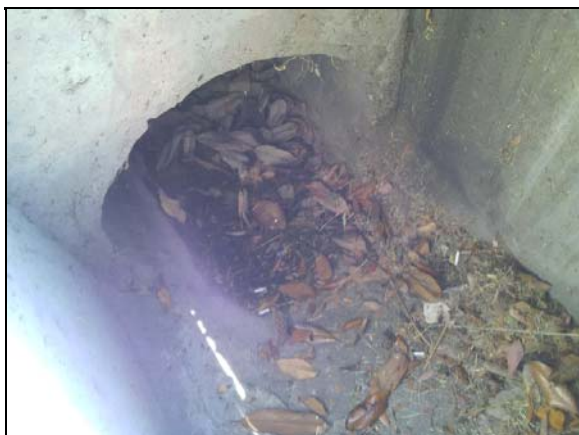
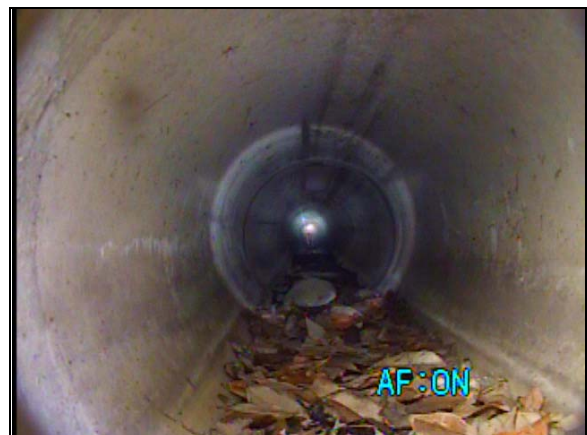
Catch Basin CB-R28-304

Susceptible to burial/overgrowth: No
Susceptible to ponding/flooding: No
Sediment/debris depth (%): 10
Type of sediment/debris: Vegetation
Infiltration in structure: None
Obstruction/deflection: 0.0
VANDA Condition Rating: Level 1 - No Damage
Prioritization Rating: Level 1 - Excellent
Prioritization Rationale: Condition
Illegal dumping evidence: No

Pipe	Dir.	Hdn g	Dia. (in.)	Mat'l	Rim-inv (ft.)	Wtr Lvl (%)	Sed. (%)	Sed. Type	Infil-tration	Obs/Dfl. (%)	VANDA Rating	Priority Rating	Priority Rationale	Notes
CB-R28-304_CB-R28-305	Out	SE	18	RCP	5	0	10	Silt/Vegetation	None	0	Level 1 - No Damage	Level 1 - Excellent	Condition	Under roadway.

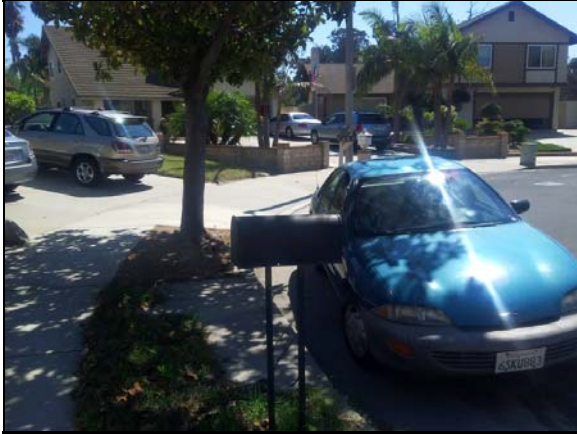
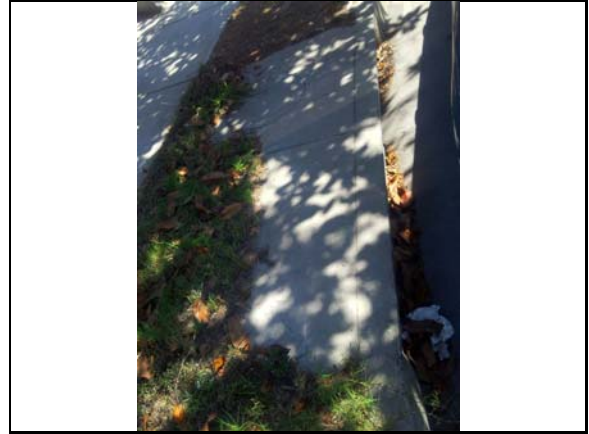
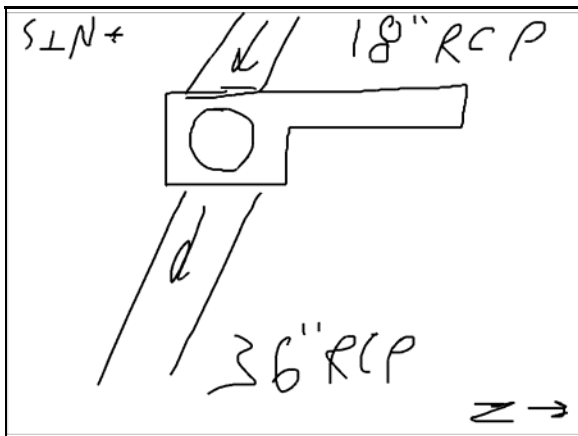
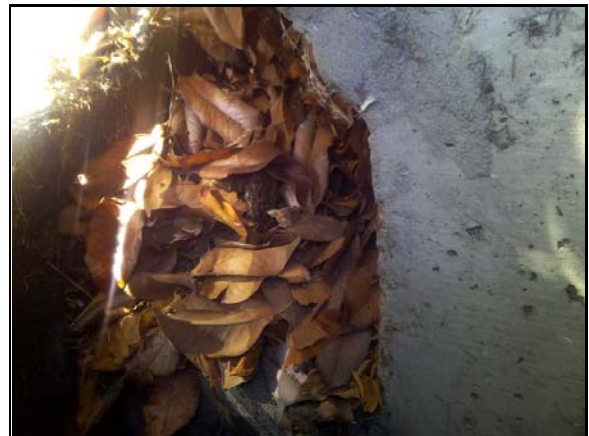
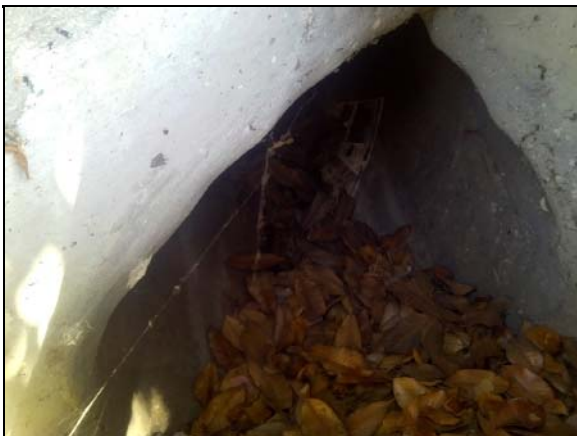
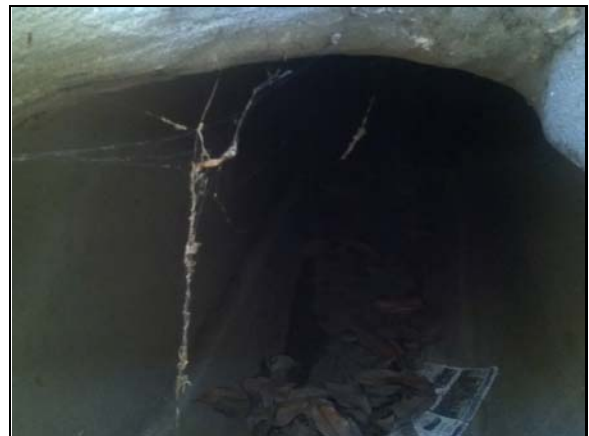
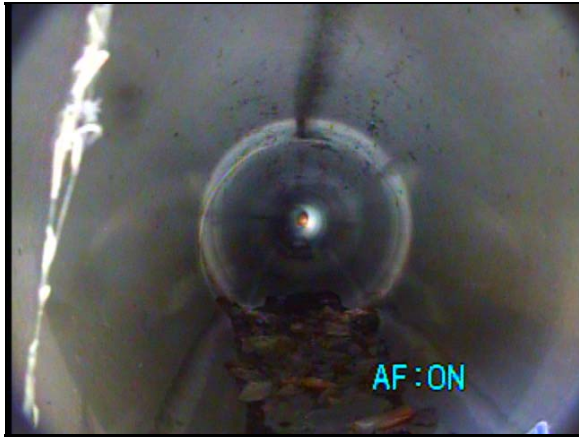
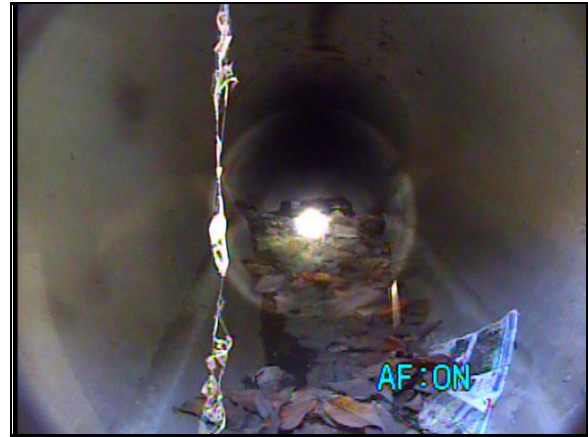
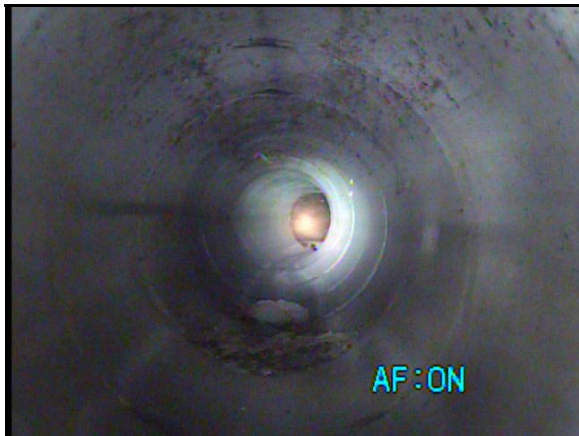
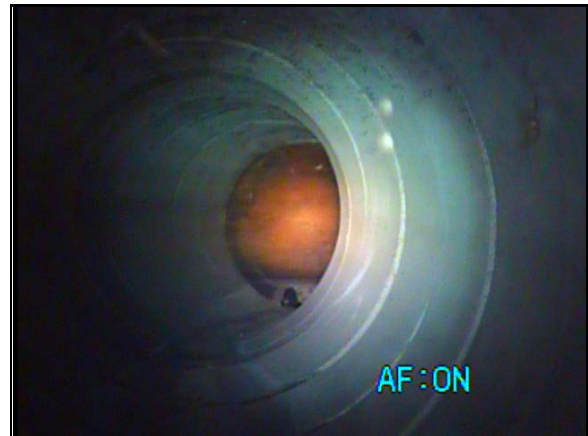
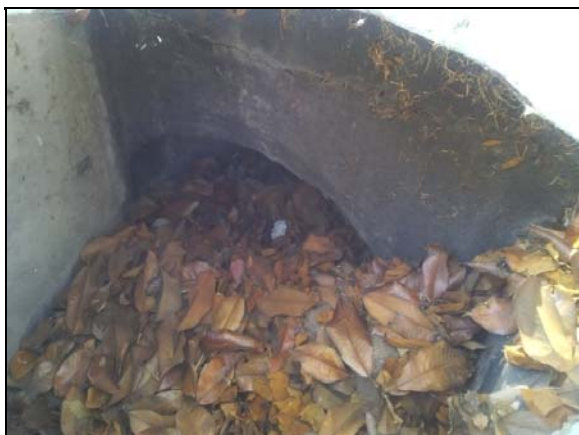
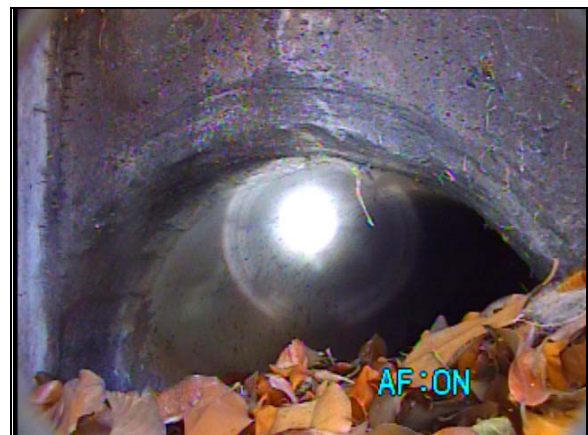
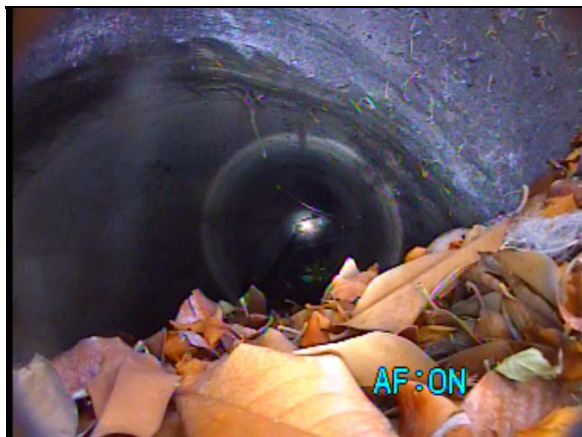
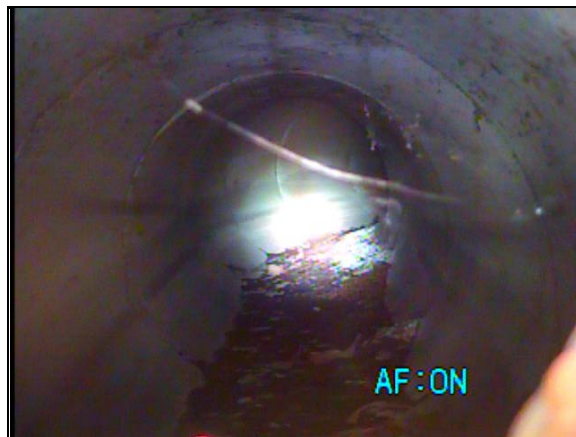
Catch Basin CB-R28-305

Susceptible to burial/overgrowth: No
Susceptible to ponding/flooding: No
Sediment/debris depth (%): 50
Type of sediment/debris: Vegetation
Infiltration in structure: None
Obstruction/deflection: 0.0
VANDA Condition Rating: Level 1 - No Damage
Prioritization Rating: Level 4 - Poor
Prioritization Rationale: Sediment/Location
Illegal dumping evidence: No

Pipe	Dir.	Hdn g	Dia. (in.)	Mat'l	Rim-inv (ft.)	Wtr Lvl (%)	Sed. (%)	Sed. Type	Infil-tration	Obs/Dfl. (%)	VANDA Rating	Priority Rating	Priority Rationale	Notes
CB-R28-304_CB-R28-305	In	SE	18	RCP	4.7	0	10	Silt	None	0	Level 1 - No Damage	Level 1 - Excellent	Condition	Under roadway.
CB-R28-305_JS-R28-503	Out	SE	36	RCP	4.7	0	5	Silt/Vegetation/Rock	None	0	Level 1 - No Damage	Level 1 - Excellent	Condition	Under residence.

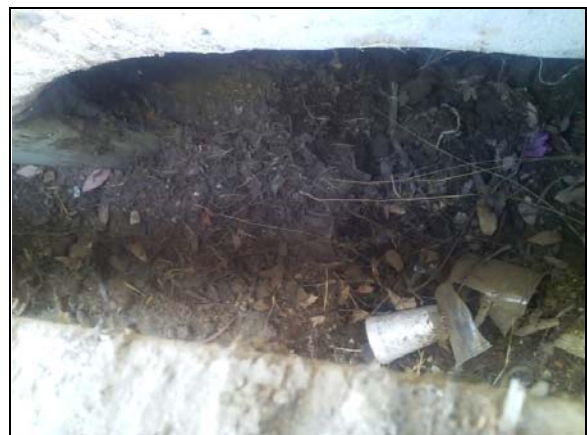
View of outlet

Pipe	Dir.	Hdn g	Dia. (in.)	Mat'l	Rim-inv (ft.)	Wtr Lvl (%)	Sed. (%)	Sed. Type	Infiltration	Obs/Dfl. (%)	VANDA Rating	Priority Rating	Priority Rationale	Notes
CB-S28-306_CB-R28-306	Out	SW	12	CMP	2.7	0	5	Silt/Vegetation	None	0	Level 3 - Moderate Damage	Level 3 - Fair	Condition/Location	Under roadway. Moderate corrosion on invert.

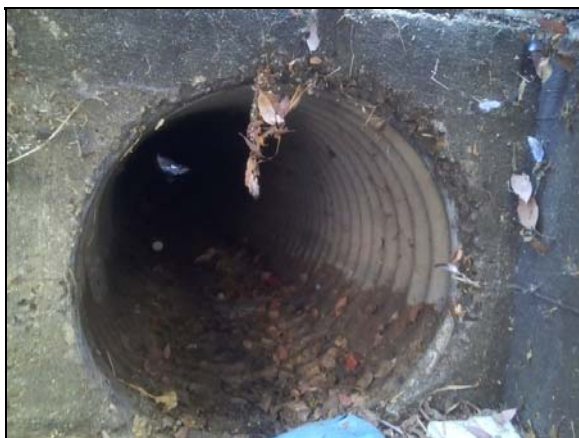
View of outlet

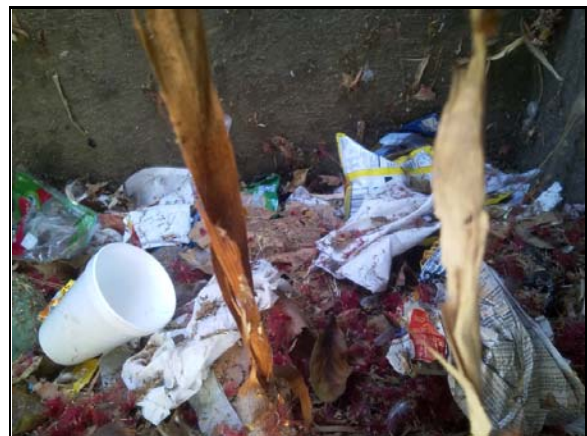
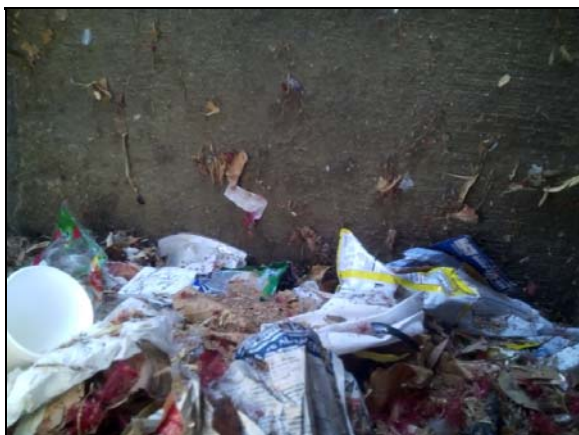
Susceptible to burial/overgrowth: No
Susceptible to ponding/flooding: No
Sediment/debris depth (%): 50
Type of sediment/debris: Vegetation/Trash
Infiltration in structure: None
Obstruction/deflection: 0.0
VANDA Condition Rating: Level 1 - No Damage
Prioritization Rating: Level 4 - Poor
Prioritization Rationale: Sediment/Location
Illegal dumping evidence: No

View inside catch basin

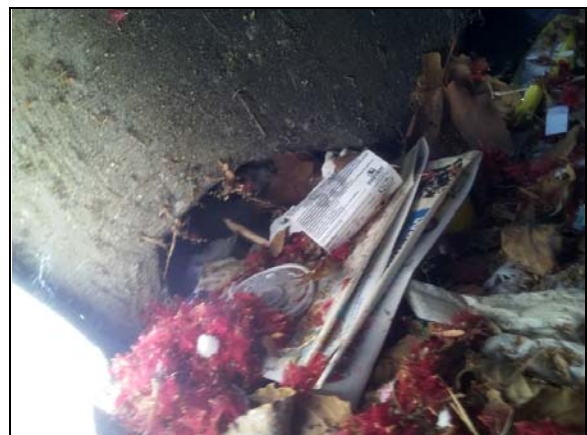
Pipe	Dir.	Hdn g	Dia. (in.)	Mat'l	Rim-inv (ft.)	Wtr Lvl (%)	Sed. (%)	Sed. Type	Infil- tration	Obs/Dfl. (%)	VANDA Rating	Priority Rating	Priority Rationale	Notes
CB-R28-302_MH-R28-104	Out	E	10	RCP	2.3	0	80	Vegetation/Trash	Unknown		Unknown	Level 5 - Immediate Attention	Condition/Sediment	Pipe inlet is filled with trash and debris.

View of outlet

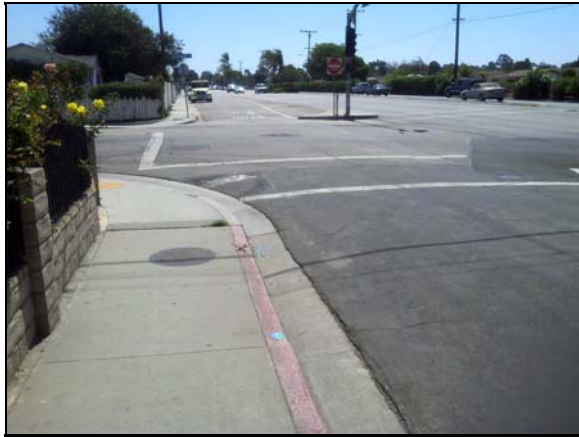
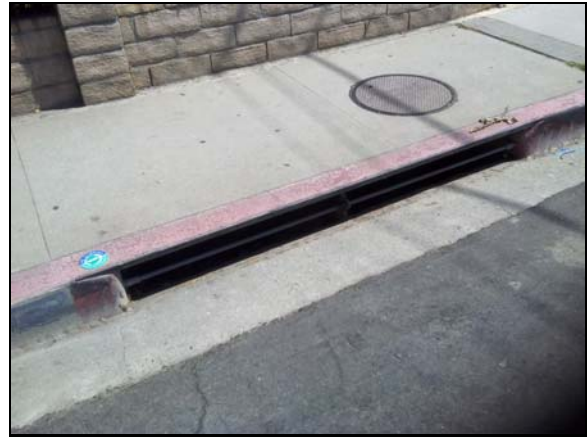
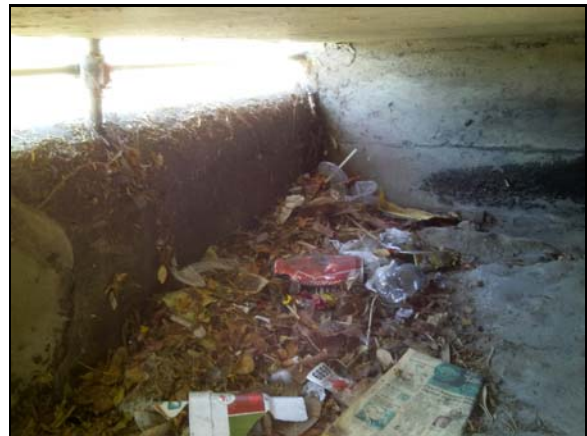
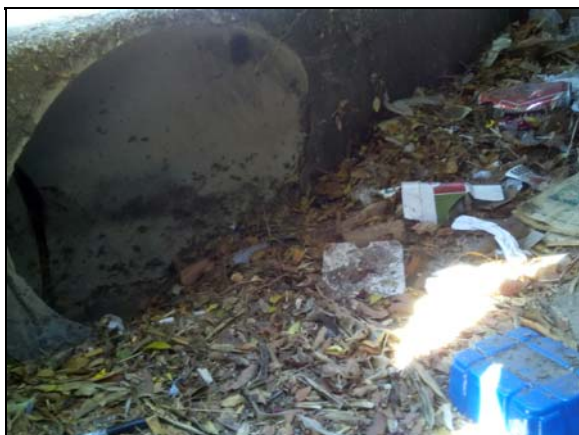
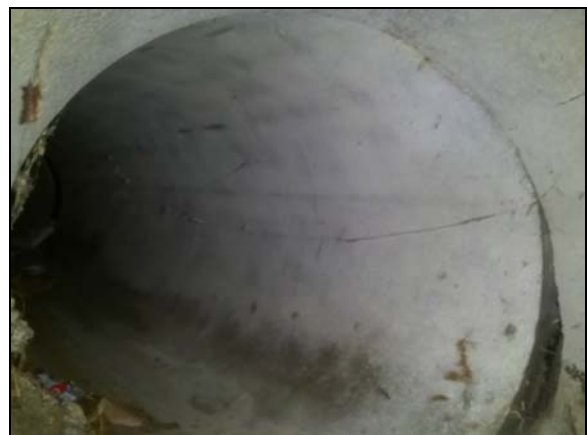
Catch Basin CB-L26-302

Susceptible to burial/overgrowth: No
Susceptible to ponding/flooding: Yes
Sediment/debris depth (%): 10
Type of sediment/debris: Vegetation/Trash
Infiltration in structure: None
Obstruction/deflection: 0.0
VANDA Condition Rating: Level 1 - No Damage
Prioritization Rating: Level 1 - Excellent
Prioritization Rationale: Condition
Illegal dumping evidence: No

Pipe	Dir.	Hdn g	Dia. (in.)	Mat'l	Rim-inv (ft.)	Wtr Lvl (%)	Sed. (%)	Sed. Type	Infil-tration	Obs/Dfl. (%)	VANDA Rating	Priority Rating	Priority Rationale	Notes
CB-L26-302_JS-L26-500	Out	SW	18	PVC	2.1	0	0	None	None	0	N/A	Level 1 - Excellent	Condition	Under roadway.

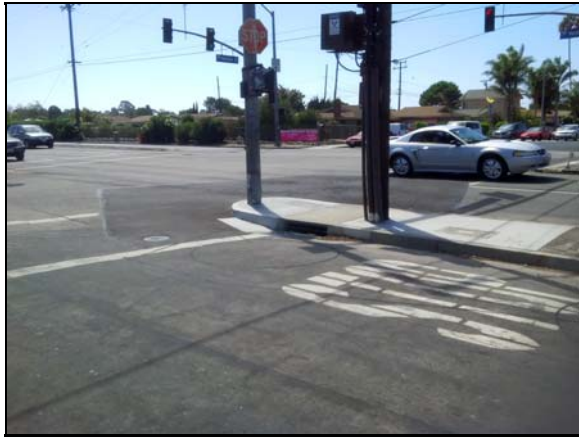
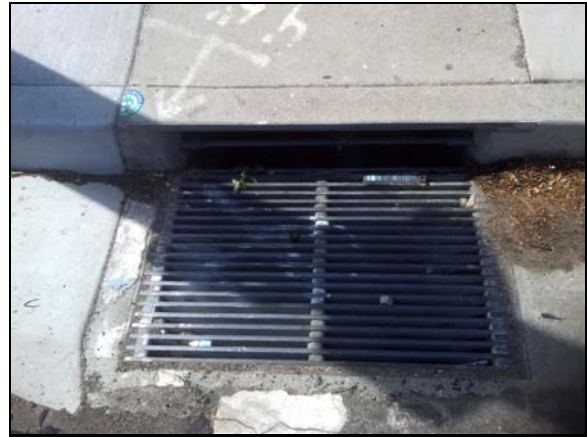
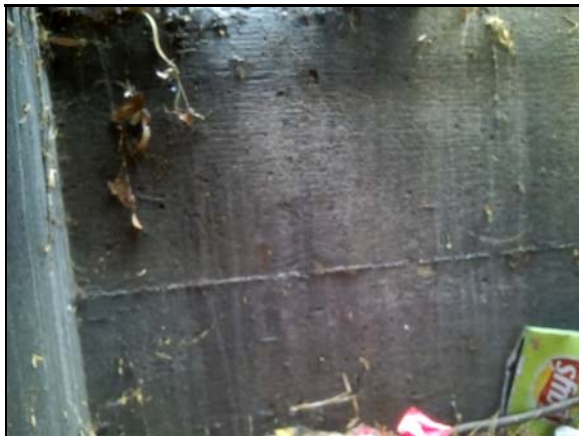
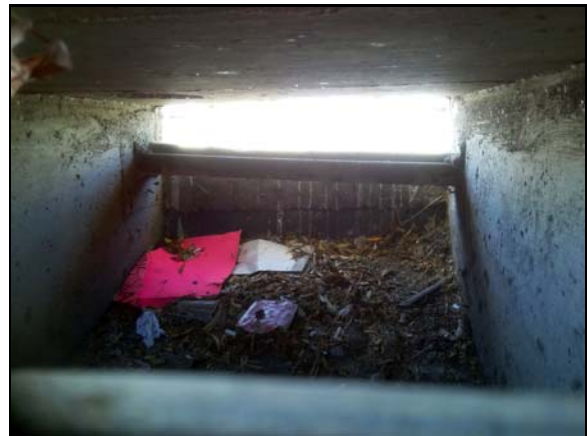
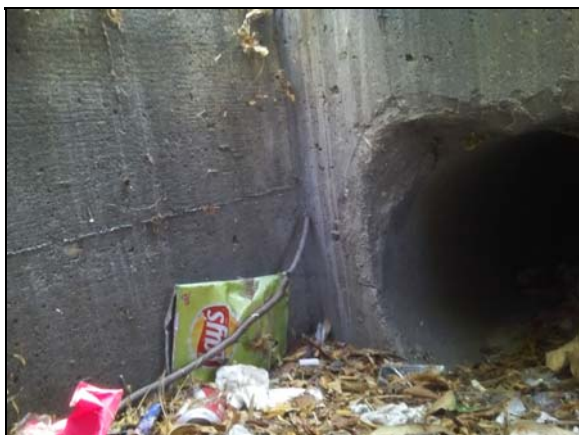
Catch Basin CB-L26-303

Susceptible to burial/overgrowth: No
Susceptible to ponding/flooding: No
Sediment/debris depth (%): 20
Type of sediment/debris: Silt/Vegetation/Trash
Infiltration in structure: None
Obstruction/deflection: 0.0
VANDA Condition Rating: Level 1 - No Damage
Prioritization Rating: Level 2 - Good
Prioritization Rationale: Sediment
Illegal dumping evidence: No

Pipe	Dir.	Hdn g	Dia. (in.)	Mat'l	Rim-inv (ft.)	Wtr Lvl (%)	Sed. (%)	Sed. Type	Infil-tration	Obs/Dfl. (%)	VANDA Rating	Priority Rating	Priority Rationale	Notes
CB-L26-303_JS-L26-502	Out	S	12	RCP	2.1	0	5	Silt/Vegetation	None	0	Level 1 - No Damage	Level 1 - Excellent	Condition	Under roadway.

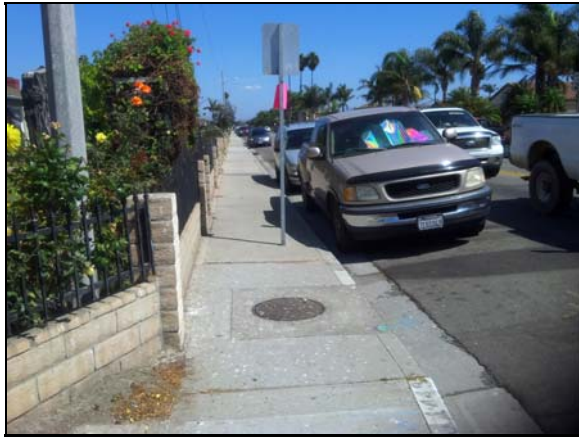
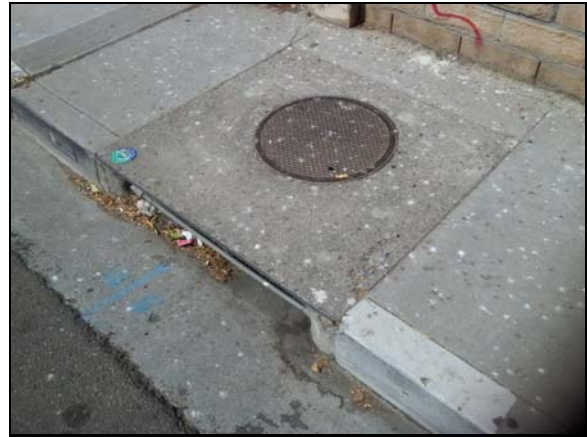
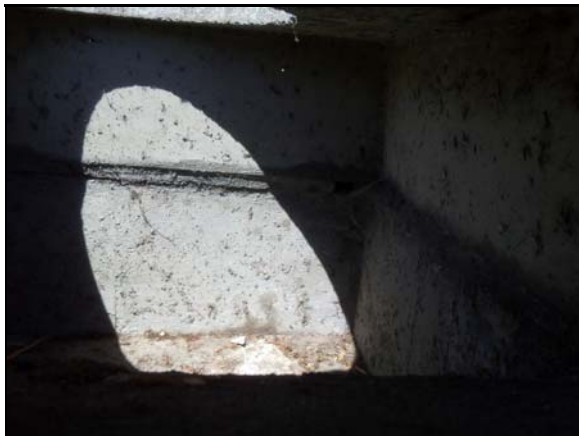
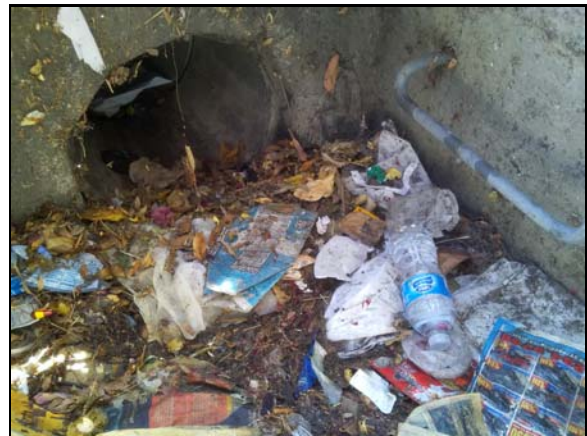
Catch Basin CB-L26-306

Susceptible to burial/overgrowth: No
Susceptible to ponding/flooding: No
Sediment/debris depth (%): 10
Type of sediment/debris: Silt/Vegetation/Trash
Infiltration in structure: None
Obstruction/deflection: 0.0
VANDA Condition Rating: Level 1 - No Damage
Prioritization Rating: Level 1 - Excellent
Prioritization Rationale: Condition
Illegal dumping evidence: No

Pipe	Dir.	Hdn g	Dia. (in.)	Mat'l	Rim-inv (ft.)	Wtr Lvl (%)	Sed. (%)	Sed. Type	Infil-tration	Obs/Dfl. (%)	VANDA Rating	Priority Rating	Priority Rationale	Notes
CB-L26-306_JS-L26-501	Out	S	12	RCP	2.5	0	5	Silt/Vegetation/Trash	None	0	Level 1 - No Damage	Level 2 - Good	Condition/Location	Under roadway.

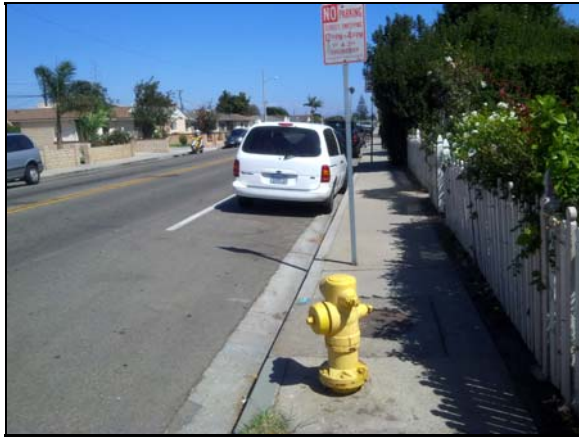
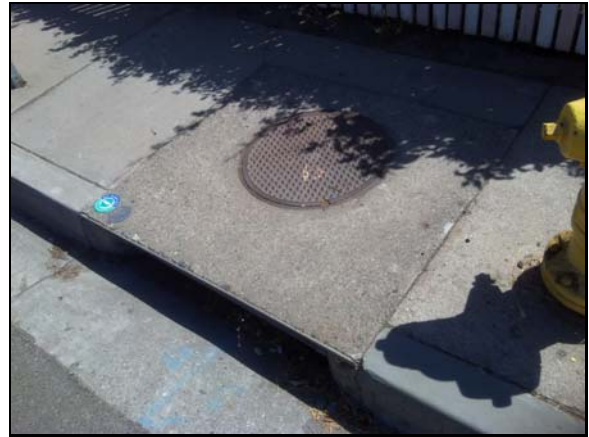
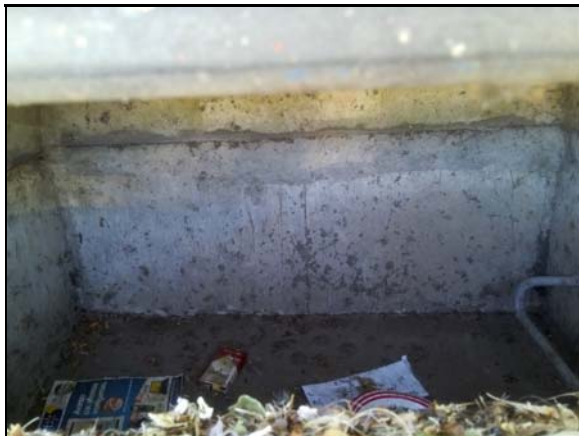
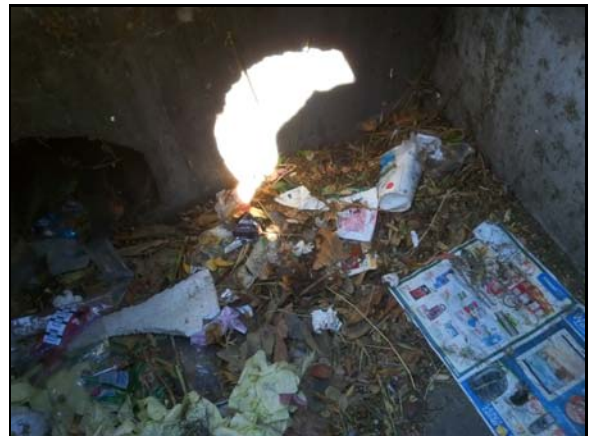
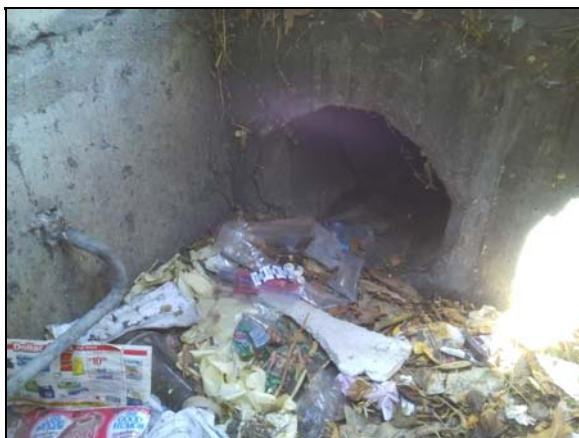
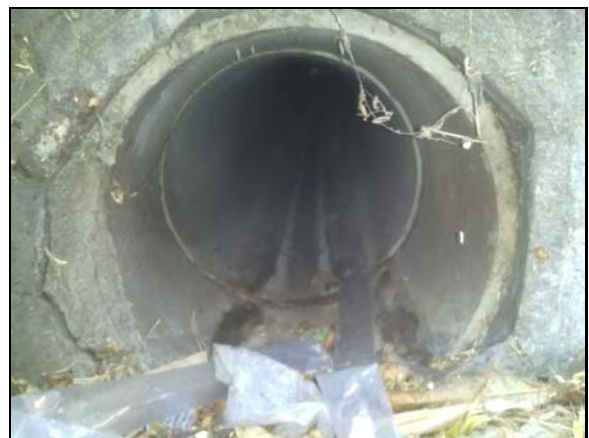
Catch Basin CB-L26-308

Susceptible to burial/overgrowth: No
Susceptible to ponding/flooding: No
Sediment/debris depth (%): 20
Type of sediment/debris: Vegetation/Trash
Infiltration in structure: None
Obstruction/deflection: 0.0
VANDA Condition Rating: Level 1 - No Damage
Prioritization Rating: Level 2 - Good
Prioritization Rationale: Sediment
Illegal dumping evidence: No

Pipe	Dir.	Hdn g	Dia. (in.)	Mat'l	Rim-inv (ft.)	Wtr Lvl (%)	Sed. (%)	Sed. Type	Infil-tration	Obs/Dfl. (%)	VANDA Rating	Priority Rating	Priority Rationale	Notes
CB-L26-308_JS-L26-501	Out	N	12	RCP	2.5	0	0	None	None	0	Level 1 - No Damage	Level 1 - Excellent	Condition	Under roadway.

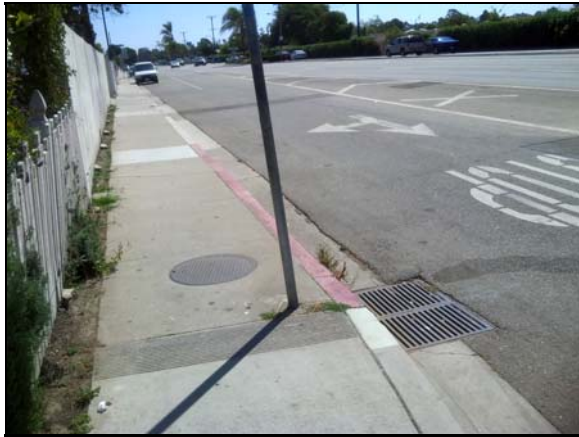
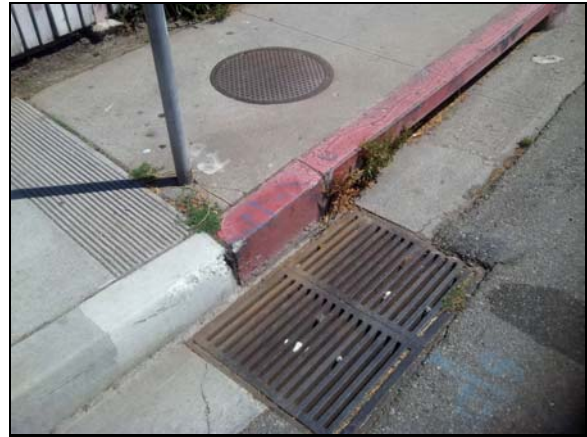
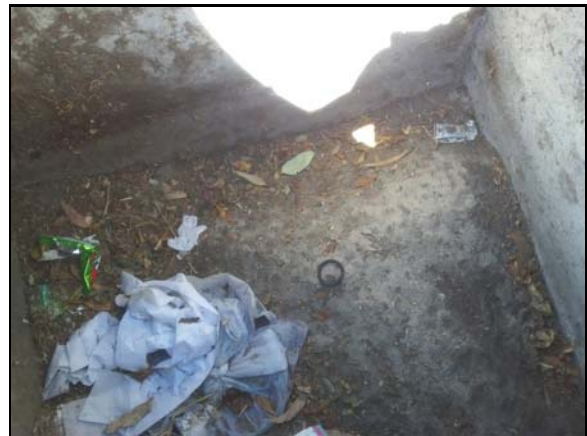
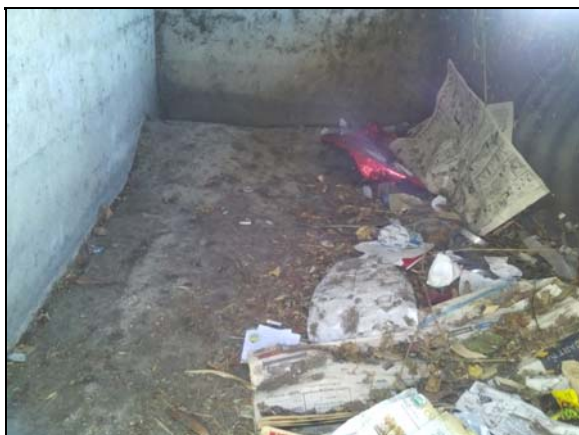
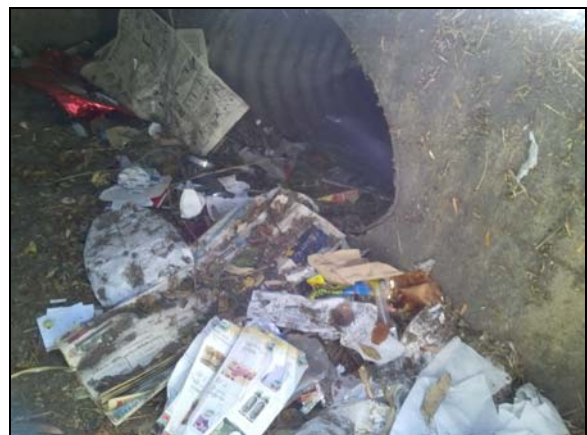
Catch Basin CB-L26-310

Susceptible to burial/overgrowth: No
Susceptible to ponding/flooding: No
Sediment/debris depth (%): 15
Type of sediment/debris: Silt
Vegetation
Trash
Infiltration in structure: None
Obstruction/deflection: 0.0
VANDA Condition Rating: Level 1 - No Damage
Prioritization Rating: Level 2 - Good
Prioritization Rationale: Sediment
Illegal dumping evidence: No

Pipe	Dir.	Hdn g	Dia. (in.)	Mat'l	Rim-inv (ft.)	Wtr Lvl (%)	Sed. (%)	Sed. Type	Infiltration	Obs/Dfl. (%)	VANDA Rating	Priority Rating	Priority Rationale	Notes
CB-L26-310_JS-L26-508	Out	W		CMP	2.8	0	15	Silt/Vegetation/Trash	None	5	Level 3 - Moderate Damage	Level 4 - Poor	Condition/Location	Under roadway.

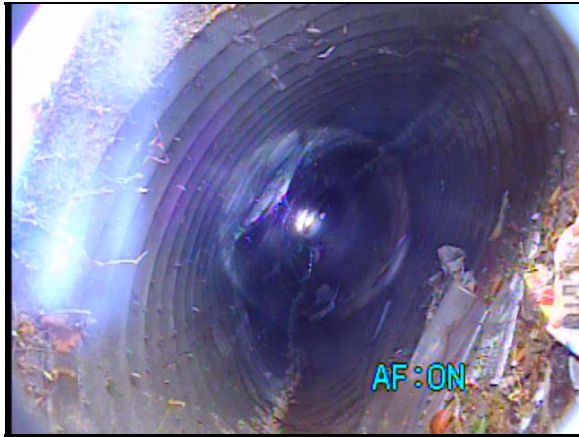
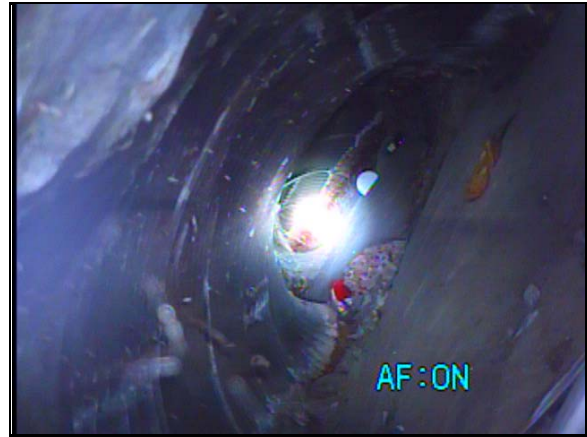
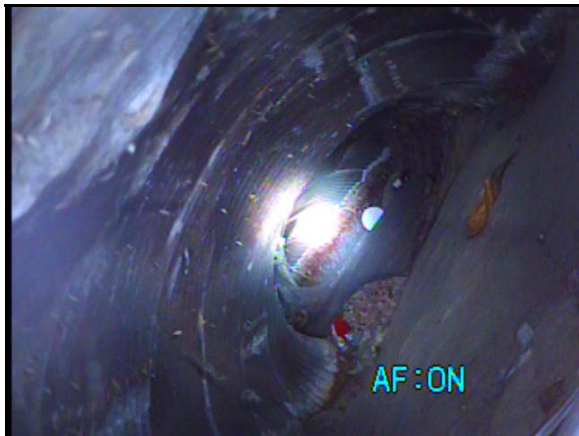
Catch Basin CB-L26-310

View inside outlet pipe

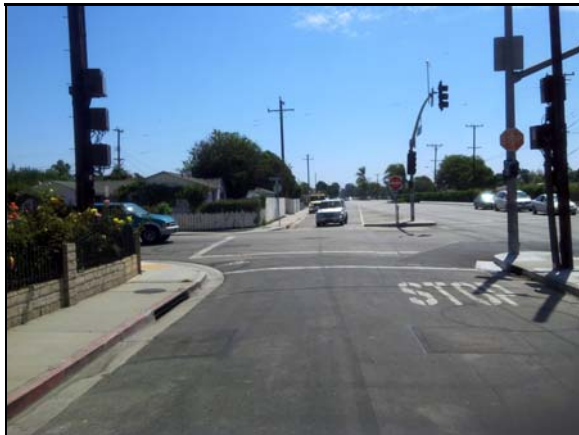
Location View

Susceptible to burial/overgrowth: N/A
Susceptible to ponding/flooding: Yes
Sediment/debris depth (%):
Type of sediment/debris: N/A
Infiltration in structure: N/A
Obstruction/deflection:
VANDA Condition Rating: N/A
Prioritization Rating: Level 3 - Fair
Prioritization Rationale: Other
Illegal dumping evidence: No

Area has history of flooding.

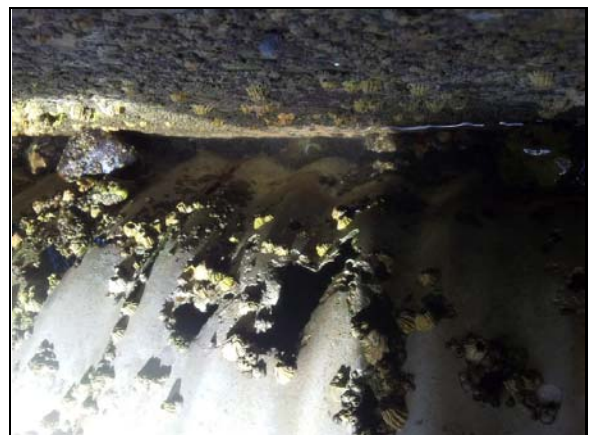
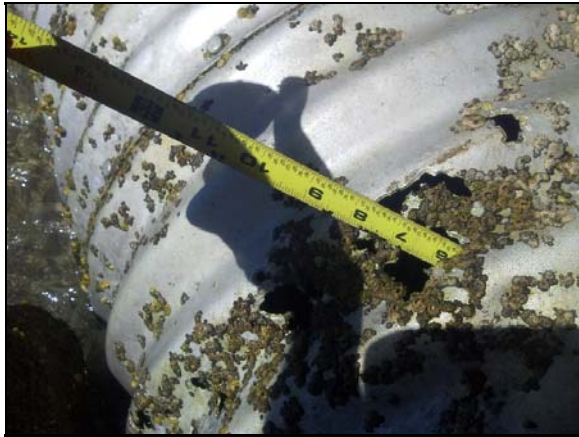
Outfall MH-H31-100_MIS-H31-800

Prioritization Rating: Level 3 - Fair
Prioritization Rationale: Condition/Location
Illegal dumping evidence: No

Perforations
