City of Oxnard

Public Works Integrated Master Plan

**PROJECT MEMORANDUM 5.3
CONDITION ASSESSMENT**

CITY OF OXNARD STORM DRAINAGE CONDITION ASSESSMENT

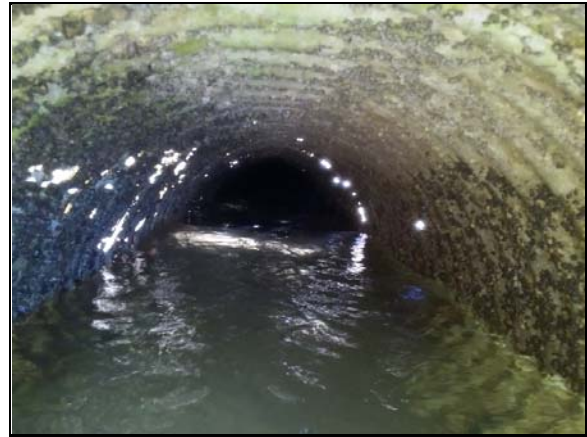
Assessment conducted at low tide. Pipe usually submerged. No signs of corrosion, but CMP does have perforations. Outfall projects 130 inches from rock shore. Water is clear, with no vegetation. Unable to evaluate catch basins due to erosion control devices in place.

Perforations
