City of Oxnard  
Wastewater Division  
**Wastewater Collection System**  
Capital Improvement Projects

# Central Trunk Sewer Manhole Replacement

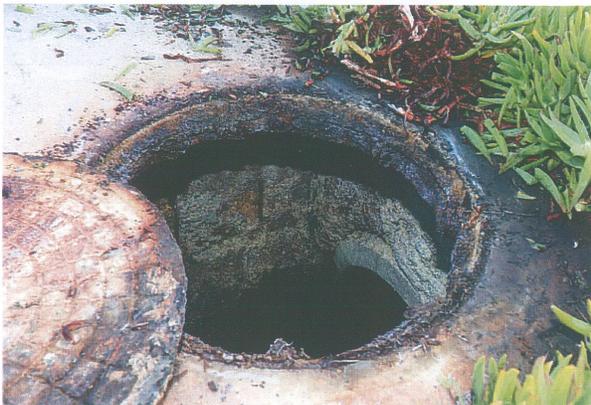
- Extensive concrete corrosion of interior of the sewer manhole structure
- Manhole access covers are severely corroded in certain locations and pose a direct safety hazard to maintenance staff
- Concrete structures are degraded to the point where both rebar and aggregate are exposed

- Extensive corrosion of interior concrete structure, which could lead to structural failure and collapse of the manhole.
- Extensive corrosion of access covers and supporting rings could result in severe fall injuries to City staff and unauthorized persons walking on top of the manholes.
- Failure could result in a large Sanitary Sewer Overflow (SSO) spill that would discharge directly into the Ormond Lagoon Waterway as well as Cal-Gisler, Blackstock North, Blackstock South and the College Estates neighborhoods. This would pose both a significant impact to public health as well as regulatory violations and financial penalties.

Phase 1	Improvements	Estimated Cost
Emergency (Yrs 1-2)	Replacement of 47 manholes	\$1,410,000
CIP (Yrs 3-5)	Replacement of 27 manholes	\$810,000
CIP (Yrs 6-10)*	None Identified	---

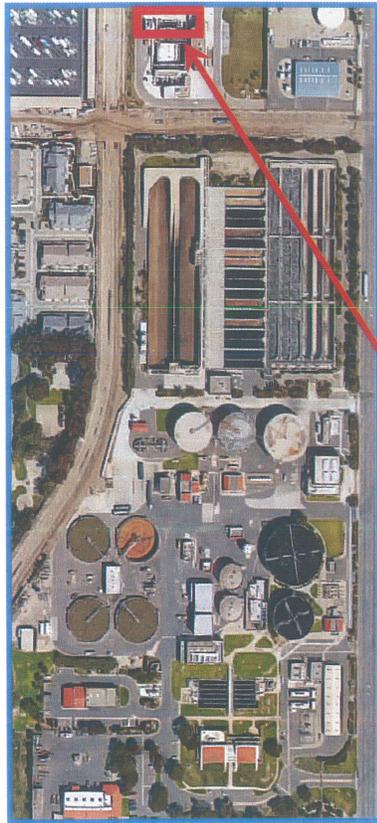
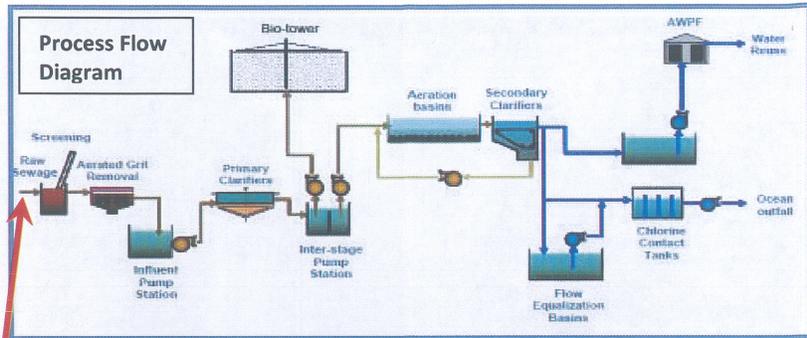
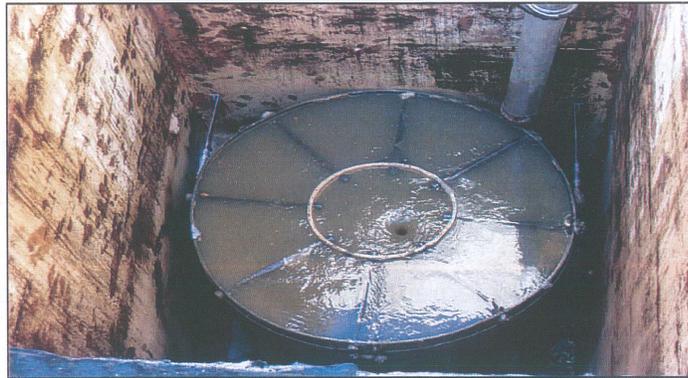
Headworks Meter Vault/Vortex Structure Location

Overall the condition of the Headworks Meter Vault/Vortex Structure is poor with a risk grading of "critical." Factors include:

- Concrete coating in the Meter Vault/Vortex Structure has failed.

- Corrosion of the vault is accelerating due to failure of coating.

- Concrete coating in the Meter Vault/Vortex Structure has failed and corrosion is accelerating creating conditions for potential structural failure.
- Structural failure of the Meter Vault/Vortex Structure would likely lead to raw wastewater spills, implementation of temporary pumping measures and costly emergency repairs.

Phase	Improvements	Estimated Cost
Emergency (Yrs 1-2)	Concrete coating repair	\$280,000
CIP (Yrs 3-5)	None Identified	---
CIP (Yrs 6-10)*	None Identified	---

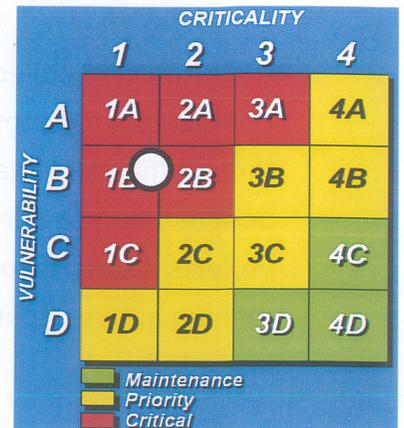
Reliability grading of “Not Reliable” due to:

- During Peak Wet Weather Flows these pipelines are at risk of exceeding capacity.
- Failure could result in a SSO event that would discharge raw wastewater directly into the storm drain system, Northeast Business Community as well as the Fremont North, Fremont South or La Colonia neighborhoods.

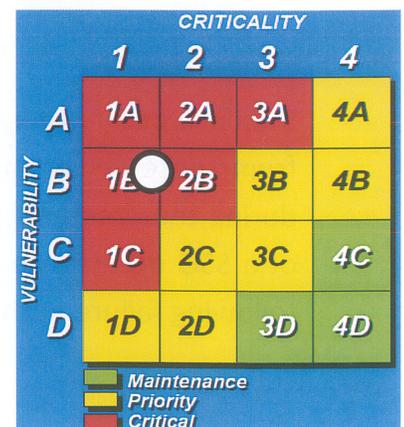
Overall the condition of the Miscellaneous Sewer Mains is poor with a risk grading of “critical.” Factors include:

- Existing sewer mains that have a poor rating (Grade 4) condition or in need of immediate attention (Grade 5) have been identified for repair or replacement under these projects.

- Based on the “critical” grade of these facilities, it is projected that Sanitary Sewer Overflow (SSO) may likely occur if these pipes are not repaired

- There are 244 pipe repairs identified in the collection system that are assigned a Poor Condition Grade (4) and contain severe defects that will probably cause failures within 5-10 years based on NASSCO PACP rating standards. These are industry wide rating standards used to assess and quantify the condition of publicly owned wastewater collection system assets.
- There are 63 pipes repairs identified in the collection system that are rated a Grade (5) condition, which contain severe defects and are projected to likely fail within the next 5 years or sooner.
- Failure may likely result in a SSO that would discharge directly into the storm drain system
- Failure may result in the creation of a sinkhole causing an immediate hazard to the residents within the community

Phase 1	Improvements	Estimated Cost
Emergency (Yrs 1-2)	Annual Pipe Repairs – None Identified	---
	Concrete Sewer Replacement – None Identified	---
CIP (Yrs 3-5)	Annual Pipe Repairs	\$200,000/yr
	Concrete Sewer Replacement	\$500,000/yr
CIP (Yrs 6-10)*	Annual Pipe Repairs	\$200,000/yr
	Concrete Sewer Replacement	\$500,000/yr
