# Mandalay Bay Seawall Repair Conceptual Study and Feasibility Analysis - FINAL

TC39527  
March 6, 2020

**City of Oxnard**  
305 West Third Street  
Oxnard, CA 93030

**Tetra Tech, Inc.** P +1-(562) 257-2589  
249 E. Ocean Blvd., Ste. 325 F +1-(562) 495-5029  
Long Beach, CA 90802 tetratech.com

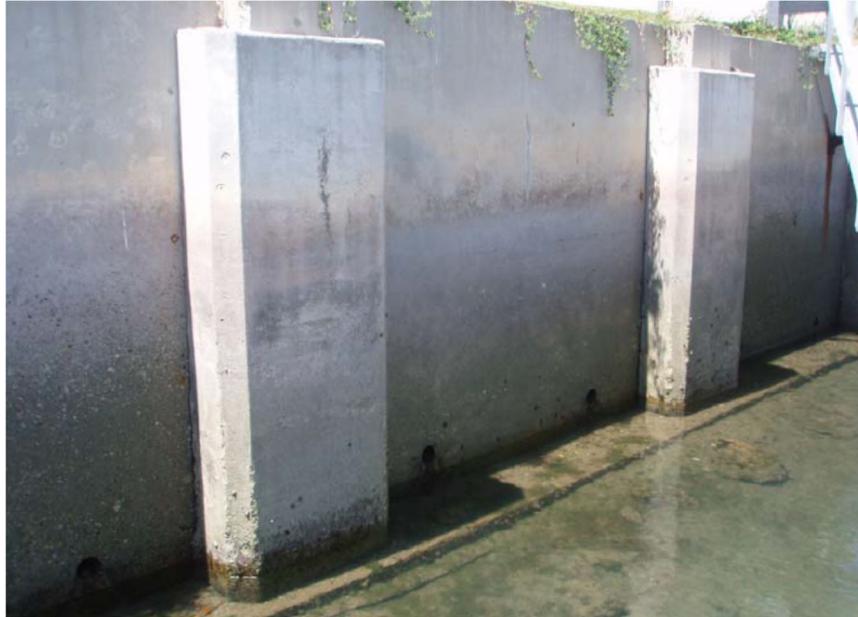
Figure 3 - Typical pilaster jacket repairs [from TranSystems (2017)]

Over the years, repairs have been made in a number of locations. A number of these repairs have been concrete jackets installed on Boise wall pilasters. Other repairs have been to the cutoff walls and channel bottom slopes to prevent undermining of the foundations and to the weep holes to control backfill losses.

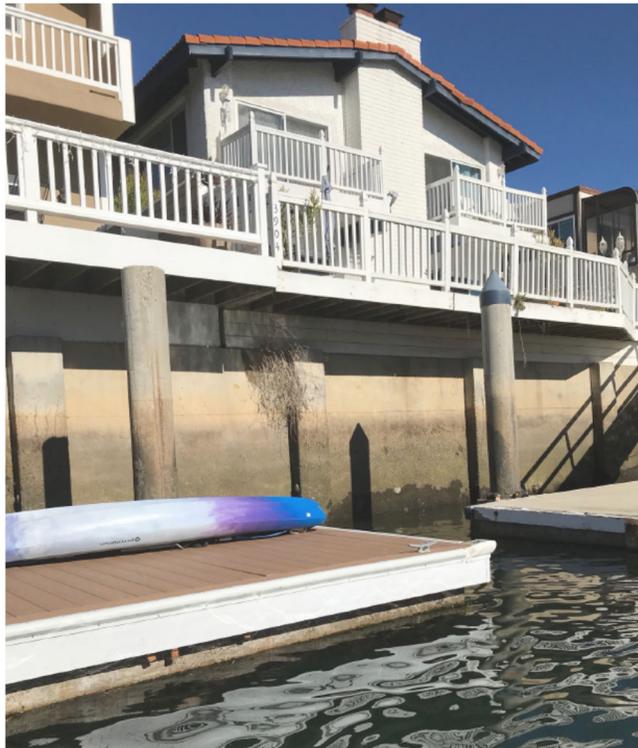
Figure 10 - Typical overhanging decks

In many locations, homeowners have decks that cantilever over the top of the seawall, complicating the work and limiting the repair options available. However, removal and replacement of the decks, in addition to being a significant expense will be a major inconvenience to the residents. Therefore, options that avoid the need to remove or alter decks are preferred.

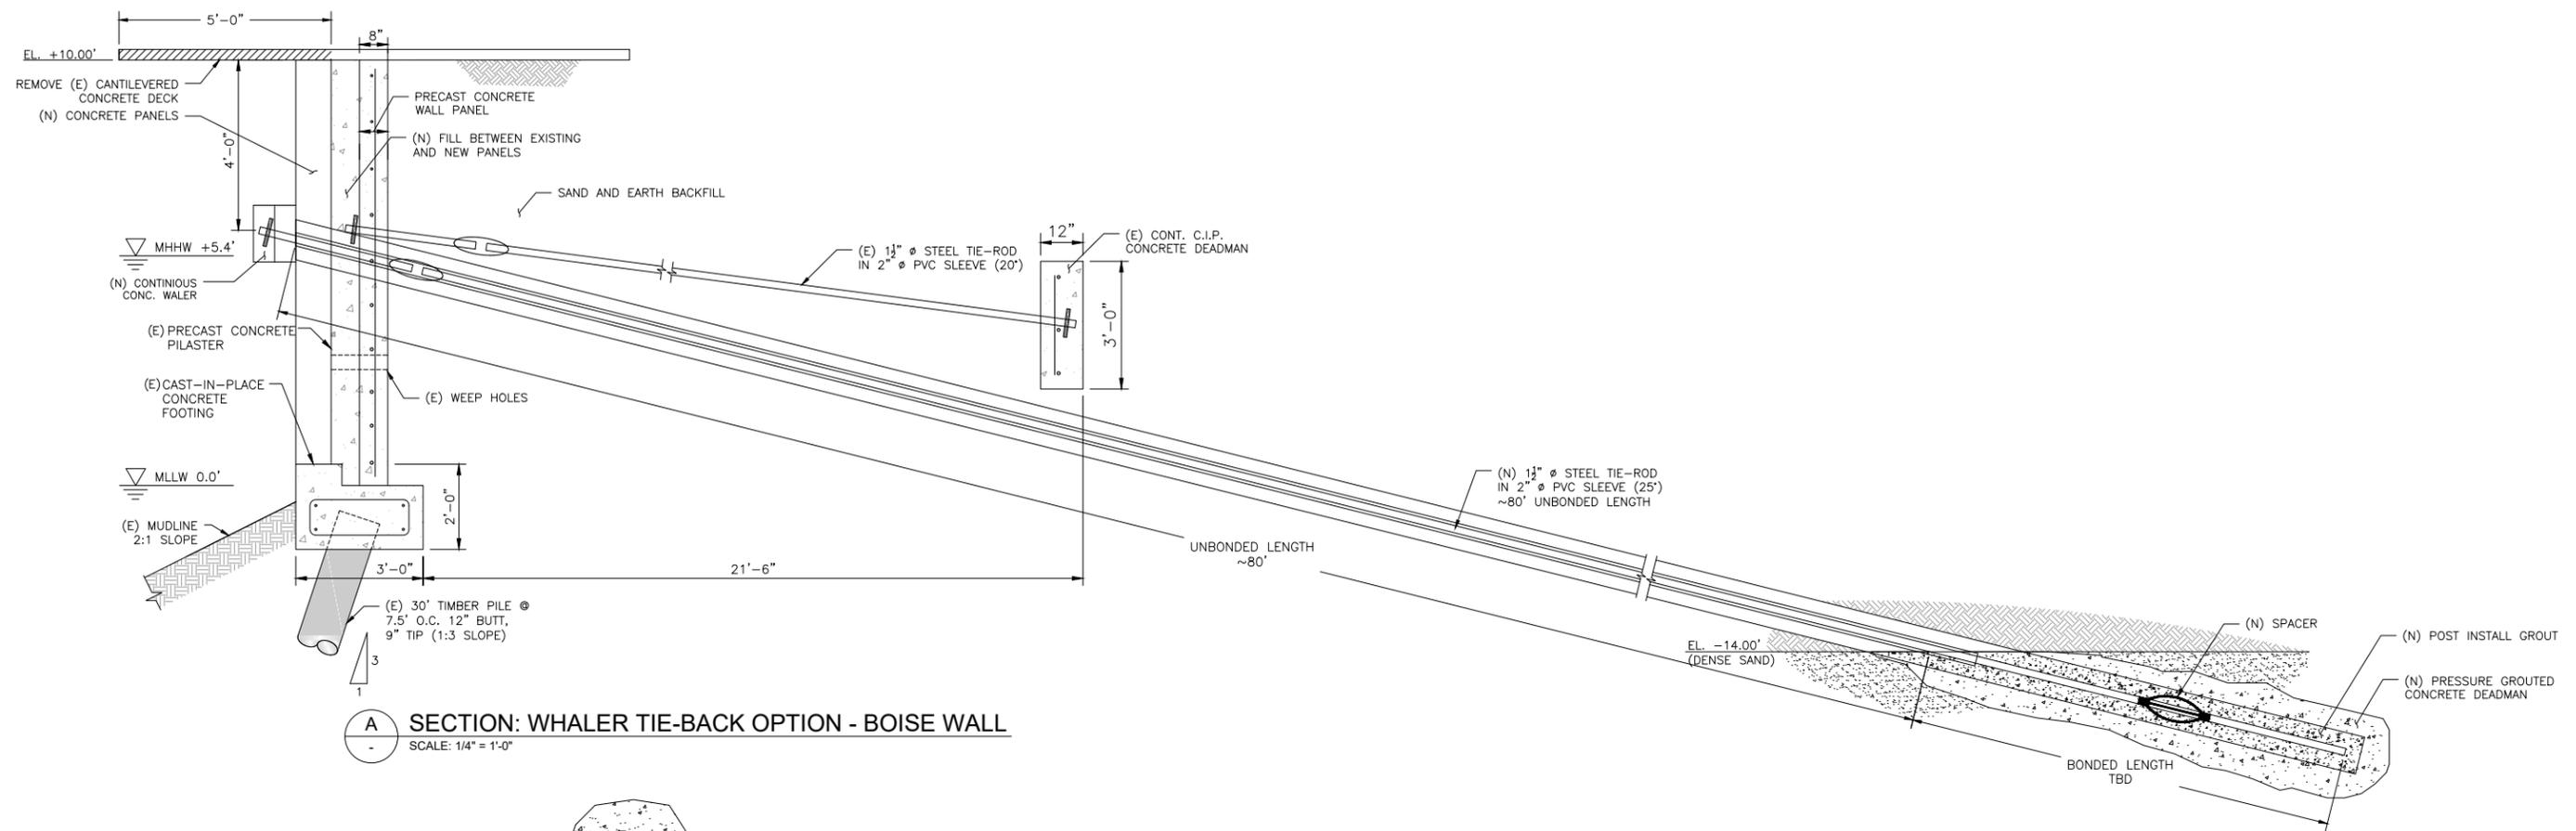
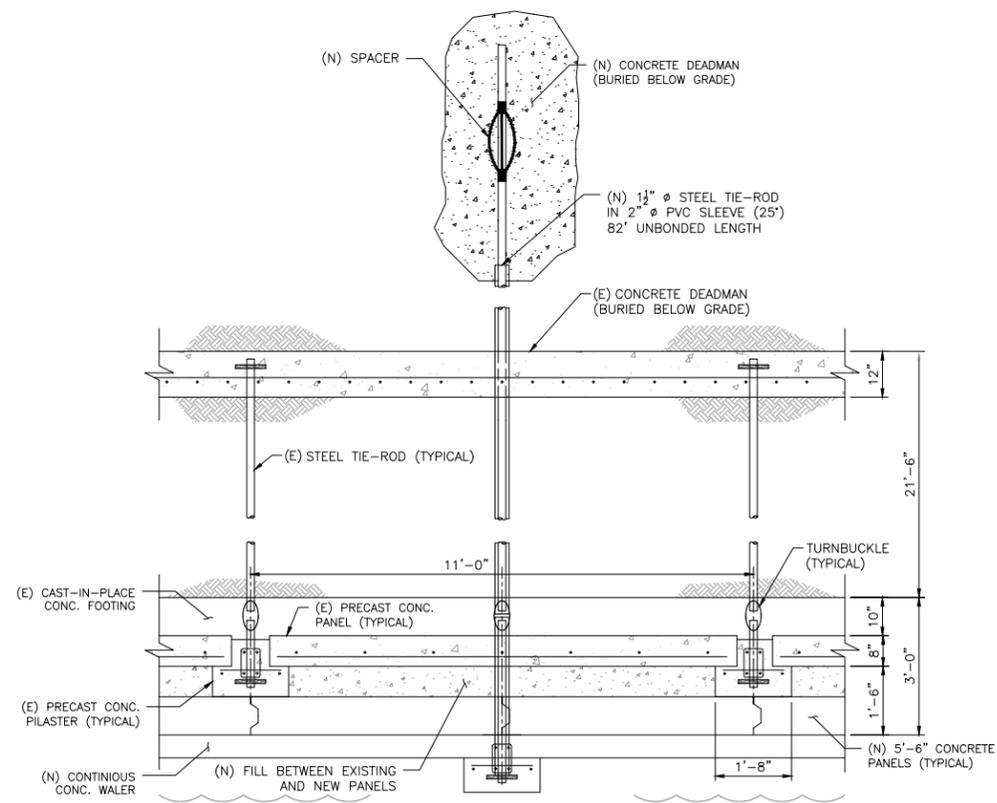
Figure 12

- Relies on the existing footing and piles for vertical support.
- Some potential geotechnical issues need to be confirmed to ensure this option is viable

**A SECTION: WHALER TIE-BACK OPTION - BOISE WALL**  
SCALE: 1/4" = 1'-0"

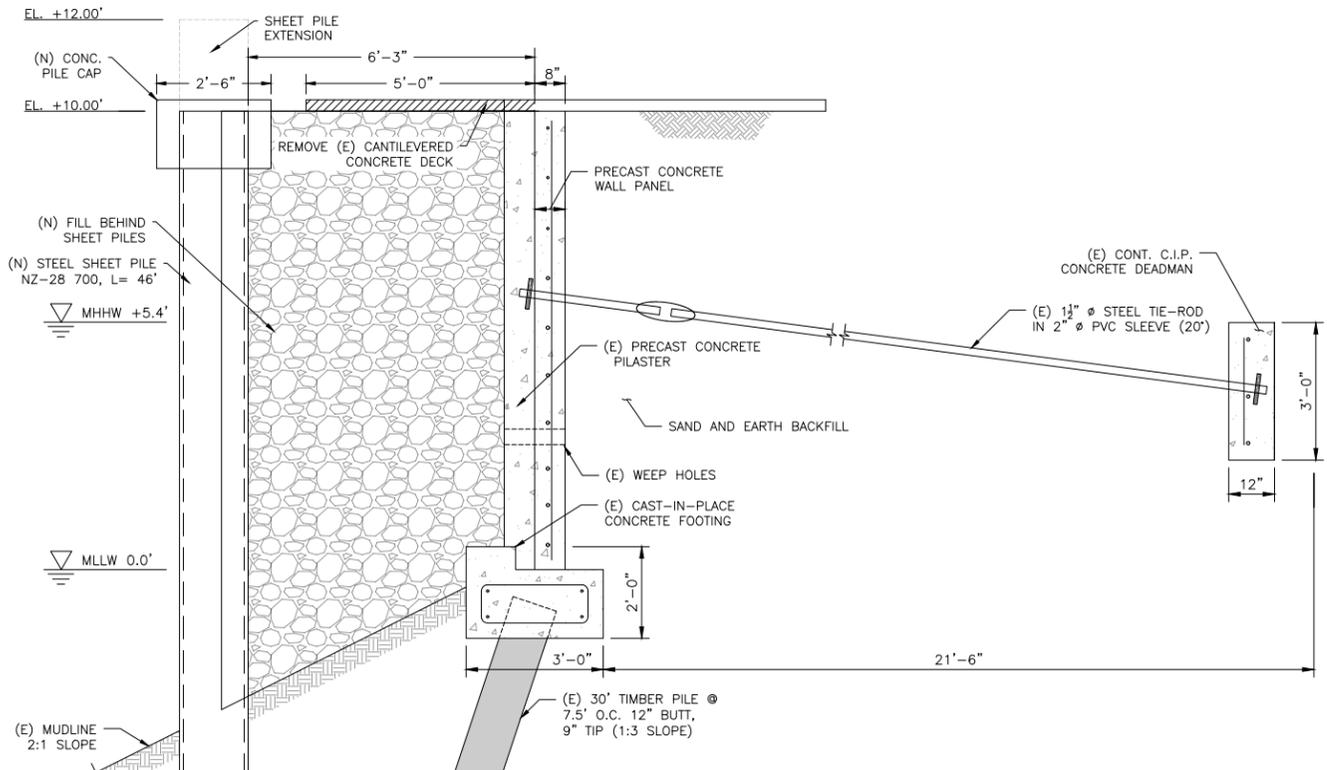
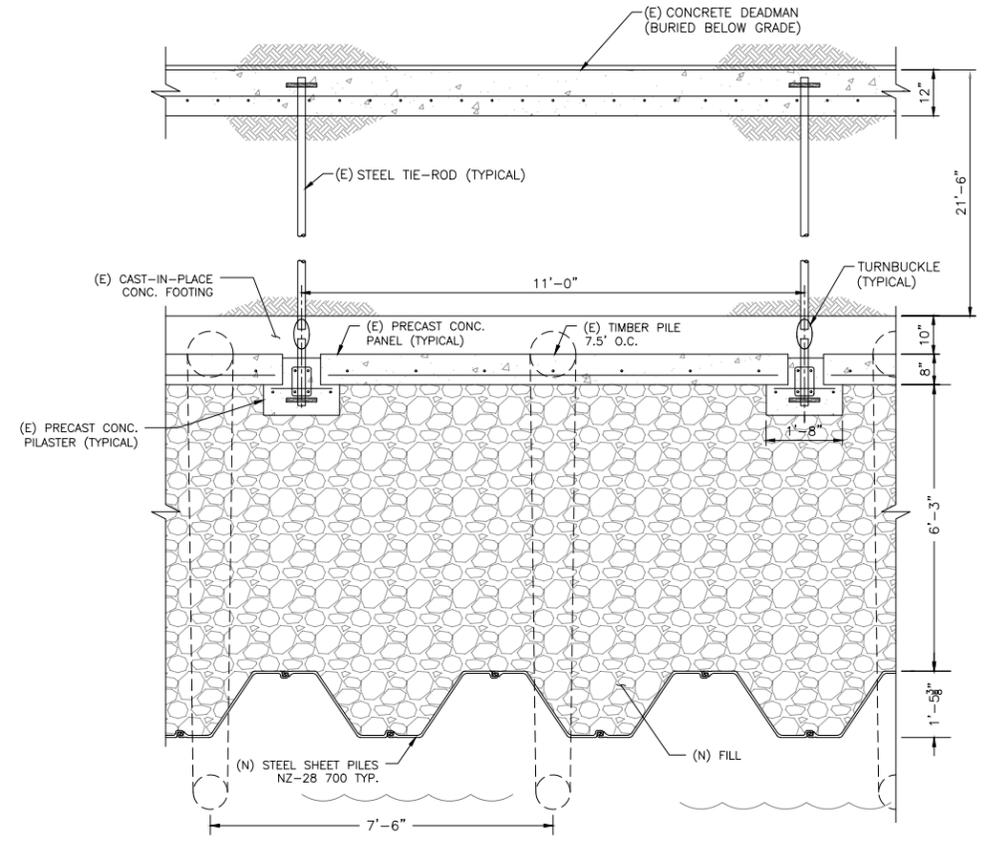
Figure 13

- Expensive
- Extends significantly beyond current footprint of wall and footing.
- Could be relatively disruptive to homeowners. Would possibly require removing and replacing some decks that overhang the seawall.
- Large offset will require significant amounts of fill and coverage of existing bottom could make permitting difficult.

**B SECTION: OFFSET SHEET PILE OPTION - BOISE WALL**  
 SCALE: 1/4" = 1'-0"  
 NOTES: FILL QUANTITY = 77.2 CF/LF

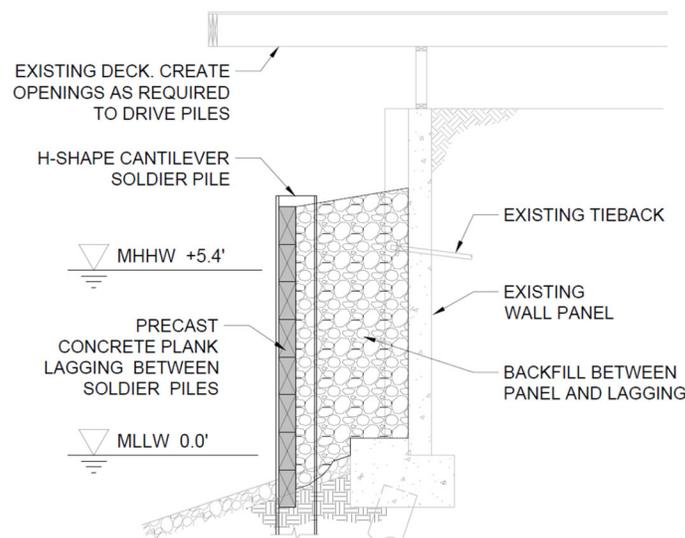
- Expensive
- Extends outside current footprint of wall and footing.
- Disruptive to homeowners. Installing soldier piles will require cutting holes in decks that overhang the seawall.
- Pile driving likely to be objectionable to residents and could lead to liquefaction and settlement. (Alternative pile installation methods to avoid this issue will significantly increase cost for this option.)
- If not carefully constructed, lagging could be uneven and/or allow leaks of backfill, which would be unattractive.

Figure 14 - Cantilever soldier pile and lagging

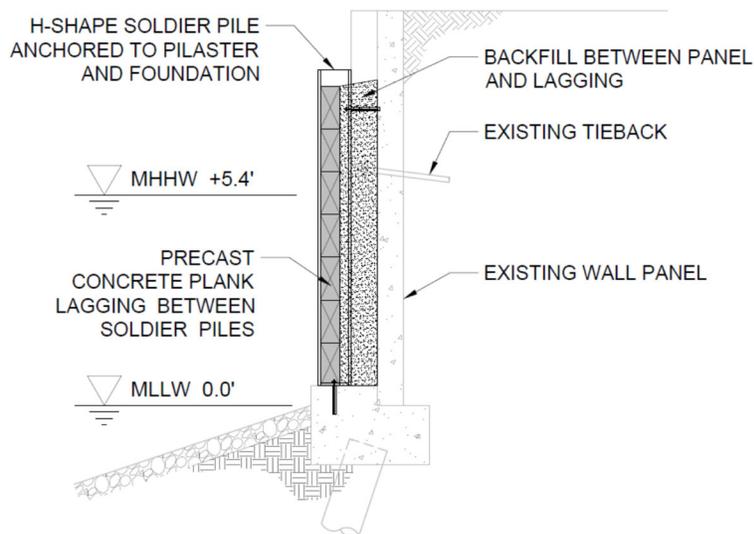
- Expensive, but likely less so than the cantilever option
- Does not do anything to protect the pilaster or footings, but still partially relies on them.
- Covers, but does not fully protect existing wall. Hides existing from inspection.
- Does not address seismic vulnerability

Figure 15 - Soldier piles bolted to existing pilasters

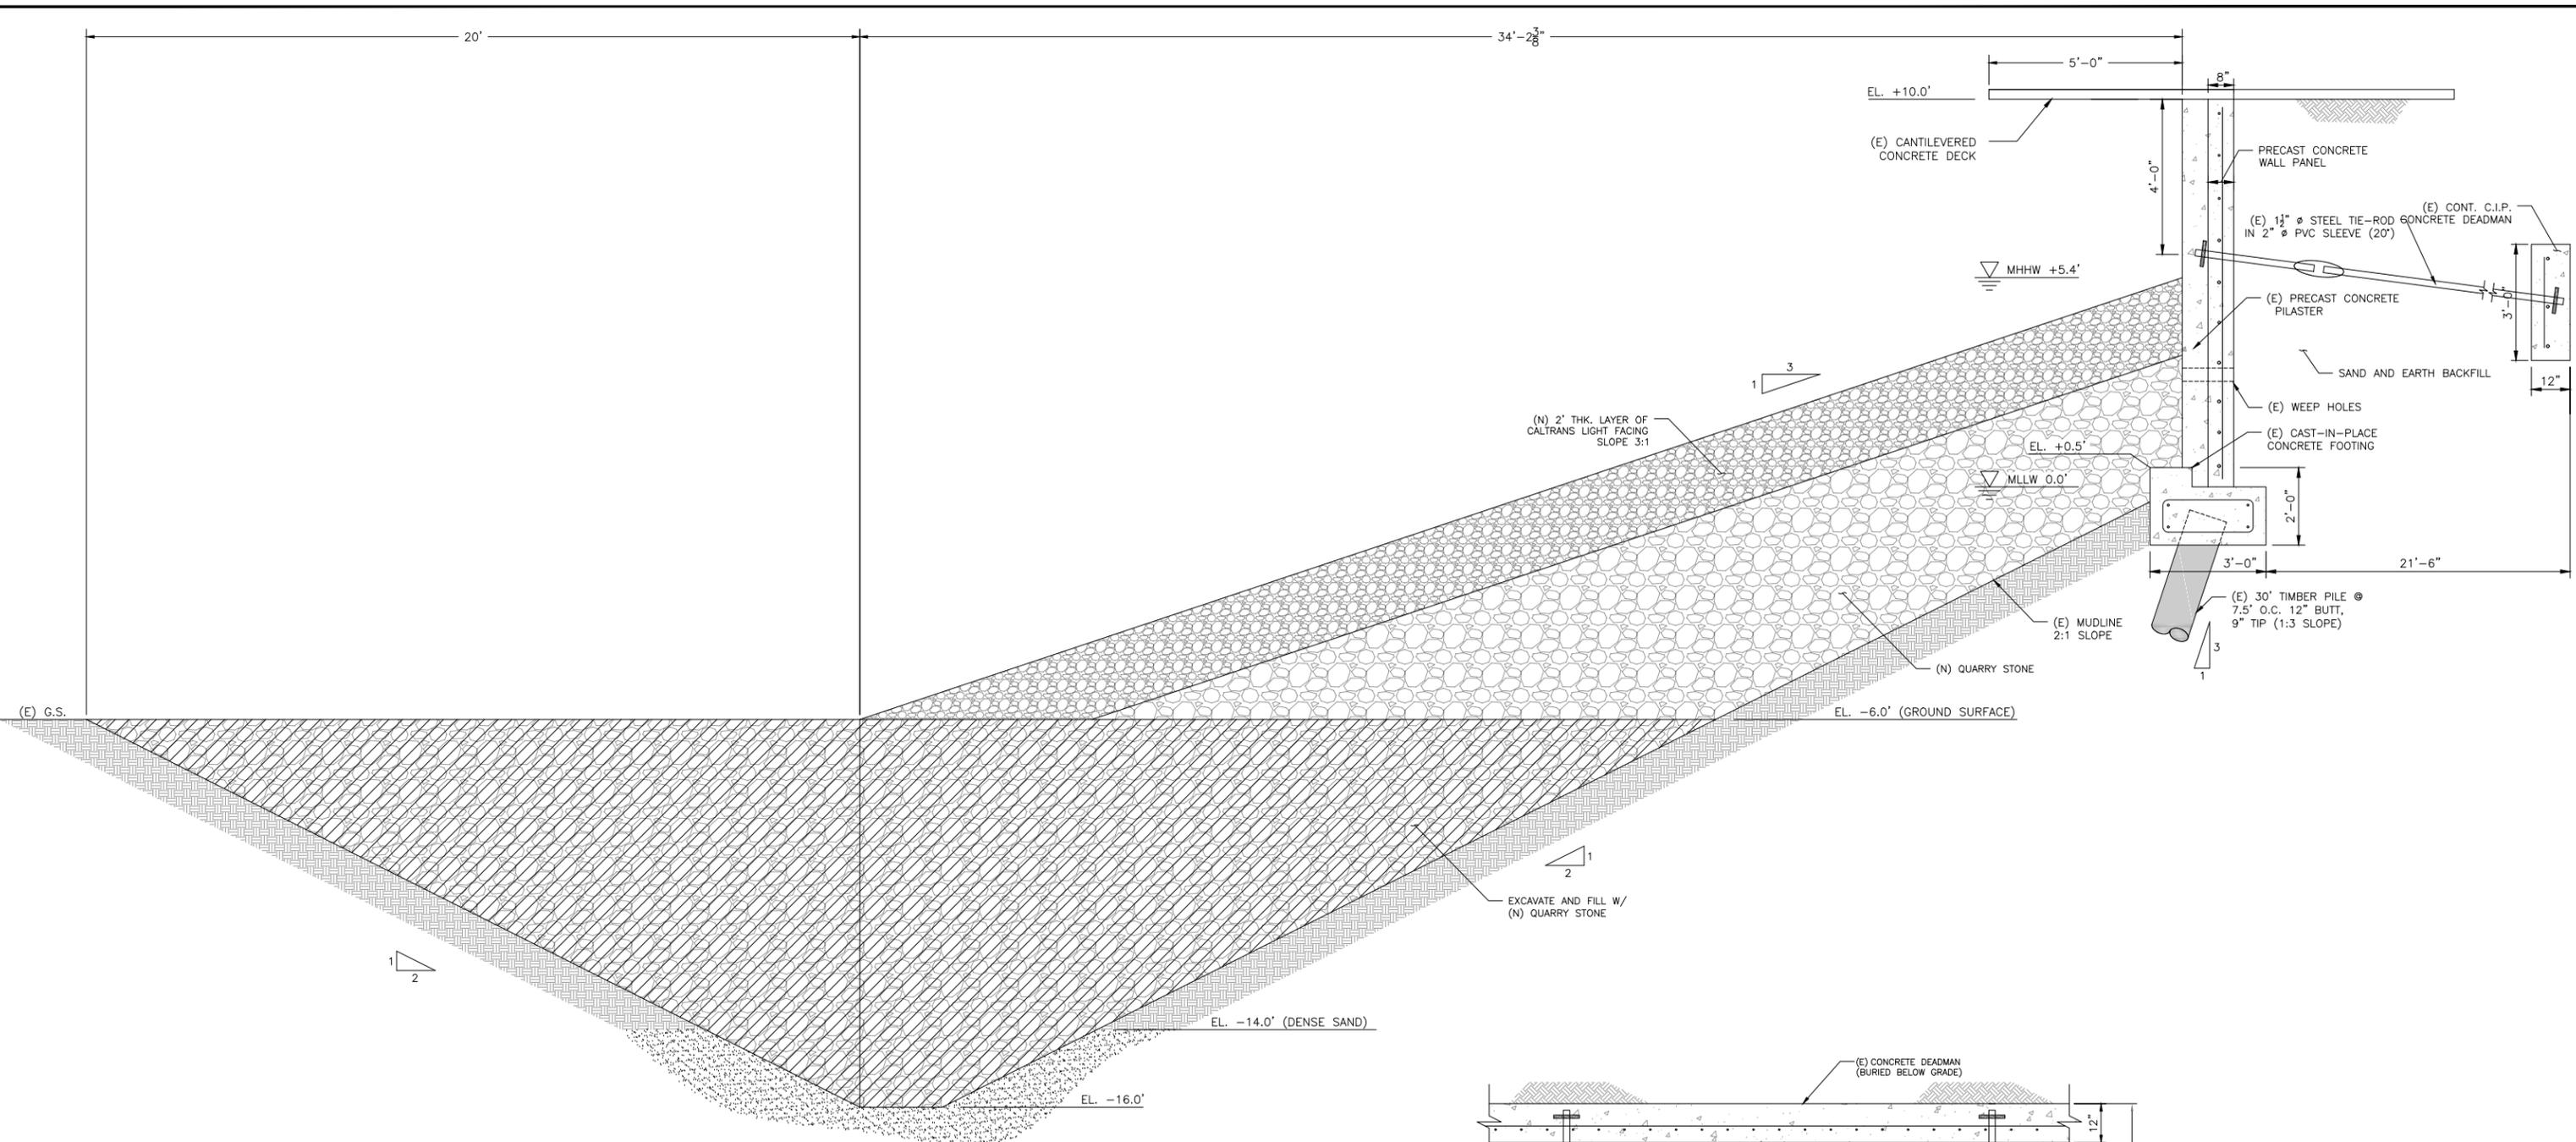
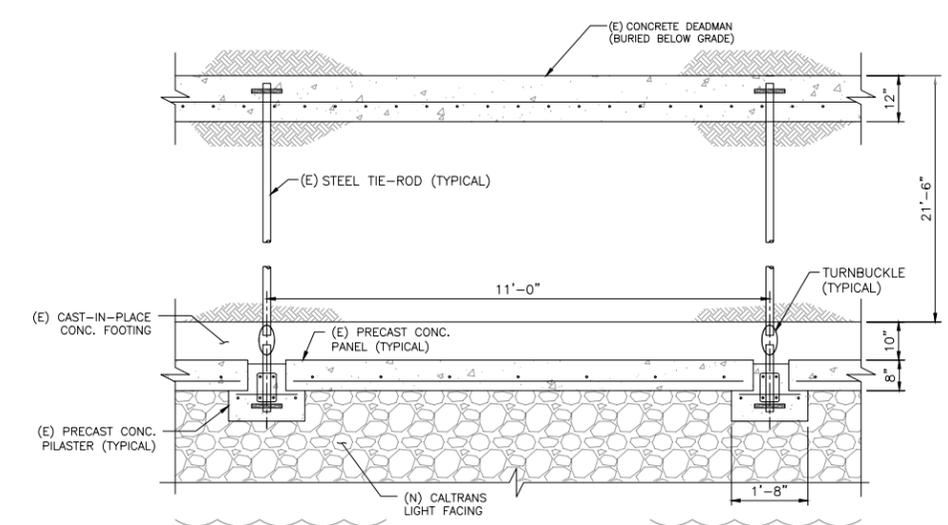
Figure 18

- Would require docks be moved further away from walls, which would require revisions to pier head line. In narrower channels there may not be sufficient room, so might require elimination of docks, which is assumed to be unacceptable to homeowners. Therefore, probably only feasible on wider channels.
- Feasibility depends on slope and depth of channel bottoms at base of walls. Limited information currently available so would require bathymetric survey.
- Large encroachment on existing soft bottom, and significant excavation will cause permitting difficulty.

**C SECTION: ROCK REVETMENT OPTION - BOISE WALL**  
 SCALE: 1/4" = 1'-0"  
 NOTES: EXCAVATION QUANTITY = 221.3 CF/LF  
 QUARRY STONE TOTAL = 316.9 CF/LF  
 CALTRANS LIGHT FACING = 62.4 CF/LF

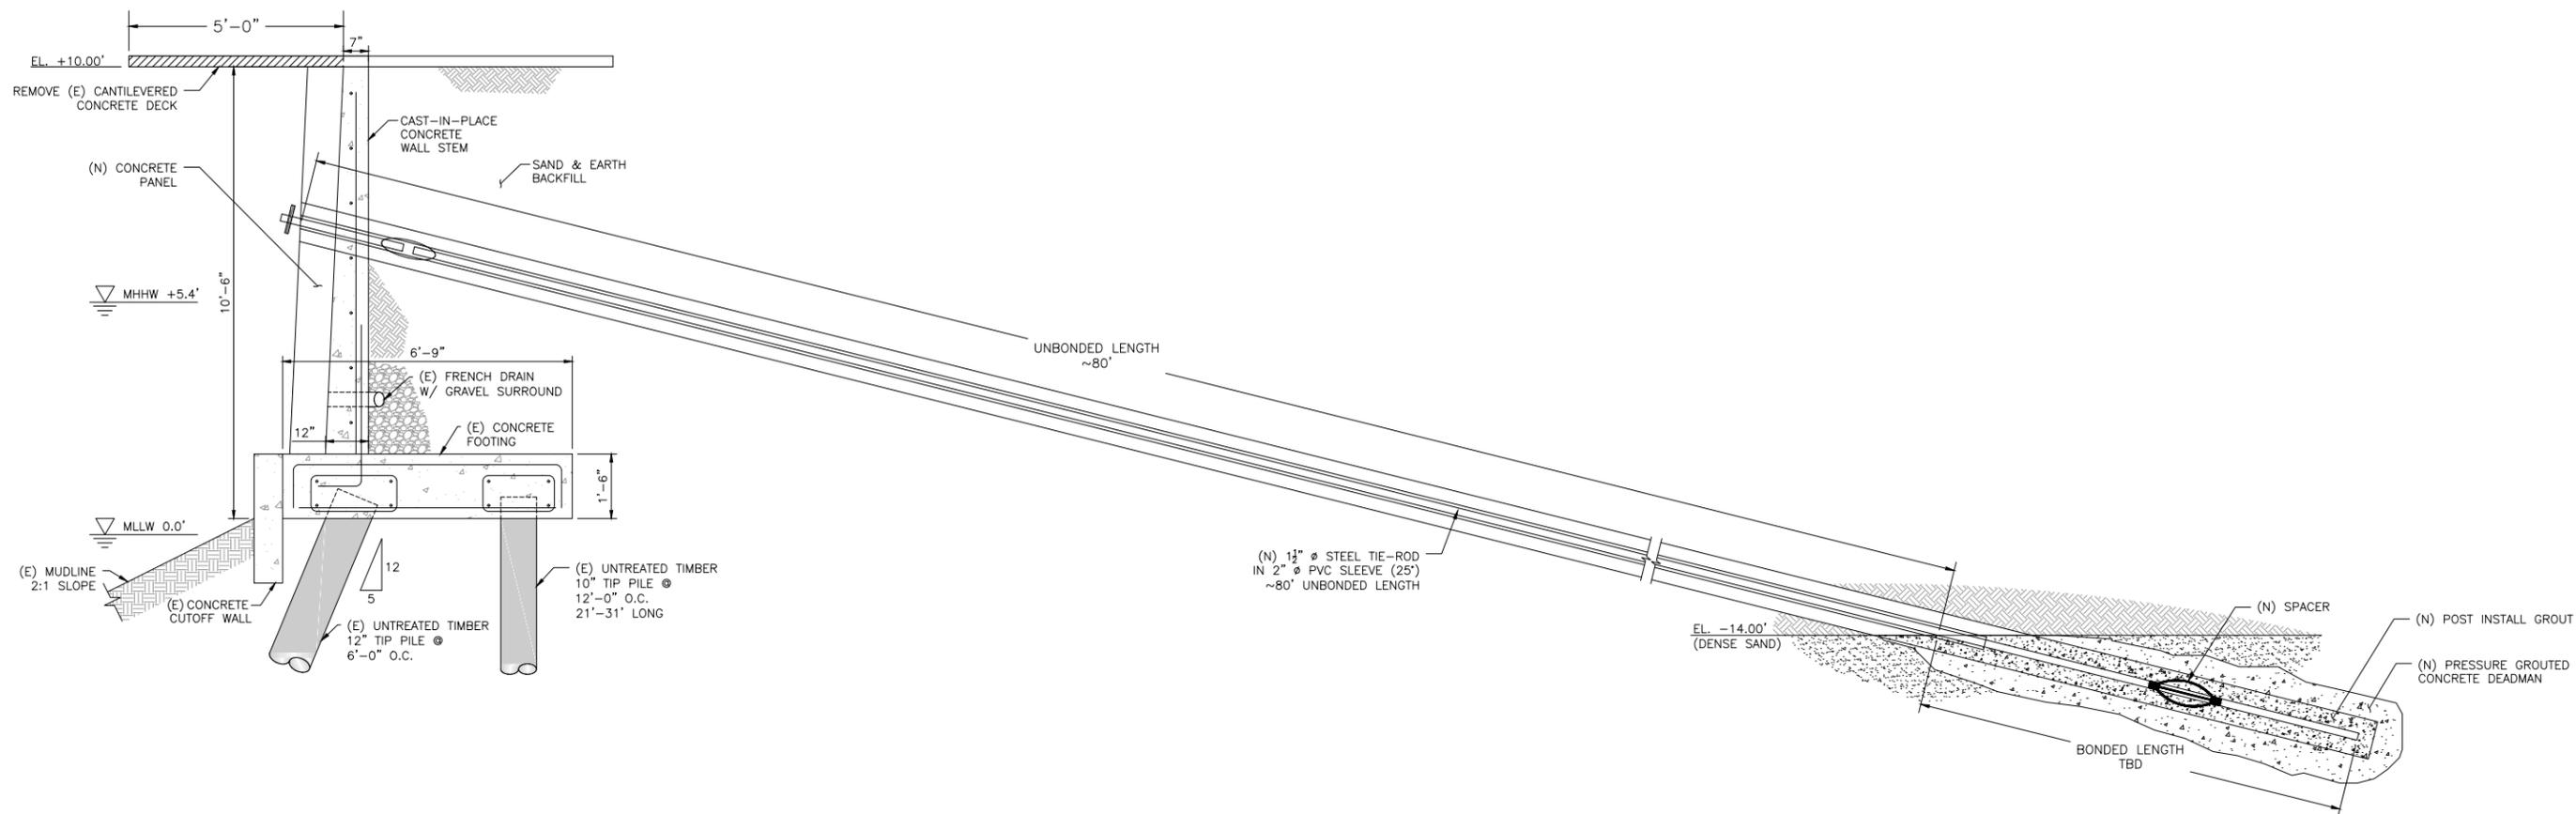
Figure 19

This scheme is essentially the same as for the Boise walls, but the wider footing with two lines of piles makes the geotechnical issues less likely to preclude this option. (See Figure 19)

**D** SECTION: WHALER TIE-BACK OPTION - ZURN WALL  
 SCALE: 1/4" = 1'-0"

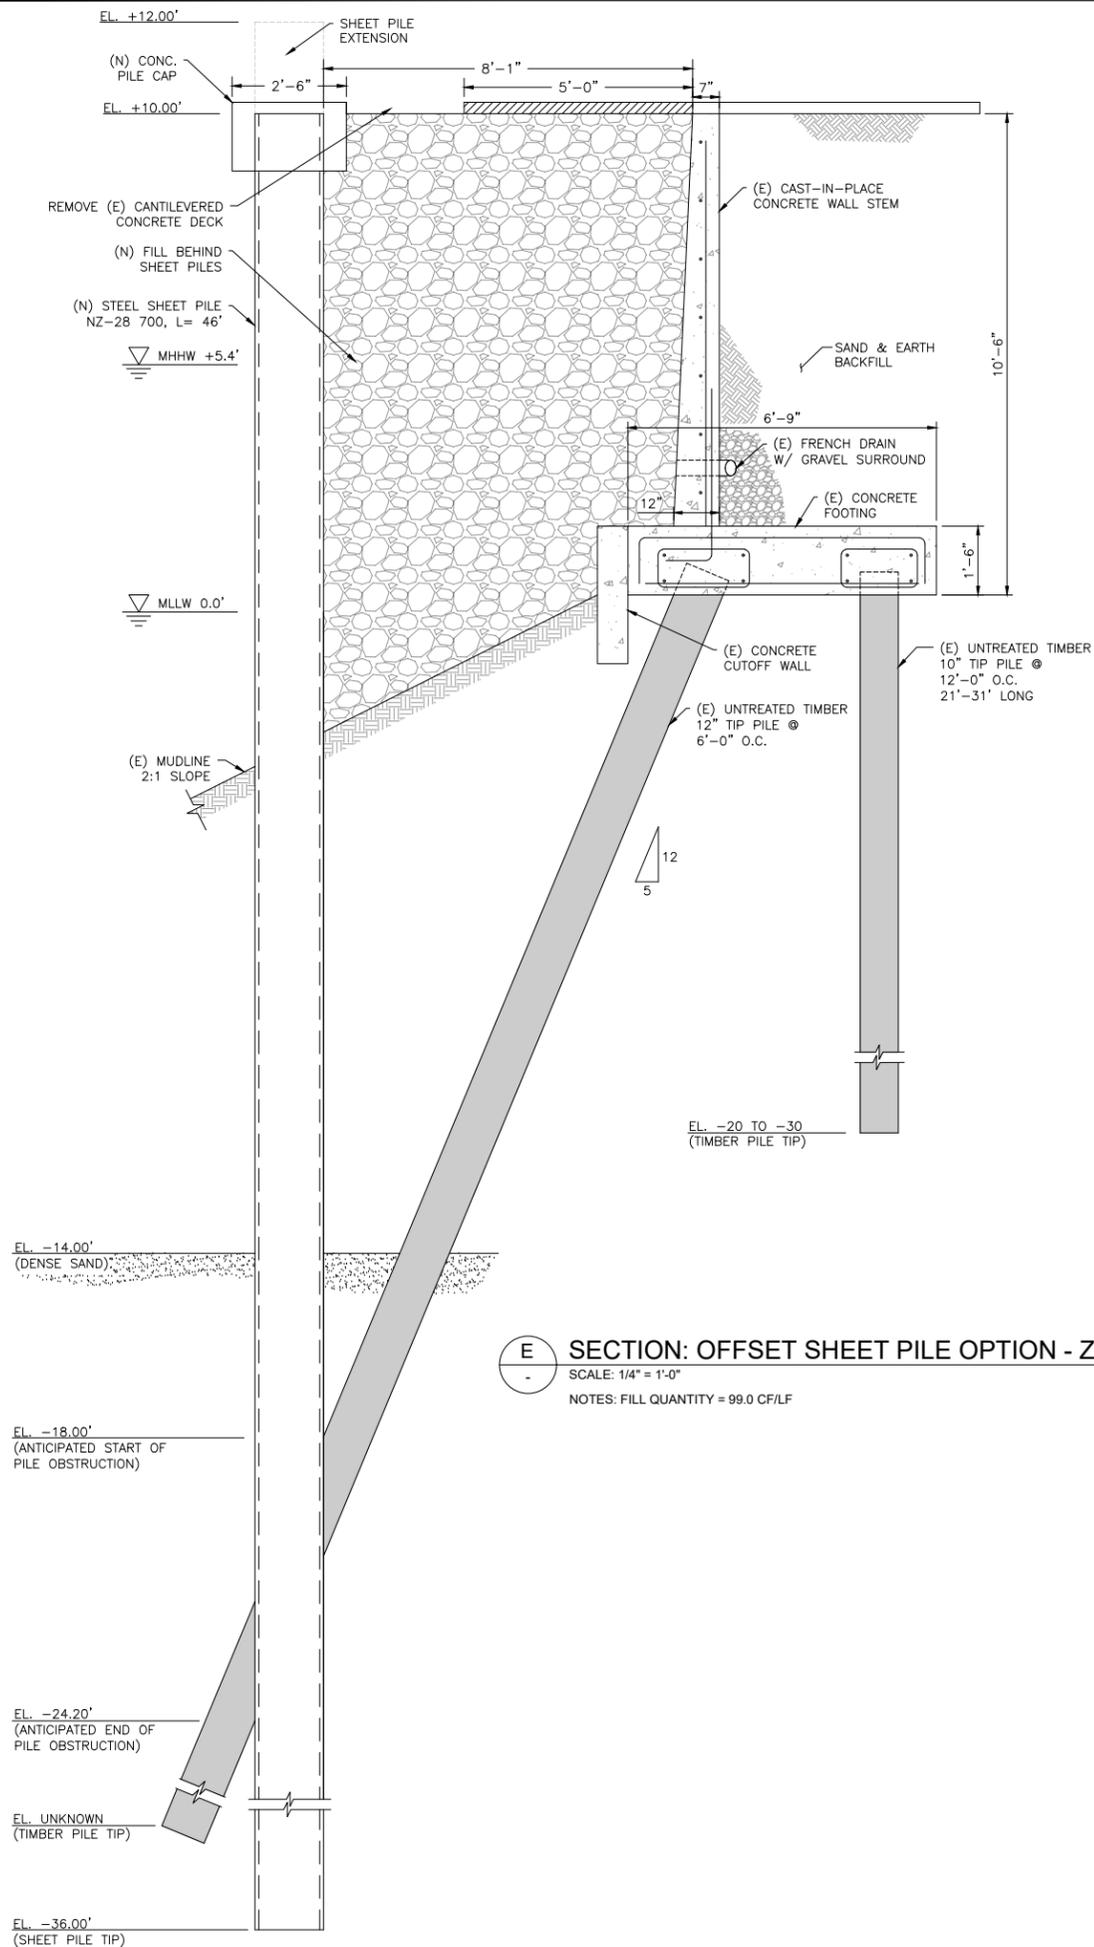
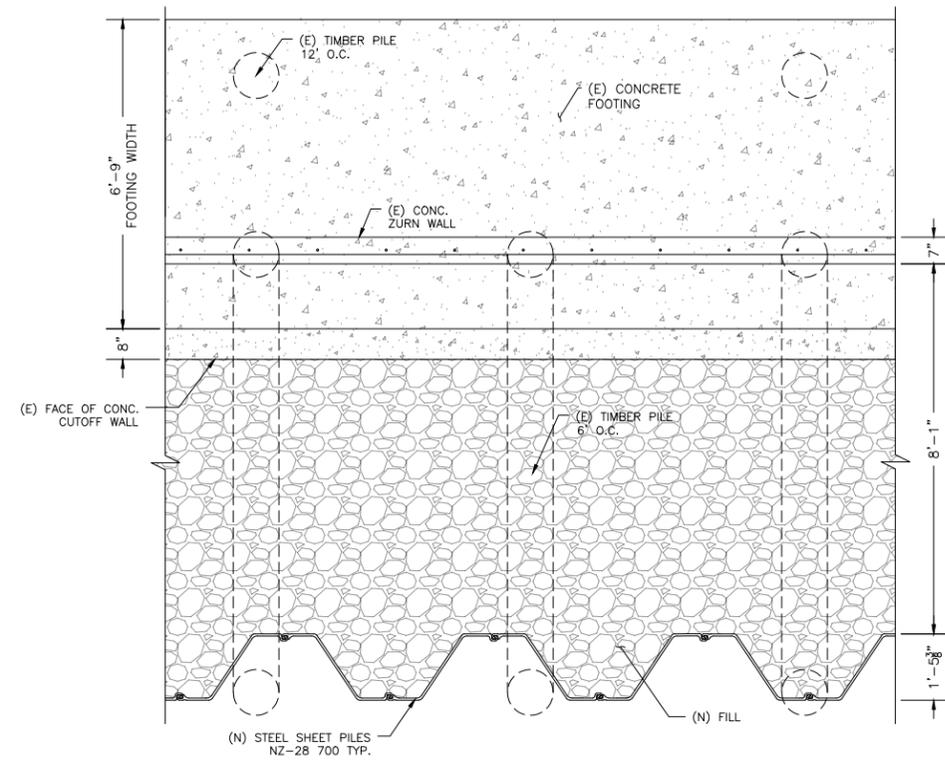
Figure 20

This scheme is essentially the same as the steel sheet pile wall option discussed for the Boise walls. (See Figure 20)

**E SECTION: OFFSET SHEET PILE OPTION - ZURN WALL**  
 SCALE: 1/4" = 1'-0"  
 NOTES: FILL QUANTITY = 99.0 CF/LF

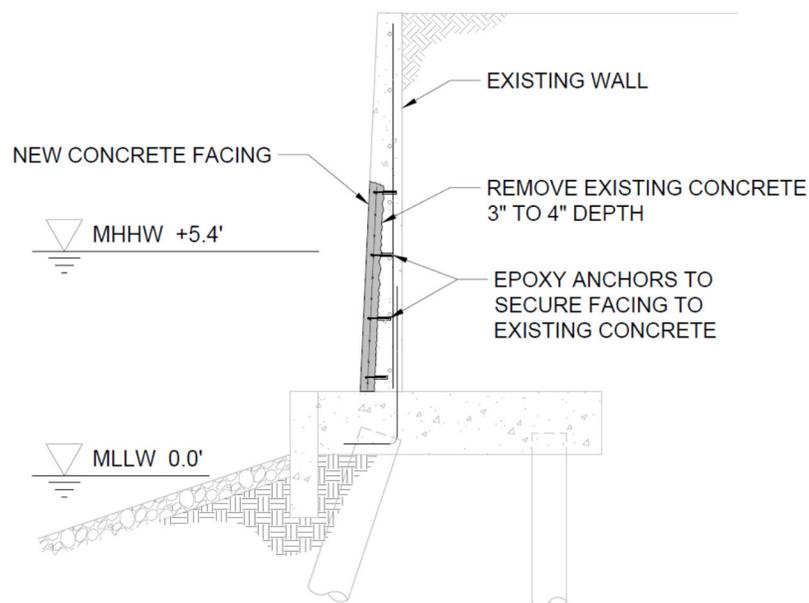
- May require shoring of the wall until new concrete has cured
- Extension of design life unknown
- Does not address seismic vulnerability

Figure 21 - Remove and replace surface concrete

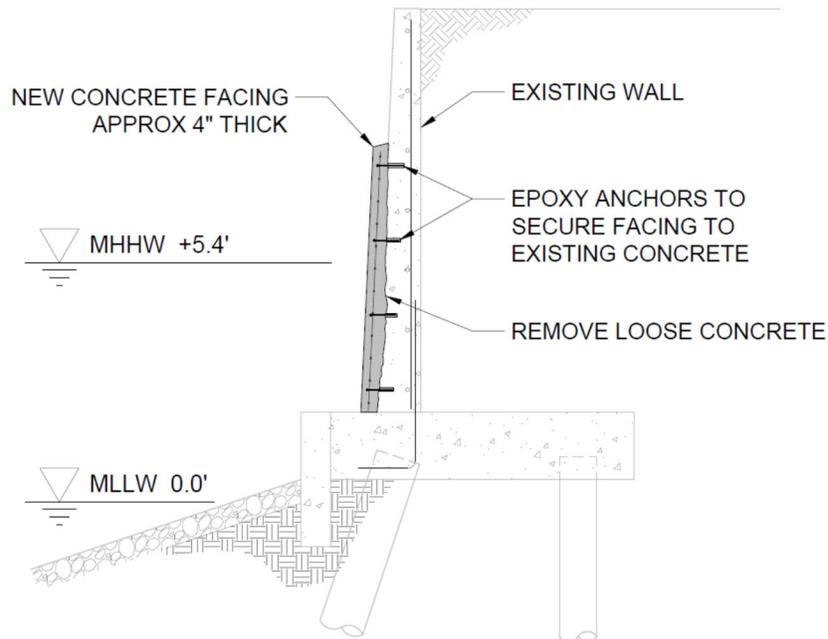
- Creates a barrier layer limiting seawater penetration to the existing concrete slowing the alkali silica reaction and reinforcing corrosion.

Figure 22 - New concrete facing

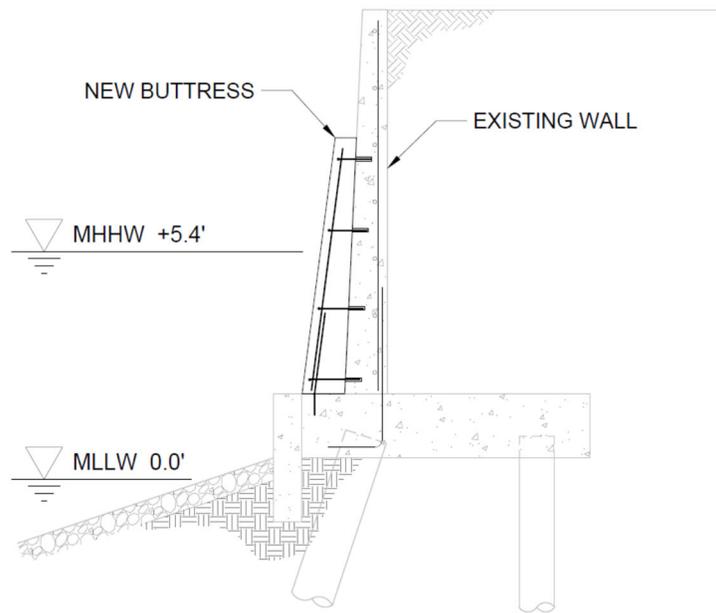
- Does not protect existing concrete between buttresses, so deterioration of the wall face will continue unabated.
- Deterioration could undermine the interface between the buttress and the existing wall, weakening the repair and shortening its effective life
- Continuing degradation of the wall face will be unattractive and could be concerning to residents
- Does not address seismic vulnerability

Figure 23 - Buttresses
